The John Bowne House

Flushing, Queens County, New York
A Preliminary Architectural Analysis Report

Prepared by
John R. Stevens

Published October, 2003

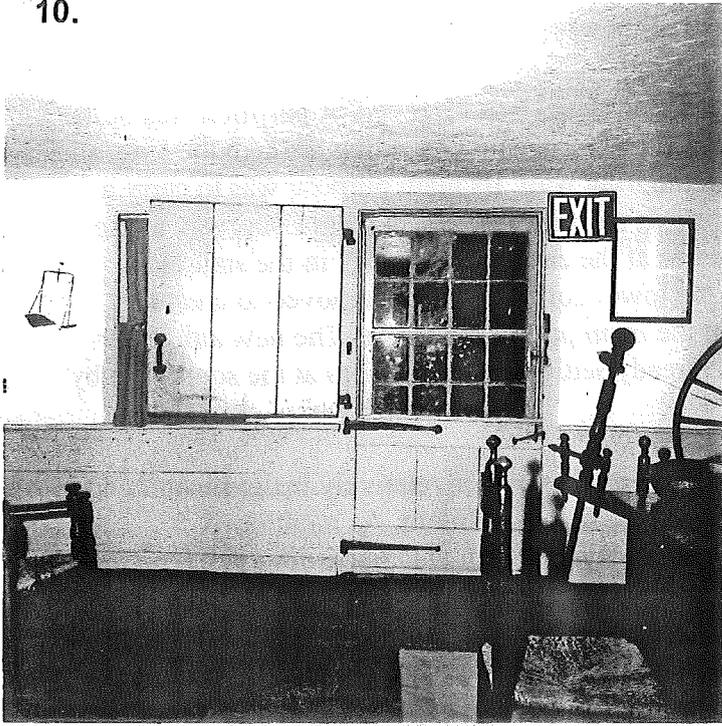
Doorway in south wall of kitchen wing.

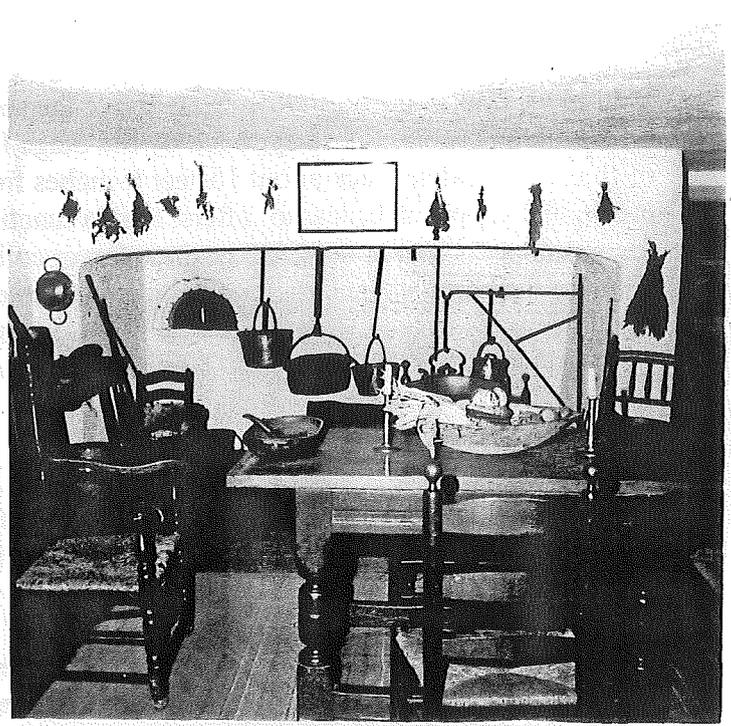
East wall of the kitchen wing showing fireplace with bake oven door in its back wall at north side. Fireplace may be from Stage III.

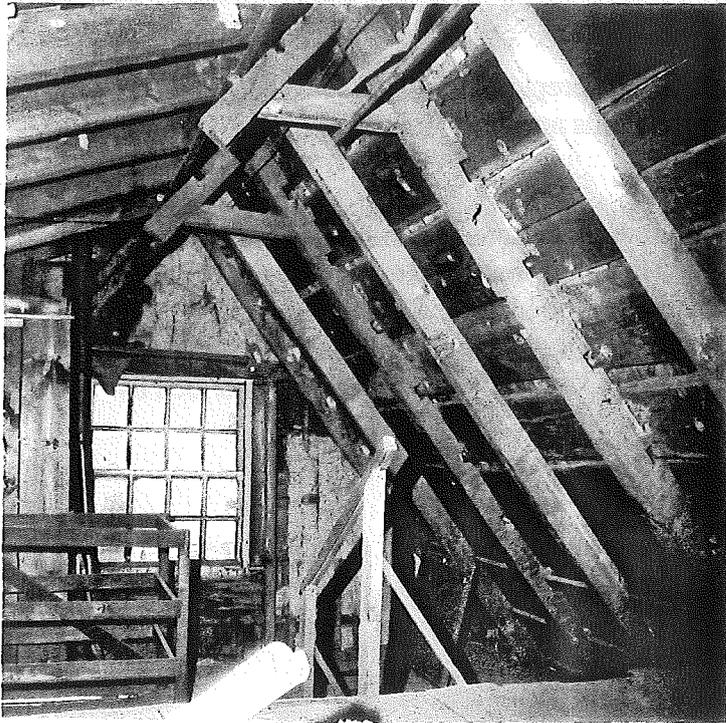
East gable of house, original Stage I pit-sawn rafters. Stage II rafter boarding and Stage III window and infill. Intermediate rafters added in Stage IV

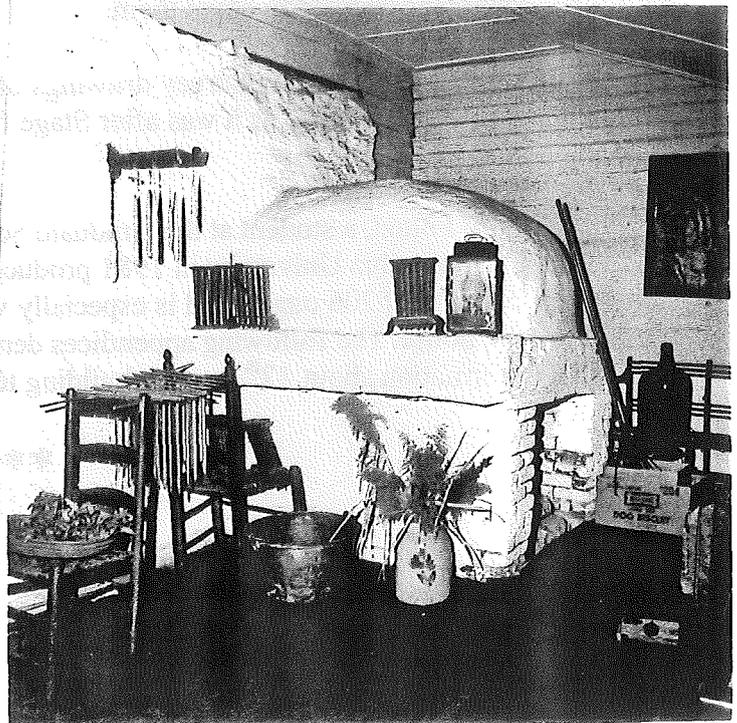
Dome of bake oven within leanto on east end of kitchen wing
