April 30, 1993

Inspection of Barns in Plattekill and Gardiner, Ulster County, NY

by Maggie MacDowell and Peter Sinclair

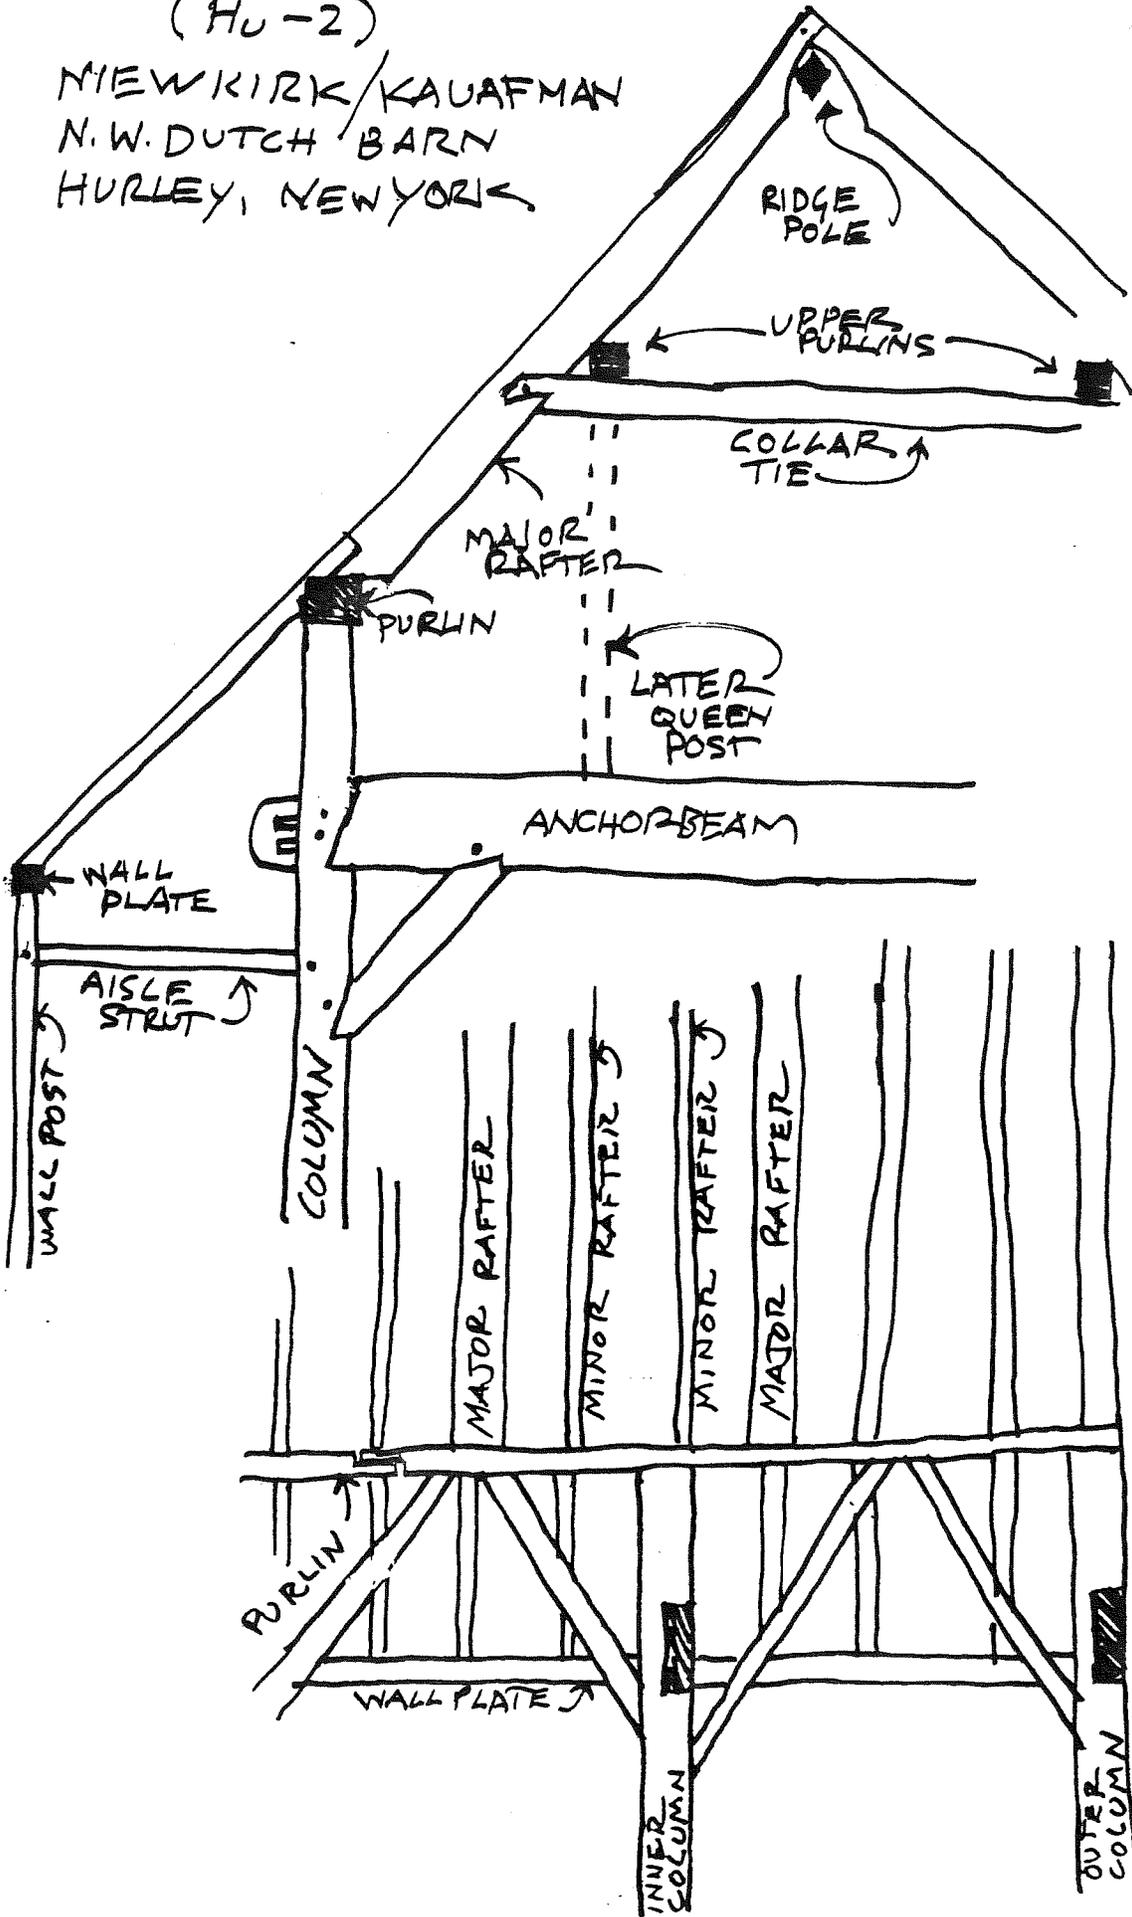
MIEWKIRK/KAUFMAN
N.W. DUTCH BARN
HURLEY, NEW YORK

The lower drawing is a partial side view as seen from inside looking out. One unusual feature of the Niewkerk barn is the splicing of the rafter on the purlin. The use of continuous tapered rafters of equal dimension, which are balanced on the purlin, is a distinguishing feature of the New World Dutch barn wherever it is found. The fact that the Niewkerk barn has spliced rafters puts it in a special category.

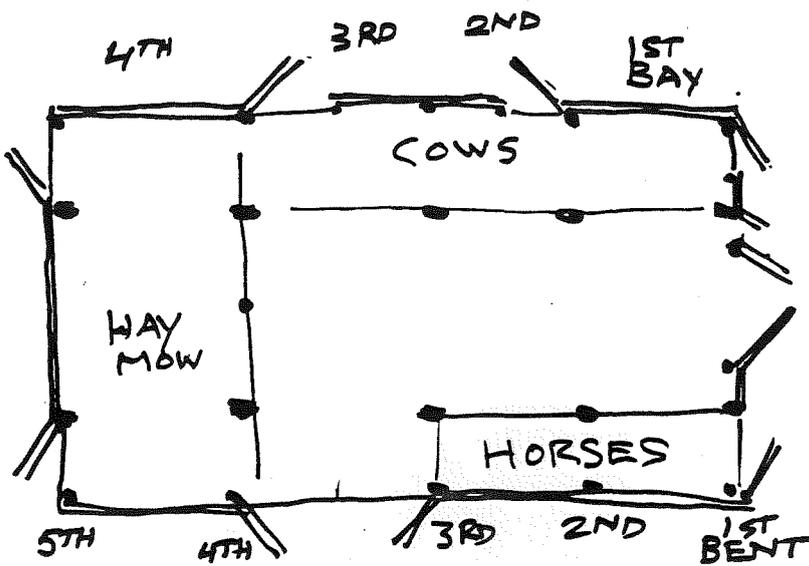
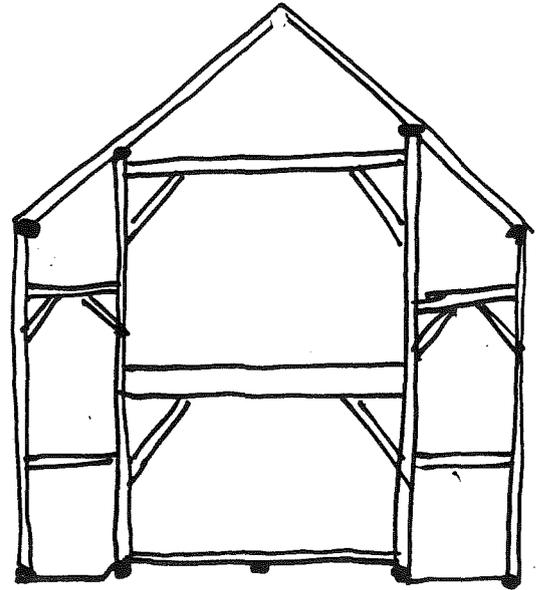
UNMEASURED DRAWING, Hardenberg barn, A. floor plan and B. fourth-bent

No measurements were taken but the columns and posts are tall and the bents have many struts and braces, typical of 19th century elaboration on the true form. There are some reused anchorbeams from an earlier barn. The Hardenberg barn is still used for farm storage and the interior retains a number of original features and evidence of stalls. A possible sheep room or converted granary in the fourth bay was interesting, as well as a long shaped pole which

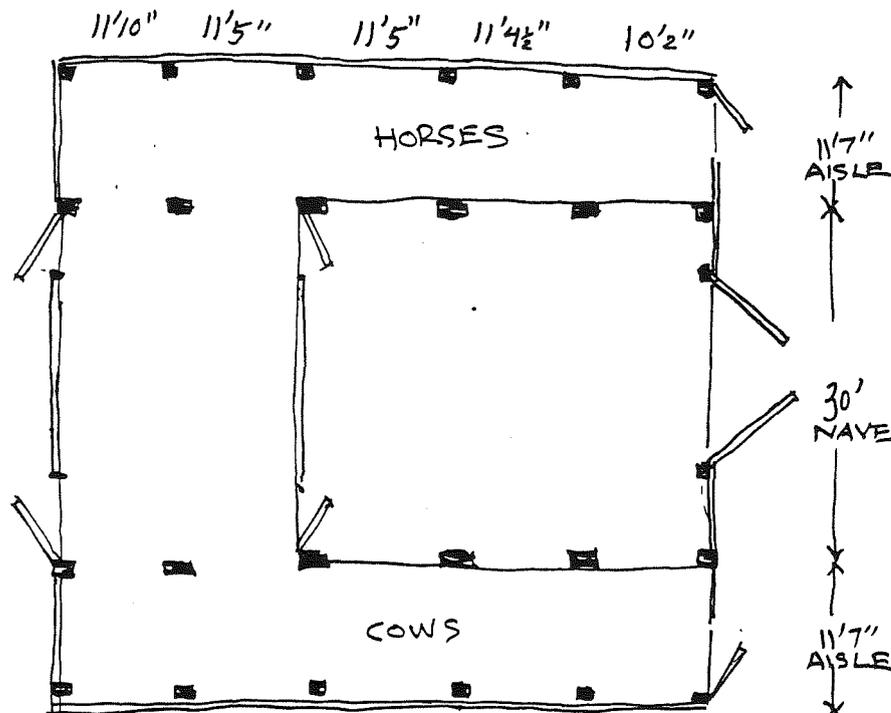
DRAWING, Decker barn floor plan. The side aisles could have been widened when the roof was raised. The bay widths seem original.

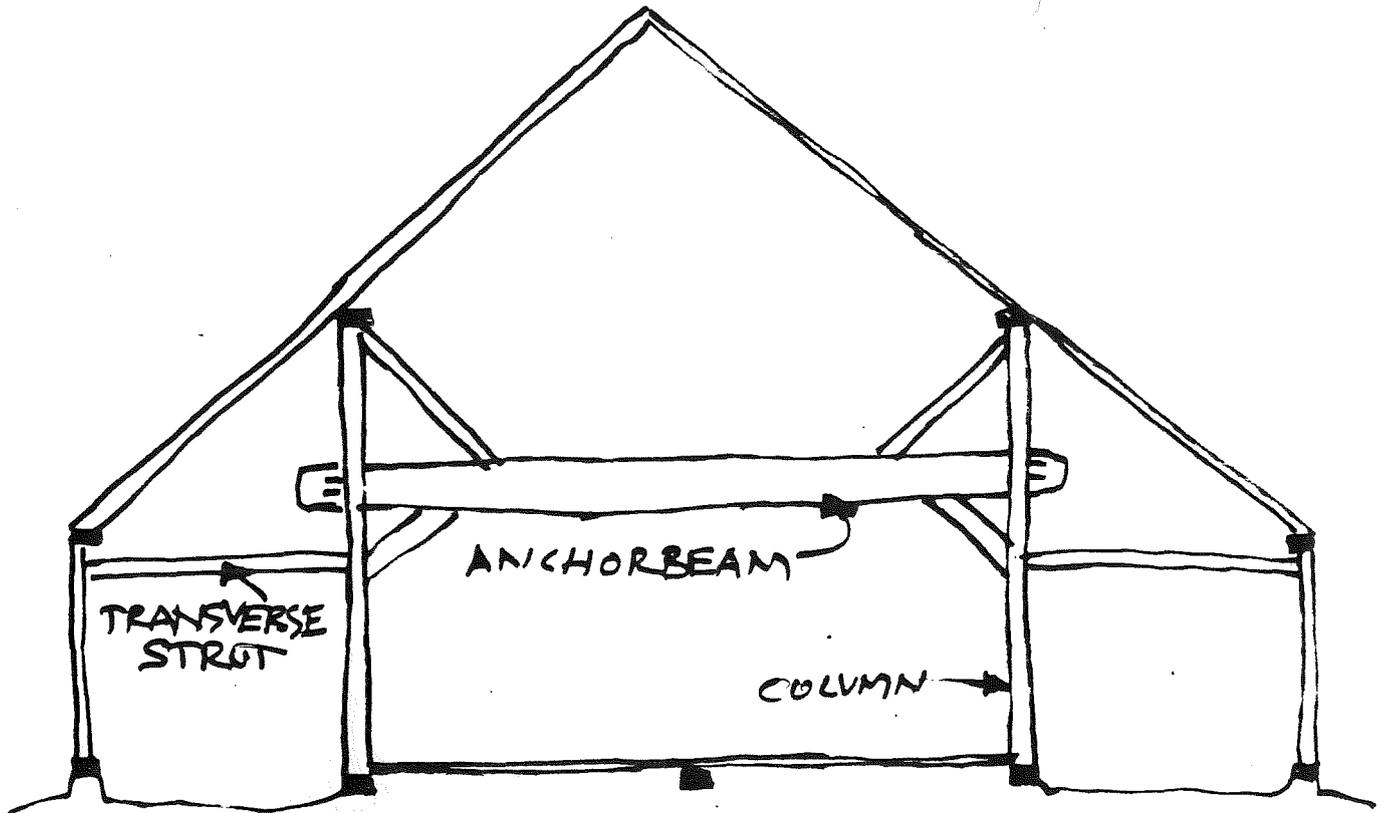
DRAWING 2. Wolven (Sa-2) barn, internal bent.

The long upper-braces in the H-bent are a unique example for Ulster County. Upper-braces are occasionally found on Dutch barns in other areas and the upper or rising-brace is characteristic of early barns in Nassau County, Long Island.

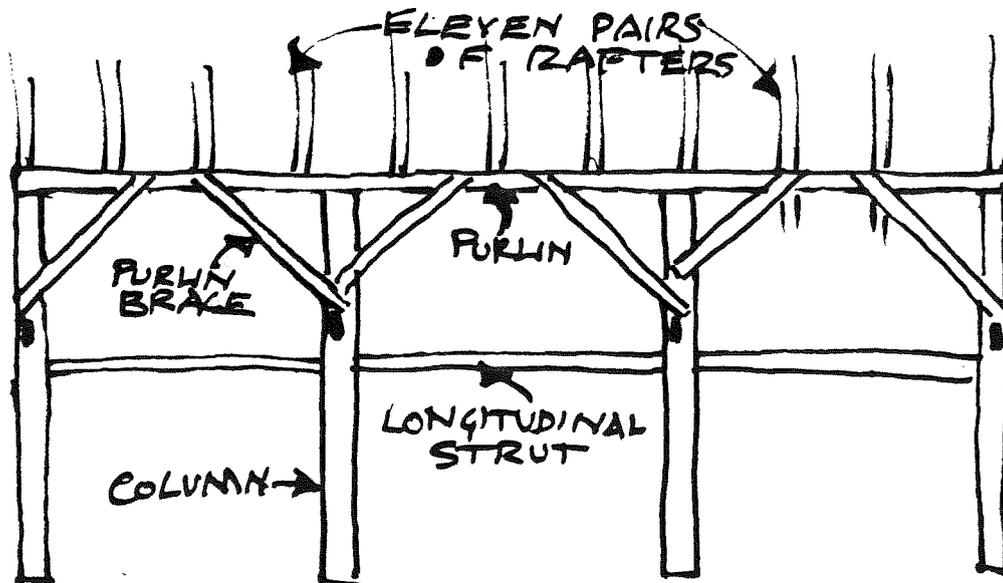
DRAWING 3. Wolven (Sa-2) barn, internal columns, longitudinal struts, purlin braces, purlin, and rafters.

The purlin braces are shorter than those of the Decker (Sh-2) 1750 barn in Shawangunk or the Kiskatoon barn (Sa-6), a second period barn built just north of here. It is an indication that the Wolven barn is a third period barn.

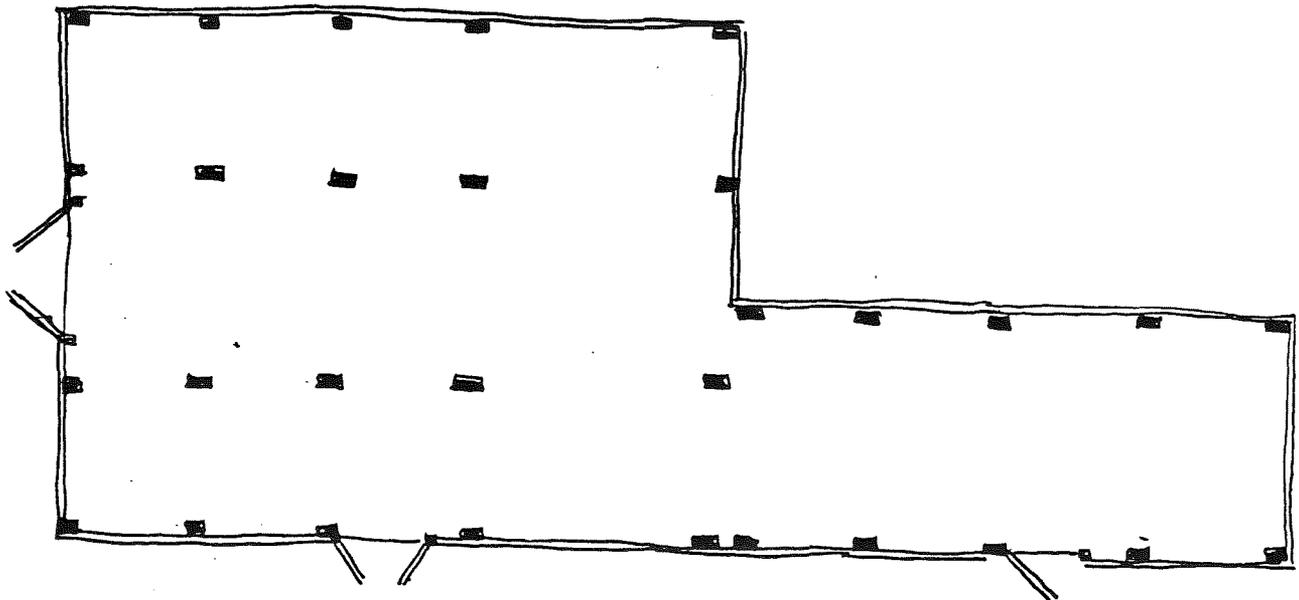
DRAWING 1. Elting/Kelley barn floor plan.

DRAWING 2. Elting/Kelley barn re-used 12"x14" collum in basement. This fragment of a column is reversed in the barn and represents only a part of the original timber. It may have been from a grist mill.

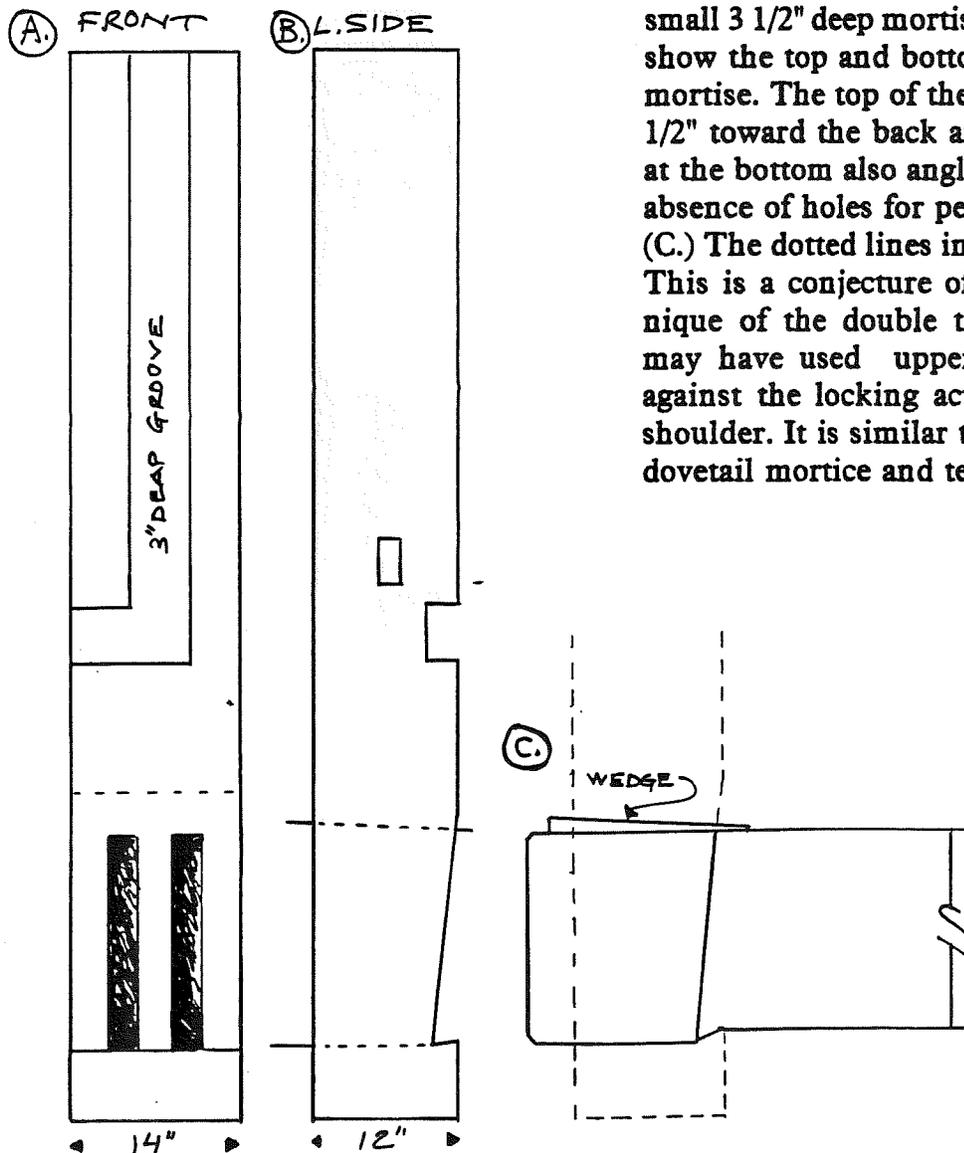
(A.) This front view shows the 3" deep L-shaped groove and the double 2"x17" through-mortises below it. The dotted line indicated the beginning of the diminished shoulder.

(C.) The dotted lines indicate the column. This is a conjecture of the joining technique of the double tenon beam which may have used upper wedges to set it against the locking action of the angled shoulder. It is similar to the thru wedged dovetail mortice and tenon.

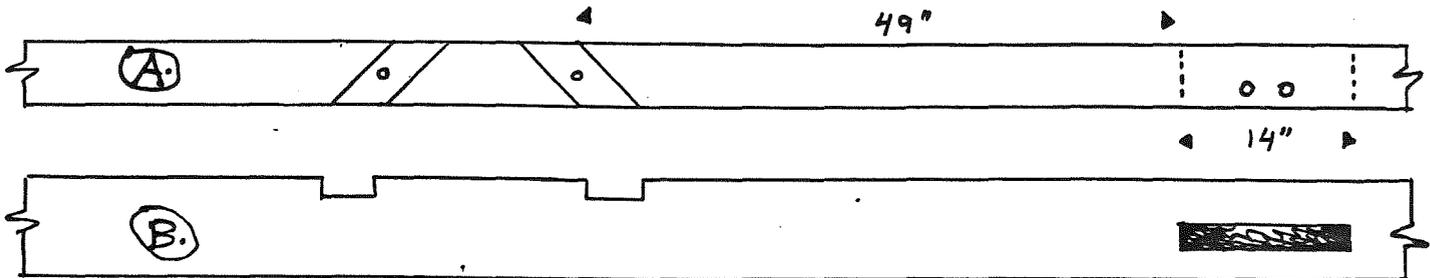
DRAWING 3. Elting/Kelley barn, re-used 5"x8" timber. This timber was re-use as a floor joist. The view of the outside face (A) shows the open grooves and peg holes which originally held the lap-dovetail braces. Their angle is an estimation. The dotted lines on the right show the 14"x2" through mortise and its two peg holes. The view of the bottom face (B) shows the offset mortise, 3 1/2" outside shoulder, 2" through mortise, and 2 1/2" inside shoulder. I had assumed that this was a purlin plate from an eighteenth century barn, perhaps part of the frame of the re-used H-bents in the small barn. Greg Huber feels that if it were a purlin the through mortise should be offset toward the outside.

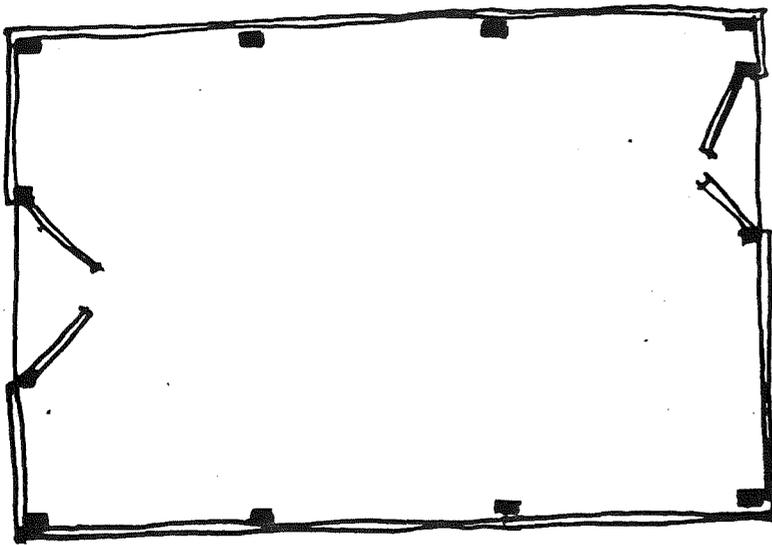
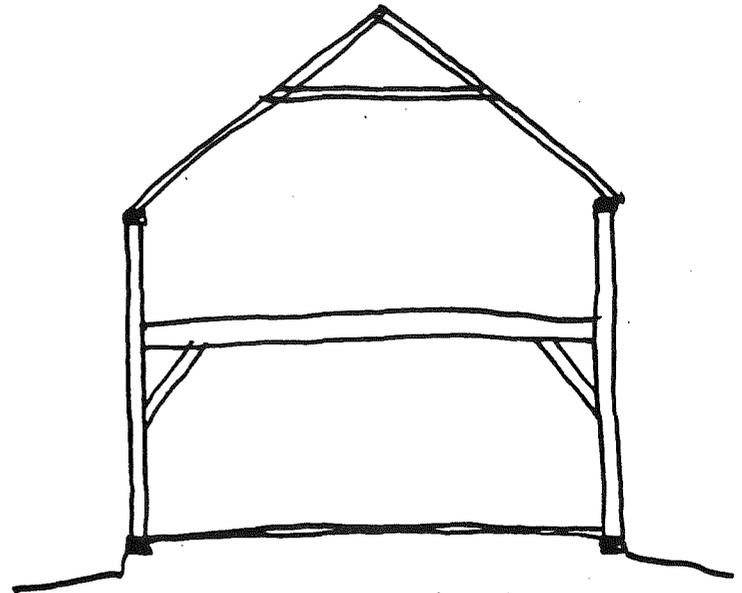
Drawing 1. /Gazlay Dutch barn (Ro-6) Internal H-bent and floor plan.

/Gazlay Single aisle Dutch barn (Ro-6) This is a rare but true-form single aisle Dutch barn which originally had wooden hinged doors at either end. It is accompanied by a two story brick house which was built in 1815 by a family from Connecticut. Every other pair of rafters in the barn have collar ties, evidently to compensate for the missing aisles. The rafters are bird-mouthed to the wall plates. The anchorbeams free span the 30' width. It has three bays and is 45' 5" long. All braces are hewn. One internal anchorbeam measures 14" high at the column and 17" at its midpoint.

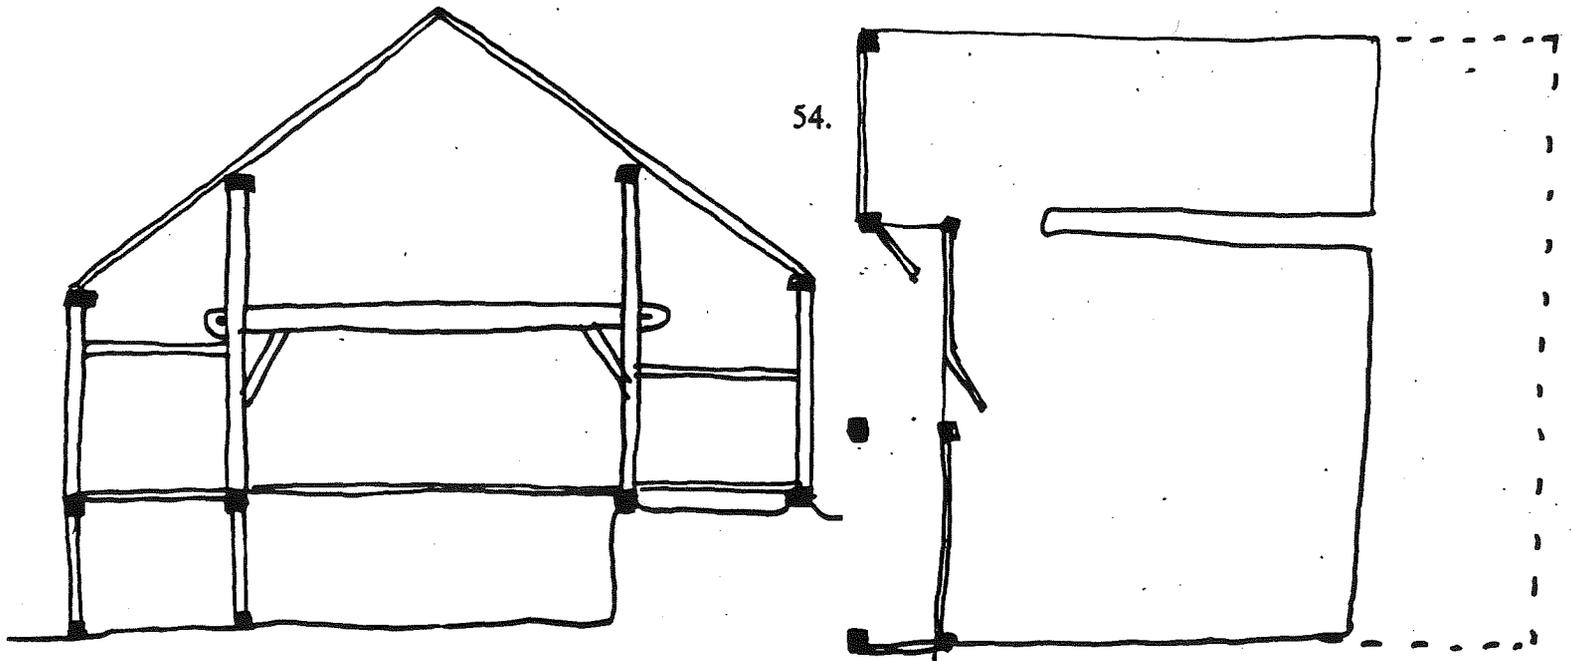
Drawing 2. ___/Cirlin Dutch barn (Ro-7) H-bent detail and basement floor plan with open bay.

/Cirlin Dutch basement barn (Ro-7) This three bay barn on Whitfield Road is 246' from its stone house with 3,540 square feet of floor space and reputed to date to 1720. A section of the barn roof over an aisle has collapsed. The property is on the market for \$187,000 so that the barn will probably not be repaired and will certainly deteriorate fast. The barn contains a number of features worth a more detailed study. One internal anchorbeam measured 12 1/2" x 8 3/4" at the column and 15" x 9 3/4" at its midpoint. One column measured 9 1/2" x 13 1/2".

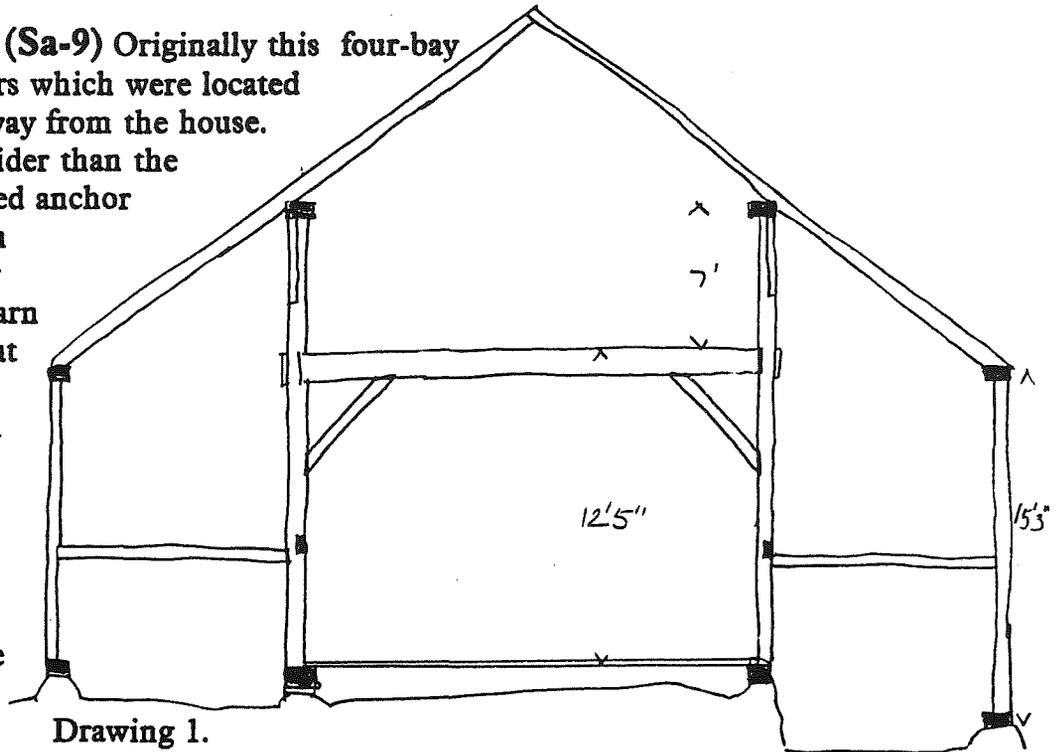
Drawing 1.
Brink/Muller Dutch Barn (Sa-9) Internal H-bent

Brink/Muller Dutch Barn (Sa-9) Originally this four-bay barn had one set of wagon doors which were located on the end wall which faced away from the house. The bay toward the house is wider than the other three bays and has lowered anchor beams as is commonly found in U-barns. The present two-story frame house is later than the barn but its foundation suggests that it is on the site of the original early 19th century house which was probably built at the same time as the barn. The lowered beams were removed and wagon doors built into the end to make it a drive-through barn. It has a lowered side aisle and there is evidence on this side of a stake manger. All the braces are hewn. It is a scribe rule frame without extended tenons.

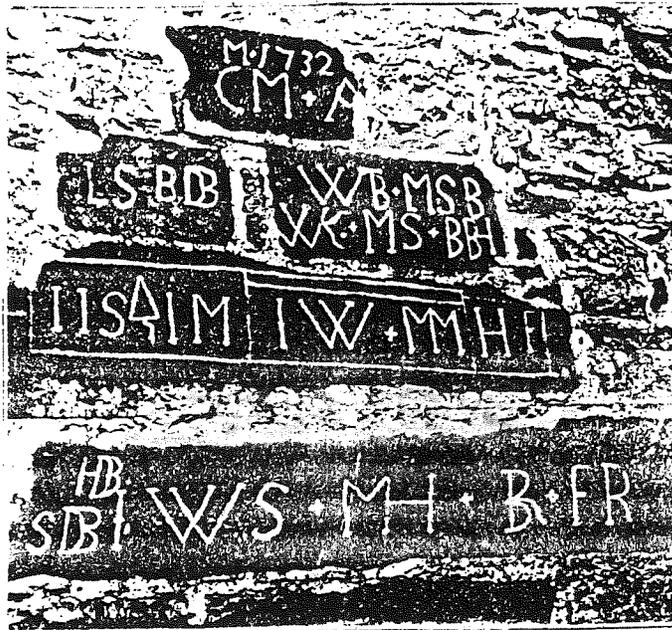
Photograph, Stones in the Back Wall of the Katsbaan Church

The marriage and baptism stone dated 1742 in the foundation of the house is probably related to those in the back wall of the nearby Katsbaan stone church which was built in 1732. The inscription on the 1742 stone refers to Frederich Rau who during the Revolution joined the British Army. Rau plays a part in one of the most interesting local stories of the Revolution, the captivity of Snyder and his son at their Blue Mountain farm by Indians who took them to Canada. Some Rau and Eiligh families had Tory sympathies which was not appreciated by the Loyalist majority. This may account for the placement of the stone in a back basement wall. The more modern "DRA" stone associated with it adds to the mystery which remains to be uncovered.

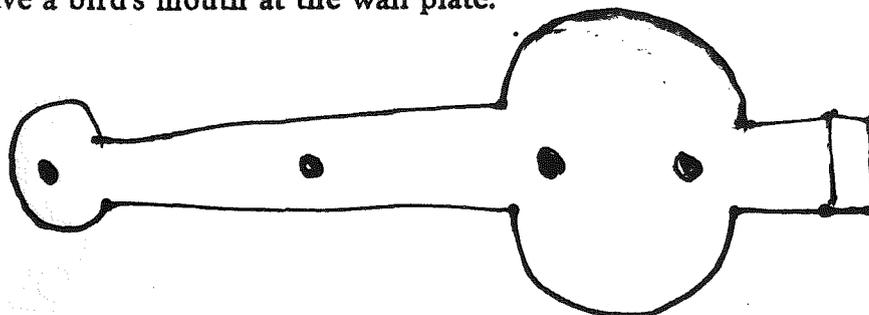
Drawing approximation, Small Pad Hinge, Schrom barn (Gh-1) This hinge is on a small door placed high on the back end of the barn.

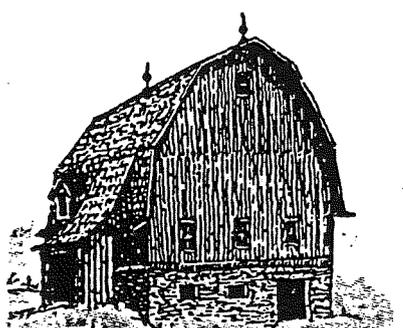
**DUTCH
GAMBREL ROOF BARN**

Extension of roof called a "Dutch Knuckle." Barn door above opened onto thrashing floor below.

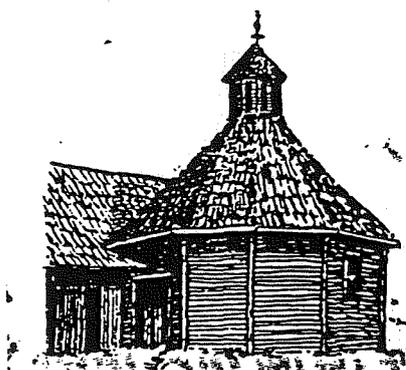
**NEW YORK
CLAPBOARD BARN**

Built in the utopian shape
O of the perfect circle.

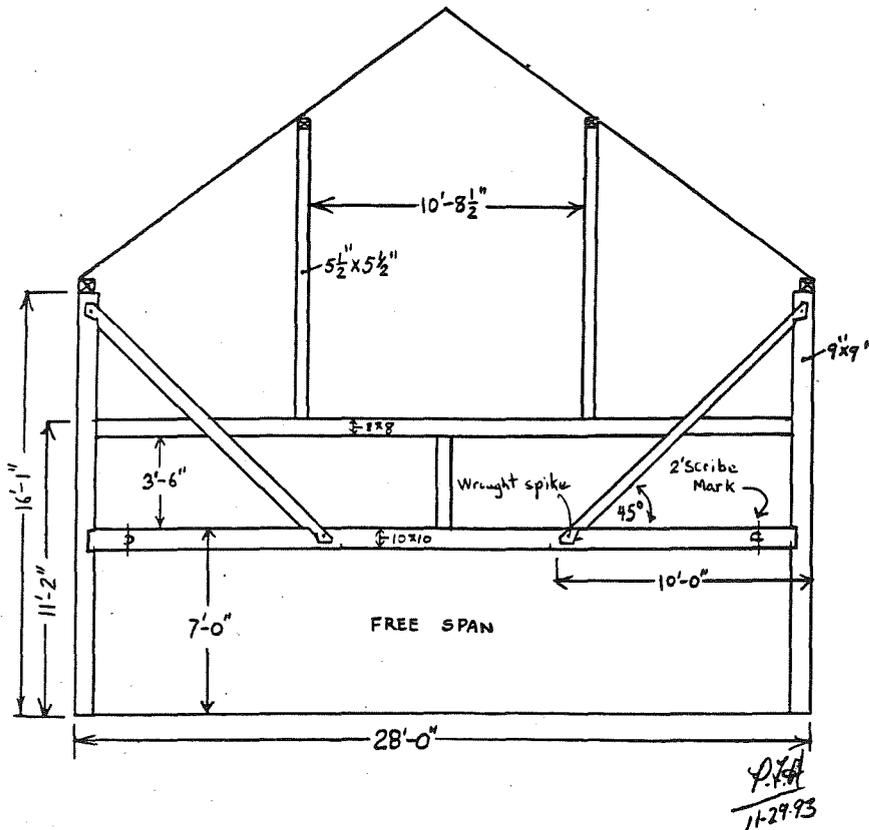
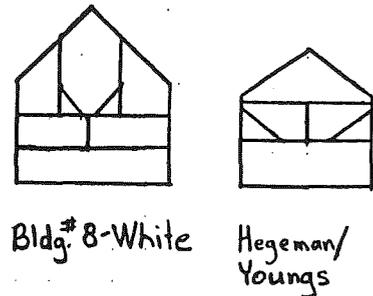
Drawings by P. Haarmann, Bent #2 of The Duryea Large Barn with Side Entrance and Bents of Three Long Island Barns with Rising Braces The use of *rising braces* on the bent is a regional characteristic of Long Island timberframing.

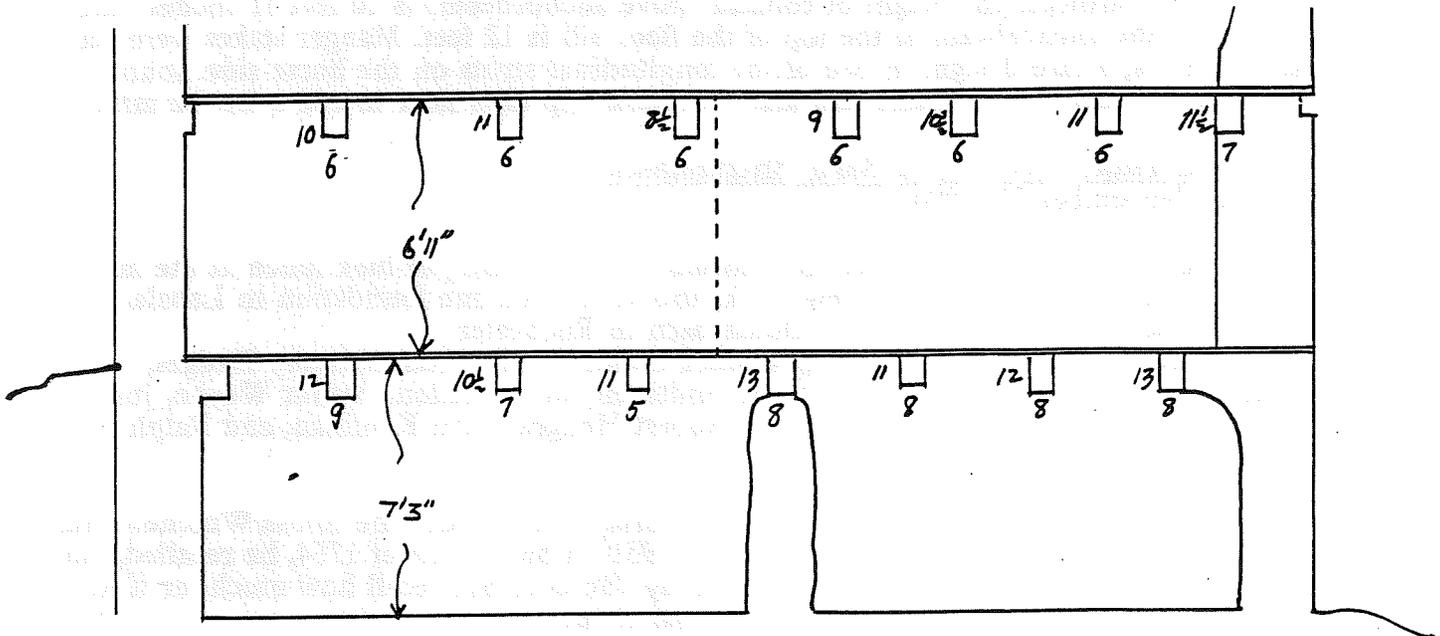
The drawing (above) is of the original two-room stone house in Lamontville and shows the distribution and dimensions of beams. The basement kitchen fireplace has a trimmer arch to support the hearth of the one above. There were only two fireplaces in the original house. A one-room stone addition was made later. There were once hanging shelves in the far room on the left.

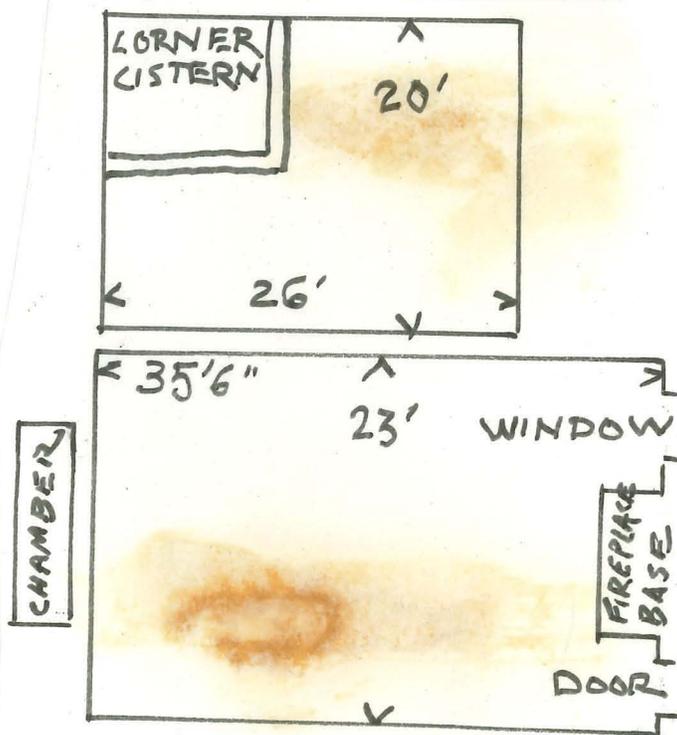
Dawing 1.

The next house foundation was closer to the river. It measured 23'x35'6", had a fireplace base at one end, and a small stone chamber in the ground outside the basement at the other end. This chamber is thought to have been a hiding place from an Indian attack. It might have been a water cistern, although most house cisterns in this area seem to have been added within the basement as in the 20'x20' foundation up the hill. The walls of this small chamber are pitched in and stuccoed. The top is capped with large slabs of bluestone. A round tile was placed in the upper right corner. chamber can easily hold three adults and two children.

A number of hand made bricks were used to frame a basement window to one side of the fireplace. They measured 1 3/4" x 3 3/4" x 7 1/2". They were highly fired and some had areas of black vitrified glaze. There were a number of low foundations without basements.

Upper and lower stone foundations on former DuBoice farm

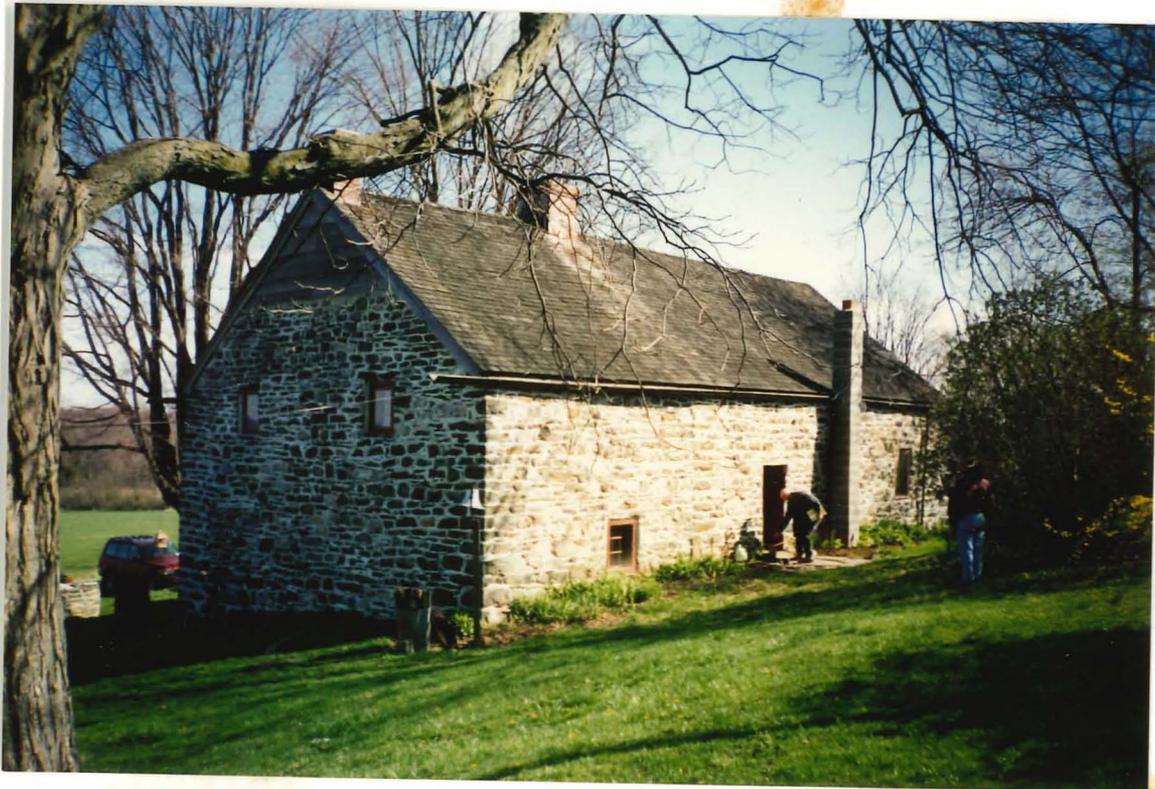
Photograph 1.
Back of the Terwilliger/Coomer stone house, by John Stevens

We last visited the Terwilliger/Coomer stone house on Myers Road. It was built in two 27' wide sections, 17'1" and 36'2" long. Its date-stone in the longer section reads "1770 MM". It has many early features in its woodwork and hardware. There are four rectangular mortises in the floor of the loft which may have been for a loom. One interior door has a pair of Germanic L-shaped hinges with braced pintals. The house has been carefully preserved.

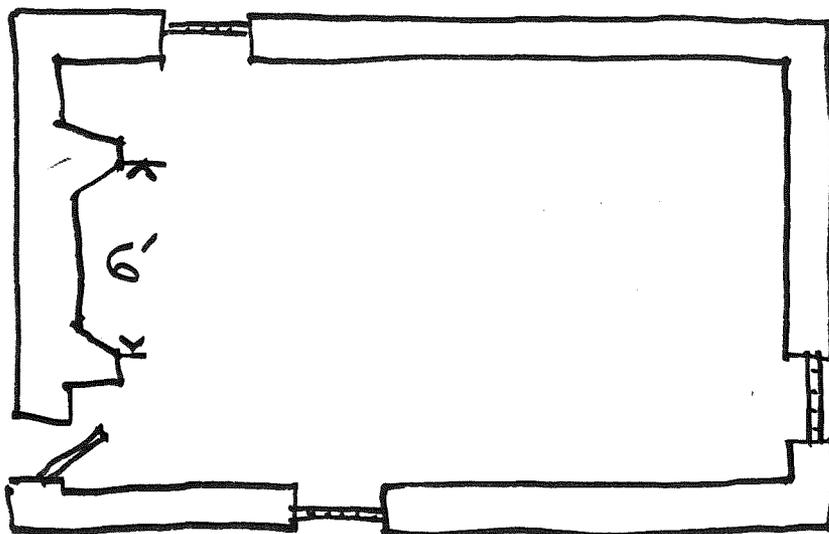
Drawing, Basement (the placement and size of elements are from memory)....The kitchen fireplace is 6' wide and has a crane with a short vertical member, and set with distinctive pins into the masonry. There are two one inch holes bored into the chamfered wood lintel, as in the Gazley house in Accord. Are they for pegs to hold tools? The trimmer arch above the fireplace is corble and rests against the joist.

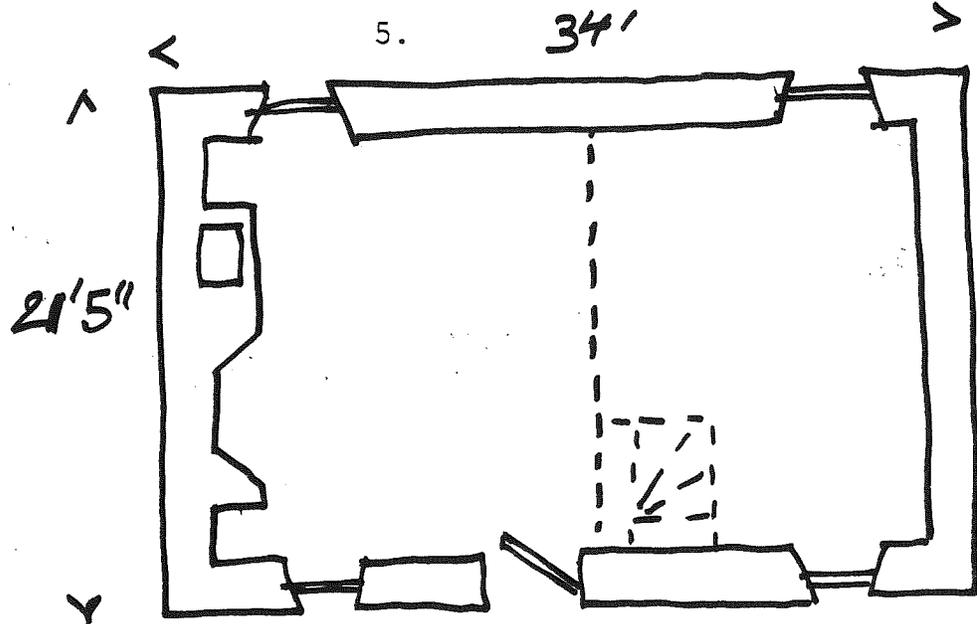
Drawing First Floor....The fireplace is set to the side for the flue of the basement fireplace and the stone wall behind it continues to the peak. On the other end the stone wall ends at the top of a garret window. First floor window frame measures 33" x 48" outside. Most of the wood on the inside of the window frames was burned away by the fire. Some large blocks of hewn wood are used as nailers in the stone work around the windows. They may be joist cut-offs.

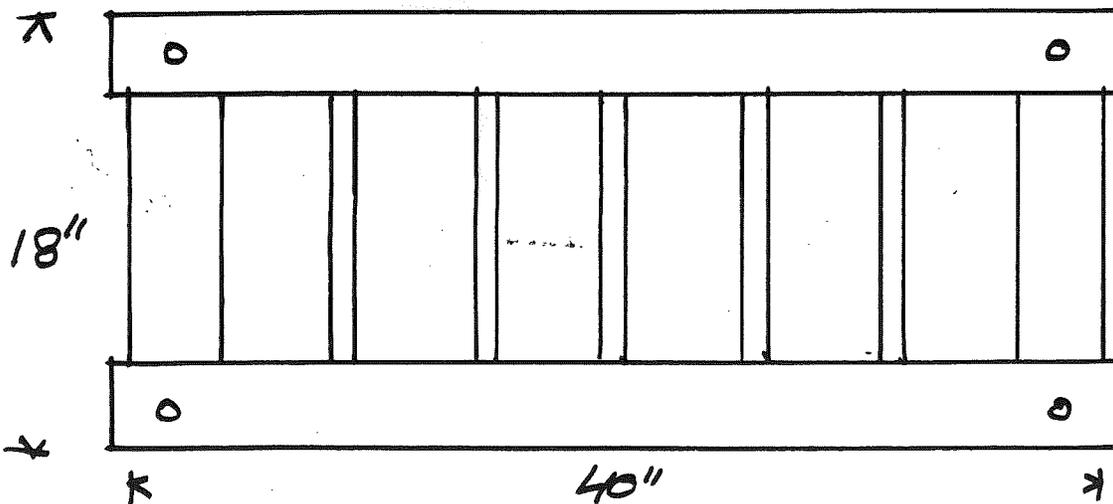
Drawing, basement window....The seven vertical oak bars were set into 7/8" diameter holes. Whether they were round or square in dimension can not be determined. These common basement open windows with bars never show evidence of how they might have been closed in winter. Did they fill the cavity with loose hay?

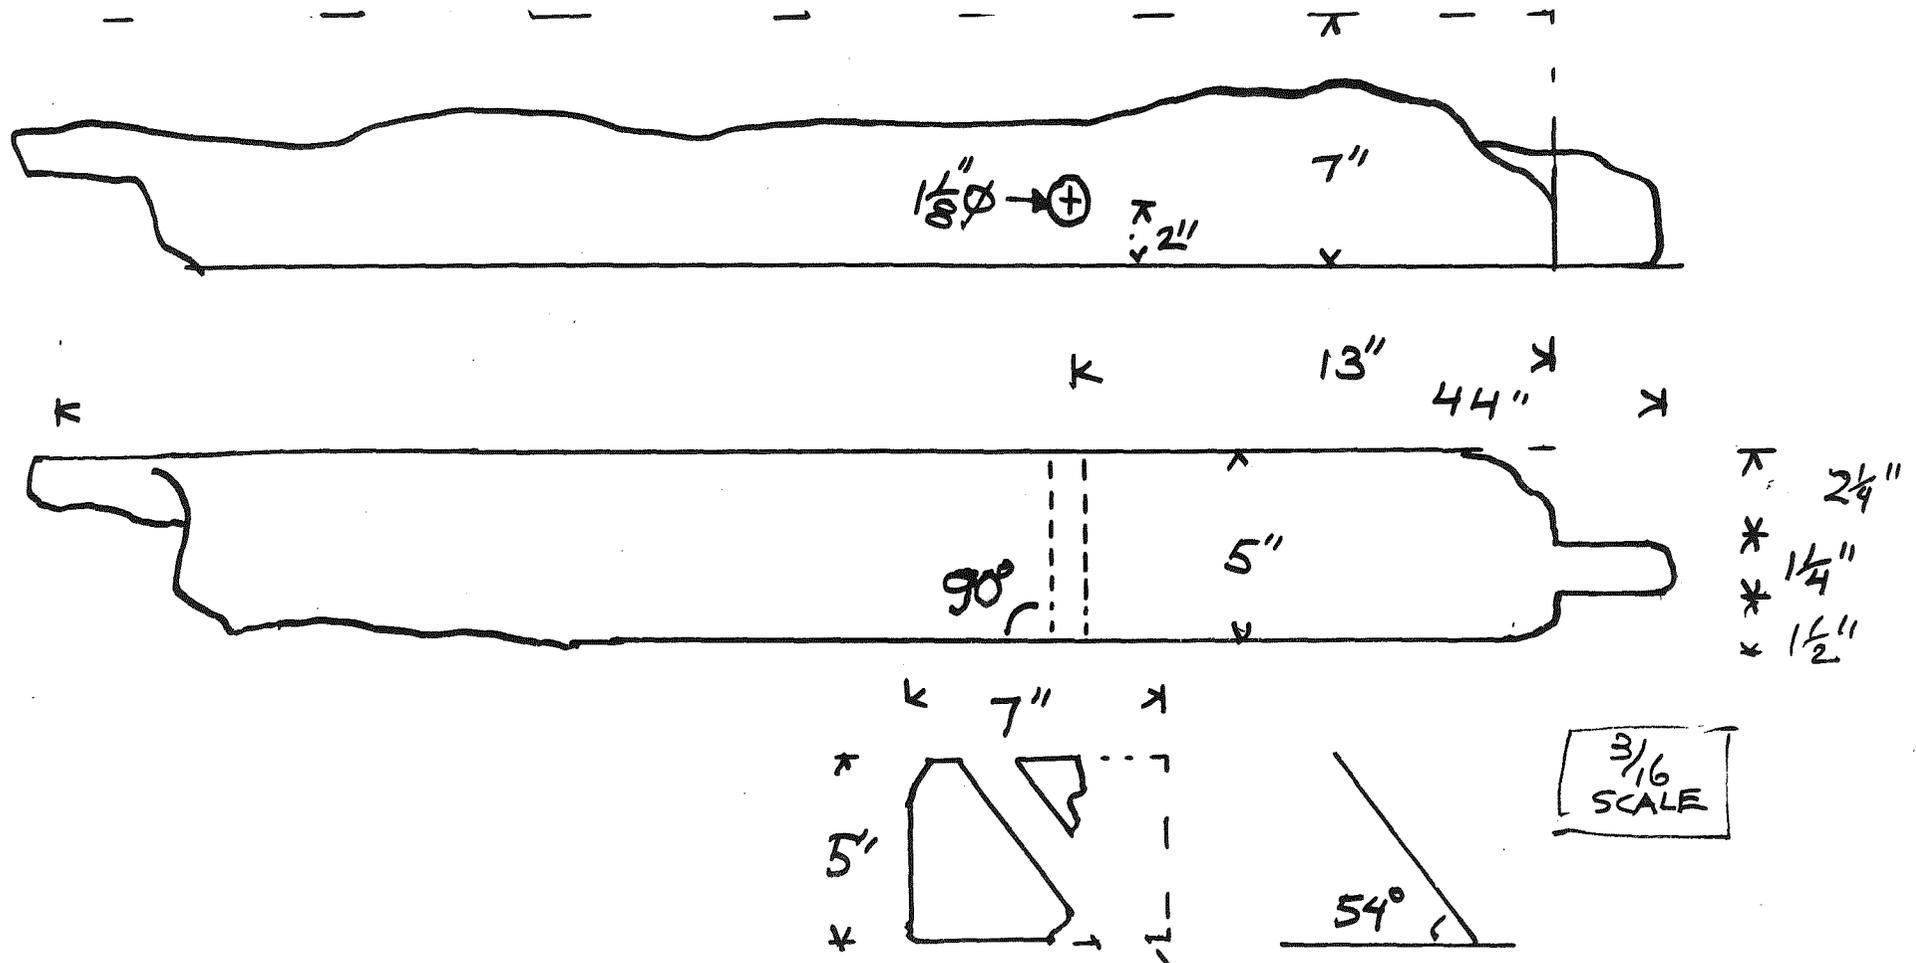
Two barrack plates of pine were found re used in a side wall of the Dam Dutch barn (An-1) in Columbia county. Although missing their original ends, they are the most complete examples yet known. We did not have a tool to measure the angles but have assumed them. The major rafter mortise is $1\frac{1}{2}'' \times 4\frac{1}{2}''$ and is cut through the plate. The minor rafter holes are $1\frac{1}{4}''$ in diameter and are not cut through.
