DUTCH BARN PRESERVATION SOCIETY NEWSLETTER

New World Dutch Barns of Bergen County, New Jersey (Part two)

By Gregory D. Huber

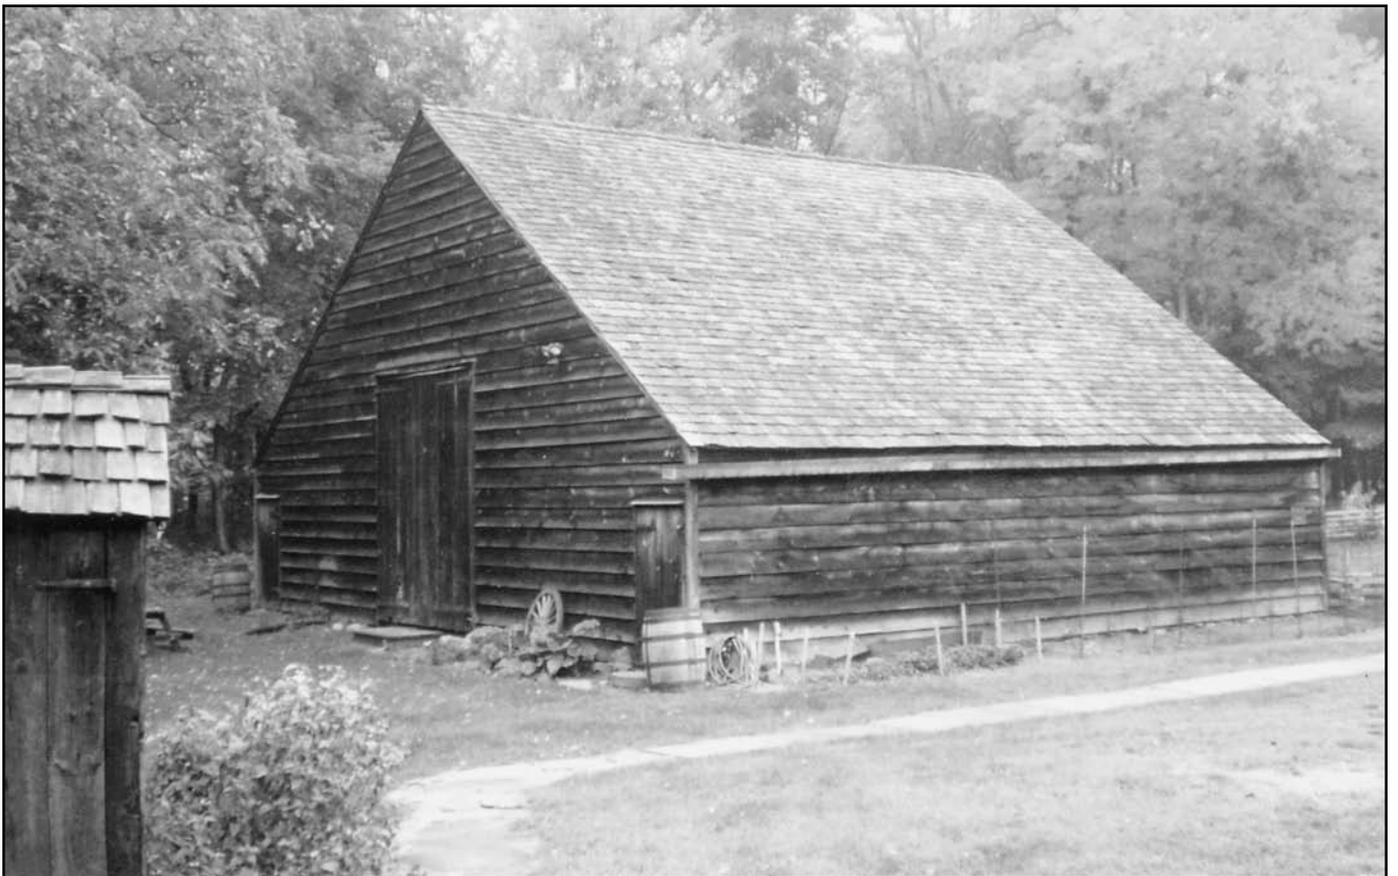
Frontispiece. Rebuilt three-aisle barn at the Hopper Goetschuis Farm Museum in Upper Saddle River, New Jersey was relocated about one mile away in its Anglicized form. The barn was rebuilt at the museum site in 1990 and only the H-frames, purlin plates and braces and south end wall wagon doors are original. H-frame posts have raising holes, a rare trait in Bergen County barns.

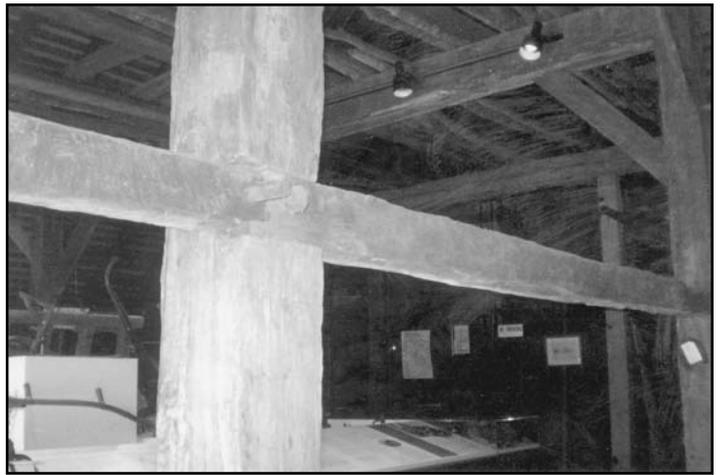
Photo 1. Interior of the c.1760 (dendrodated) Wortendyke three-aisle barn has longitudinal struts lapped onto widely slotted H-frame posts. These lapped struts are often seen in Bergen County and Rockland County barns and are considered a regionalism.

One interesting regionalism that is often seen in both Bergen and Rockland County barns are wide slots in H-frame posts, created to receive beams frequently referred to as “longitudinal head height struts.”⁸ The struts (Fitchen’s term) were lap-jointed over these slots (Photo 1). The slots were normally four to six inches wide and 2 to 2½ inches deep. They appear 3½ to 5½ feet or so above the threshing floor on the cow side of the barn. In barns that have lower side aisles these numbers can be somewhat misleading; in those instances the floor for the animals was at a lower elevation, with attendant lower placed slots for the struts. On the horse side slots generally appear eight to twelve inches higher than on the cow side in the same barn.

These slots are quite often oriented in the same direction. That is, on one range of H-frame posts slots faced one of the side or eave walls, while on the other range of posts the slots face the same side wall. One would presume that the timber framers would have positioned the slots in both post ranges in opposite directions; they would then face the adjacent side walls. The appearance of slots in H-frame posts, however, is not consistent in all Bergen County barns. Some barns have slots in all posts in one range while others have no slots at all of the type described. Barns in other counties almost never have these strut attachment slots. When these do occur in other areas, they

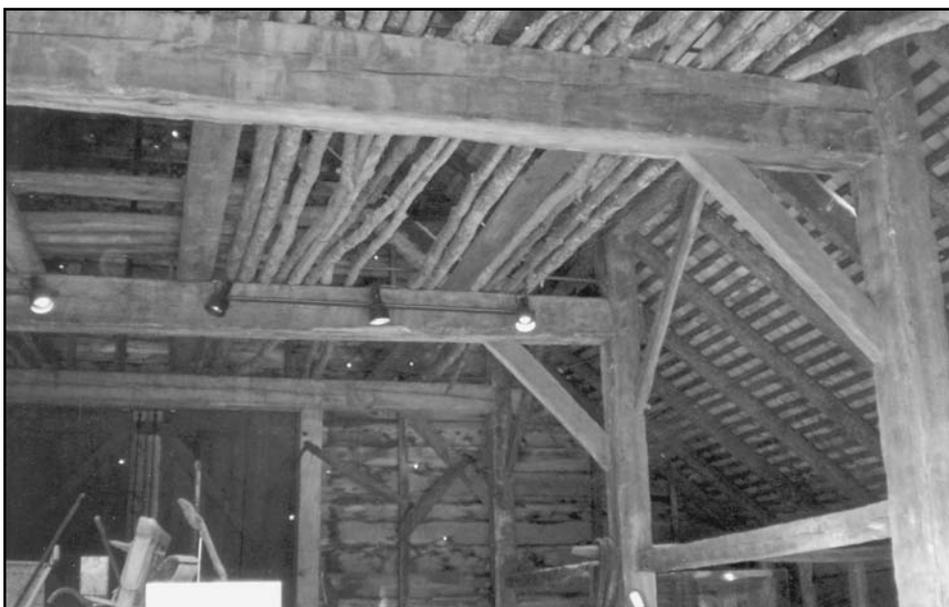
Photo 2. Interior of the Wortendyke barn, a good example of three traits that are often found in Bergen County barns. These traits include short *verdiepinghen*, purlin braces connected to H-frame posts two feet below the anchorbeams, and low side walls.

The earliest positively dated barn in Bergen County is the dendrodated 1760 Wortendyke barn. It has a 22 inch *verdiepingh*, six foot high side walls and purlin braces that attach about two feet below the soffits of the anchorbeams. As a group these are genuinely exceptional numbers. It is due to the fact that these barns have such short *verdiepingen* and attendant low side walls that only lower side aisle ties (“struts” in Fitchen) were used. Importantly, no barn is known to have upper ties, so often seen in upstate New York barns and many central New Jersey barns.

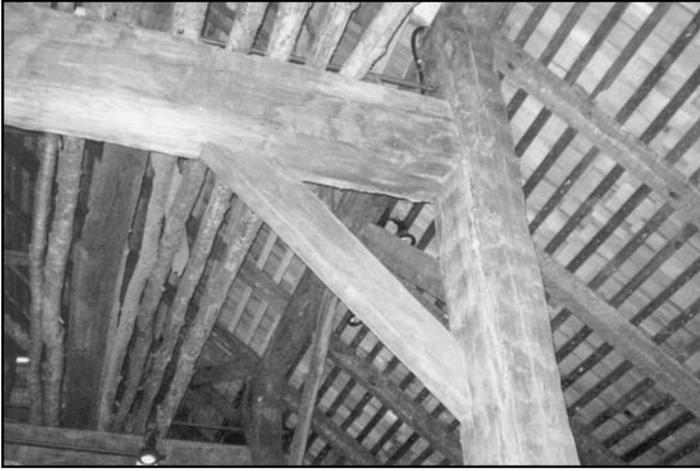
Photo 3. Interior of the Wortendyke barn. This barn has extremely short *verdiepingh* of only 22 inch length, which apparently precluded inclusion of raising holes.

Why do Bergen County barns typically lack raising holes? The ostensible reason appears to be the short *verdiepingen* in all the barns (Photo 3). Barns with such short post extensions above the anchorbeams could have theoretically used anchorbeam-to-post unions as a place where ropes could be attached for the raising of the bents. Use of such unions would have eliminated the chore of boring raising holes and thus save time in execution. This of course is speculation, and other scenarios explaining the manner in which H-frames were raised from horizontal resting positions to final vertical positions in Bergen County barns could be proposed.

As previously mentioned, the Wortendyke barn has both the shortest *verdiepingh* and the lowest side walls of any known three-aisle Dutch barn. The H-frame post extensions are quite short even among the barns of Bergen County. It is probable that most mid-18th-century barns, at least in the lower half of the Hudson River Valley and many areas of New Jersey and Long Island, had similar proportions to those of the Wortendyke barn. Only a few extant barns vie for the rarity of the Wortendyke’s proportions today. A five-bay barn in Ulster County off Route 209 in the Kerhonkson area has a quite similar exterior appearance and was likely built in the same era as the Wortendyke barn. Another barn of four-bay construction in Monmouth County has similar proportions.

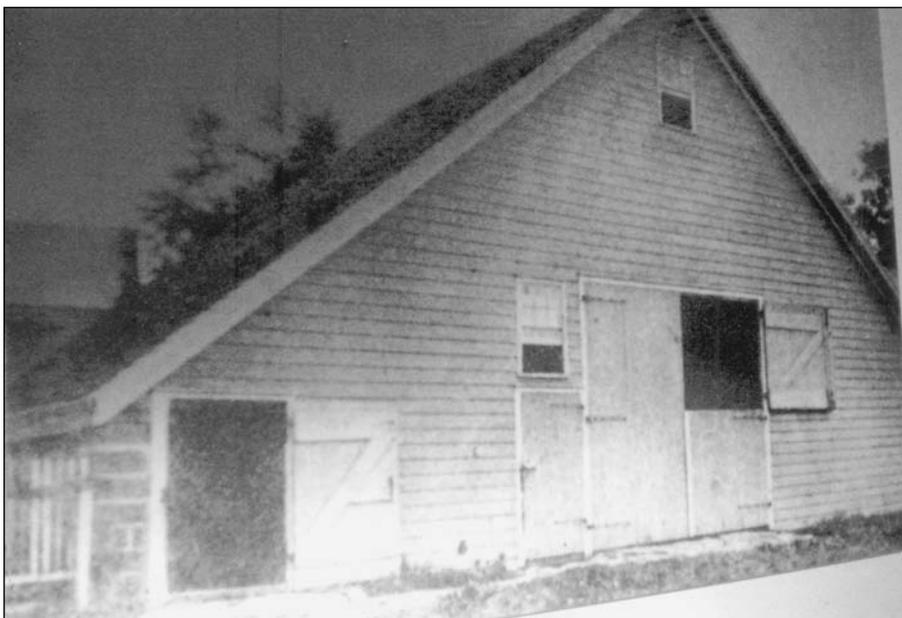
Photo 4. The 18th-century Zabriskie three-aisle barn in Paramus, New Jersey has low side walls and a relatively high peak, creating outstanding proportions. Note side wall at left with stone construction.

The rare four-bay three-aisle barn at the public golf course on Paramus Road in Paramus, north of Route 208, was first documented by the author in December 1991 (Photo 4). This is another unique Bergen County barn in that the side walls were completely of stone construction (Photo 5). No other extant New World Dutch barn can make that claim although one excellent three-aisle barn in Hunterdon County near Oldwick, possibly dating to before the Revolution, has partial end walls of stone. Few other Dutch barns had exterior masonry walls.¹⁵ The golf course barn has side walls of beautiful native brownstone often seen in New World Dutch houses in the county. An uncommon feature incorporated into this barn was the placement of a door immediately adjacent to the main wagon doors. The Larger Wemp barn (Fitchen barn No. 31), apparently the Wemple barn (Fitchen barn No. 32), and the Haring barn in Rockleigh are among a few other barns that share this trait.

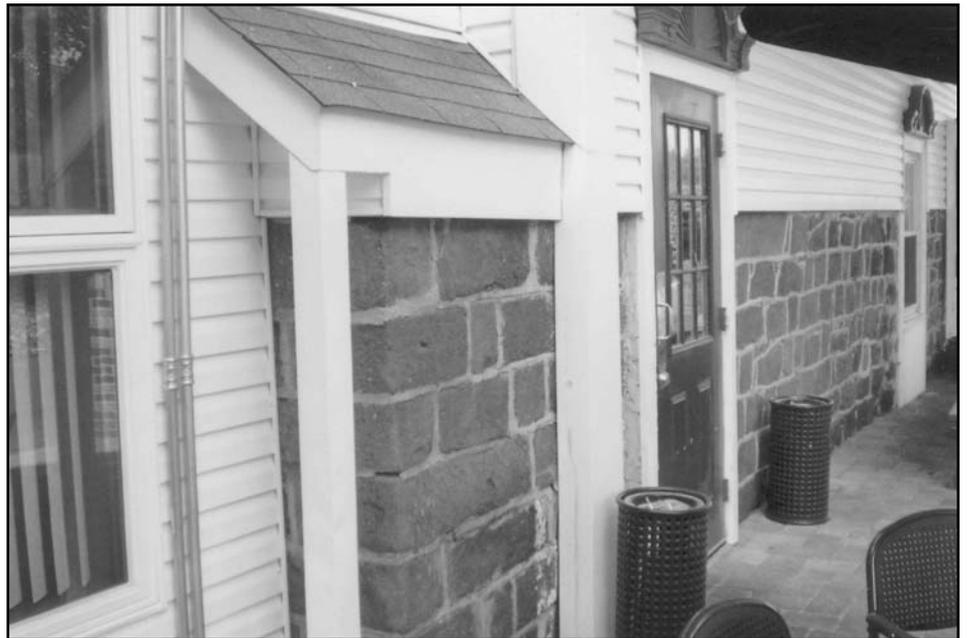
Photo 5. A detail of a side wall of the Zabriskie barn, the only known extant Dutch barn with side walls of stone construction. This native stone is often the same type seen in innumerable Dutch stone houses in Bergen County.

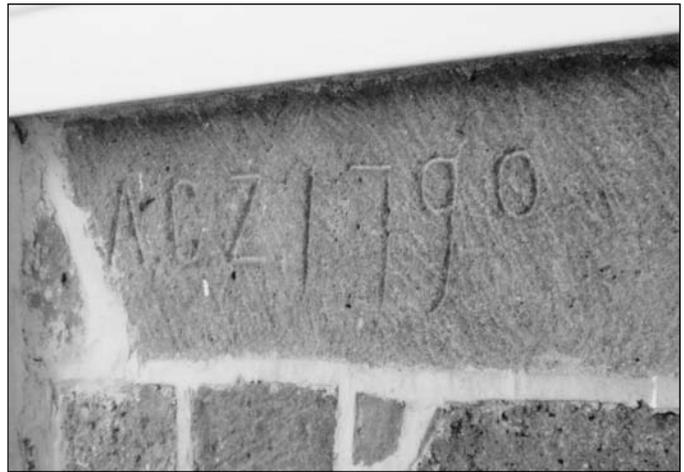
Photo 6. Detail showing initials and date carved in stone: **ACZ 1790** on the Zabriskie barn. This date is probably not the date of construction, which is likely earlier by a decade or two or more.

On a stone in the east side wall initials and a date are prominently carved: **A C Z 1790** (Photo 6). This date is between 10 and 30 years after the probable date of construction of the barn. At least three other dates, carved in stone, appear on the west side wall of the barn: 1775, 1823 and 1895. Obviously the last two are not the original construction dates of the barn. The Zabriskie barn is the only one in Bergen County with carved dates.

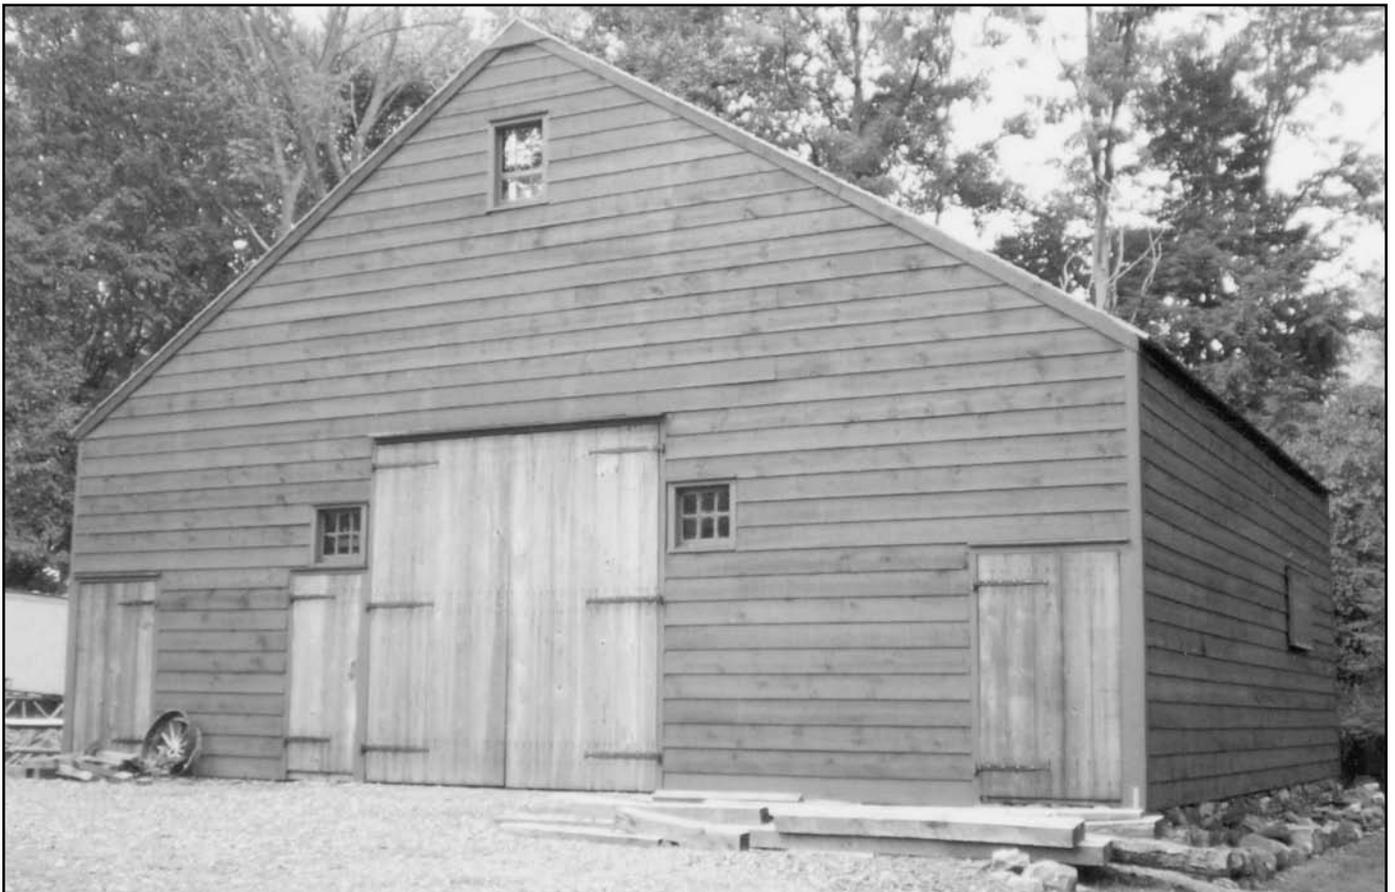
Photo 7. Johannes Haring three-aisle barn in Rockleigh, New Jersey has a roof that was subsequently raised. This barn was constructed about 1800.

The John Haring homestead on Piermont Road in Rockleigh includes a three-aisle barn, with a raised roof (Photo 7). The farm, which has new owners, has an excellent house with at least three historic sections including a stone portion dating to the first decade of the 19th century, featuring sweeping spring eaves. The barn stands about 110 feet from the house and

only 35 feet from the main road, and is the only three-aisle barn in either Bergen or Rockland Counties that had its original roof removed and then raised, using new timbers, in the 20th century. The appearance of this barn before the raising of the roof is recorded in a c.1920 photo, seen at a recent visit to the homestead. The barn is only a few feet larger than the Bartholf barn, measuring about 40 feet at each end wall and 36 feet at each side wall. The side walls are presently about 12½ feet high but were extended about three to four feet by the early-20th century alterations.

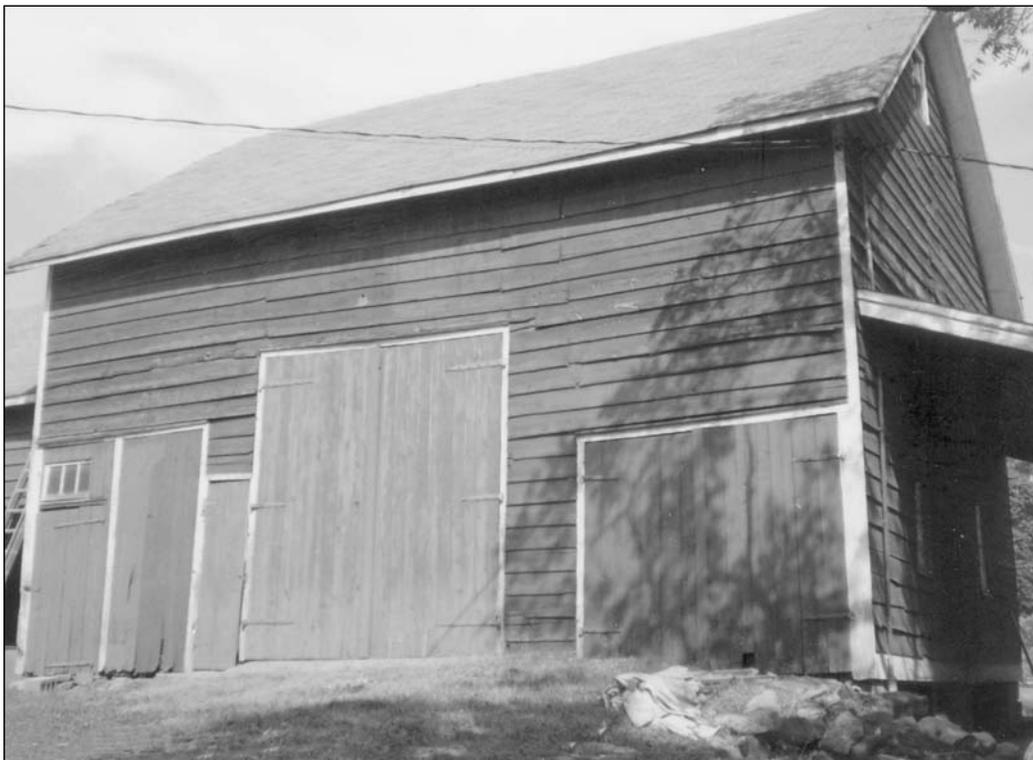
Photo 8. The George Demarest Americanized Dutch barn in Hillsdale, New Jersey is the only Dutch barn in Bergen County that includes a basement. The original three-aisle barn was likely erected before 1800. The inclusion of both the side wall wagon entry and the basement may have taken place at the same time.

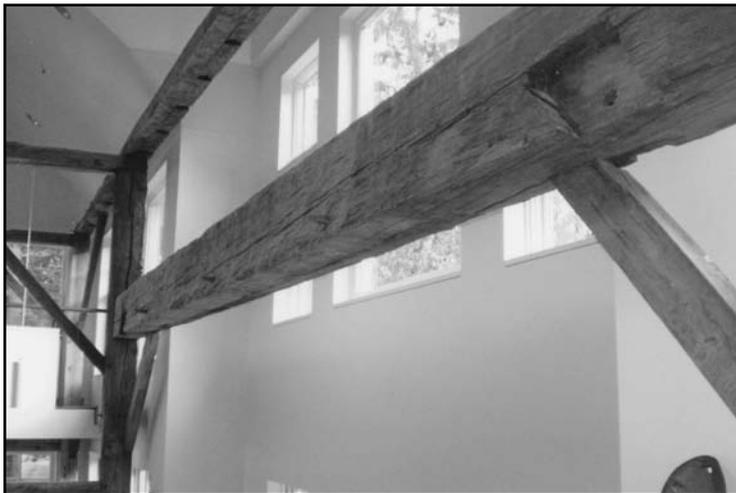
Photo 9. The Durie-Belcher Anglicized three-bay Dutch barn in Haworth, New Jersey was recently moved about one hundred feet from its original location and converted into a residence. The original three-aisle barn was likely constructed before the Revolution. Later it took a second three-aisle form and still later a barn with a side wall wagon entry. Thus to date it has had four barn lives.

Belcher Anglicized Dutch barn in Haworth. This barn was relocated about 100 feet away from its original location about four years ago. One H-frame post had to be replaced. The seven remaining original posts have single raising holes that penetrate only about half the width of the posts; the holes are visible only on the lateral faces (on the eave wall side) of the timbers.

The reader will recall that seven of the H-frame posts in this barn have raising holes, which is extremely unusual in either a Bergen or Rockland County barn. This may be due to the fact that the *verdiepingh* seen in the Durie-Belcher barn, when compared to most Bergen County barns, is a relatively long 42 inches. One H-frame post is of new construction. Before its recent move, the barn was sited a quite distant 217 feet from a stone and frame house that has distinctive flared eaves.

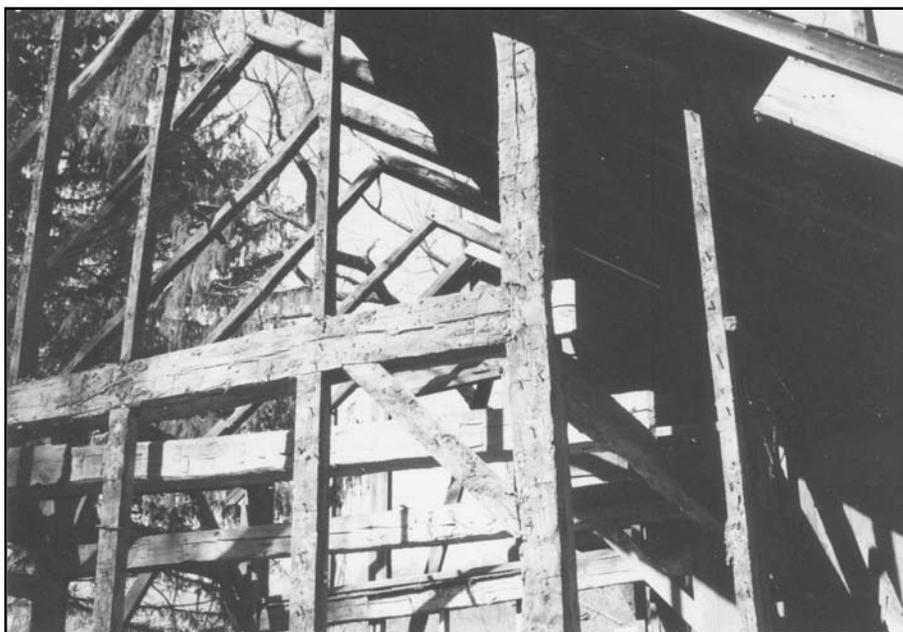
Photo 10. Duffy remnant three-aisle Dutch barn formerly in Woodcliff Lake, New Jersey of scribe rule era, or pre-1815 vintage. A number of decades ago one side aisle was removed. The barn originally had only two bays.

The clearance below the anchor-beams in the Duffy barn was not high enough for a normal-sized hay wagon to enter at the gable wall. The anchorbeams had two-foot scribe marks and the barn likely dated to 1810-1820. The precise function of this structure is unknown but it may have supplemented a larger barn on the property. The farm was also the site of a c.1840 or possibly later three-bay Dutch-Anglo barn, now gone, that stood about 220 feet from the main house. One remarkable feature seen in the c. 1840 barn was the original condition of its wagon floor; the floor planks in two sections ran not side to side (H-frame post to H-frame post) but from wagon door to opposite wagon door. This condition is presently seen in the Haring barn, but is not original to it.
