The Society for the Preservation of Hudson Valley Vernacular Architecture

October – December 2015 **Newsletter**

The William Pitcher Farmhouse Upper Red Hook, Dutchess County

Vanished Vernacular I: Two 18th Century Ferry Houses in Albany, Albany County, New York

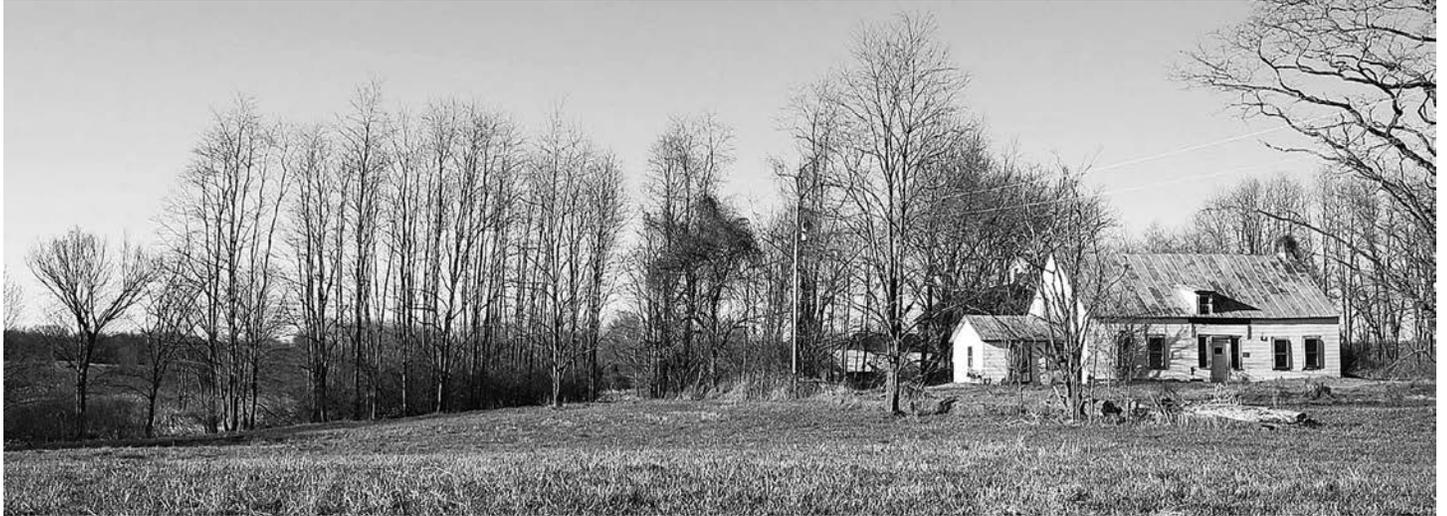
Fig.1 – View of the William Pitcher Farmhouse from Pitcher Lane (south). A barn complex is barely visible behind it. Photo by author, 2014.

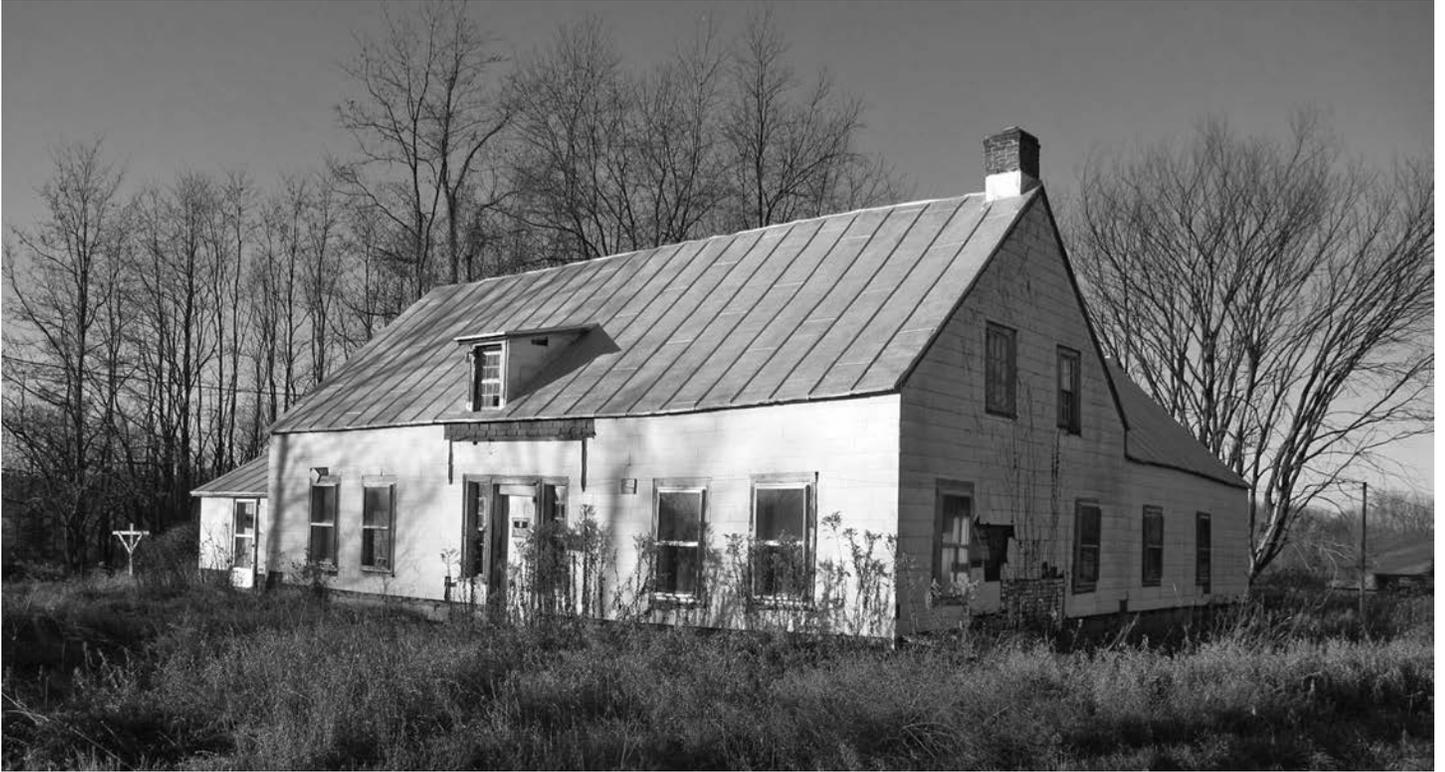
Fig. 3 – View of William Pitcher Farmhouse from southeast. Photo by Neil Larson, 2015.

The Pitcher house is a one-and-one-half story, Dutch-framed wood structure with a gable roof and five-bay front façade. A cross-gable ell is appended to the east end of the rear and a one-story wing has been added to the west gable end (Fig. 3). The main house, which faces south, and the rear ell sit on foundations of dry-laid bluestone, and both are clad in cement-asbestos shingle siding. There is an inboard brick chimney at the peak on the east gable end and a patch on the west gable end, where a brick stack was removed following a chimney fire in the late 20th century. There also is a brick chimney at the north gable end of the ell that serviced a cook stove in the mid-19th century (Fig. 4). The hand-worked, standing-seam metal roof was added in the early 20th century.

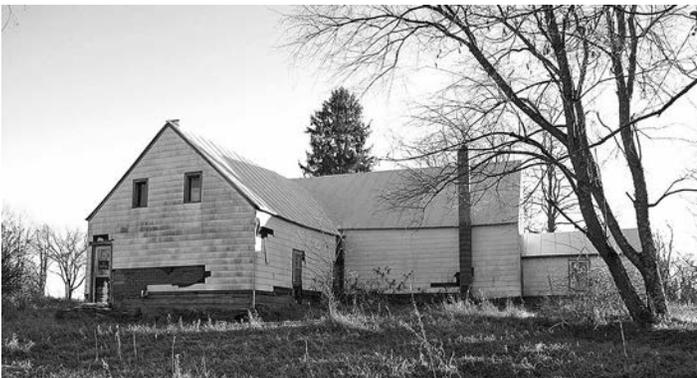
Fig. 4 – View of William Pitcher house from northwest. Photo by Neil Larson, 2015.

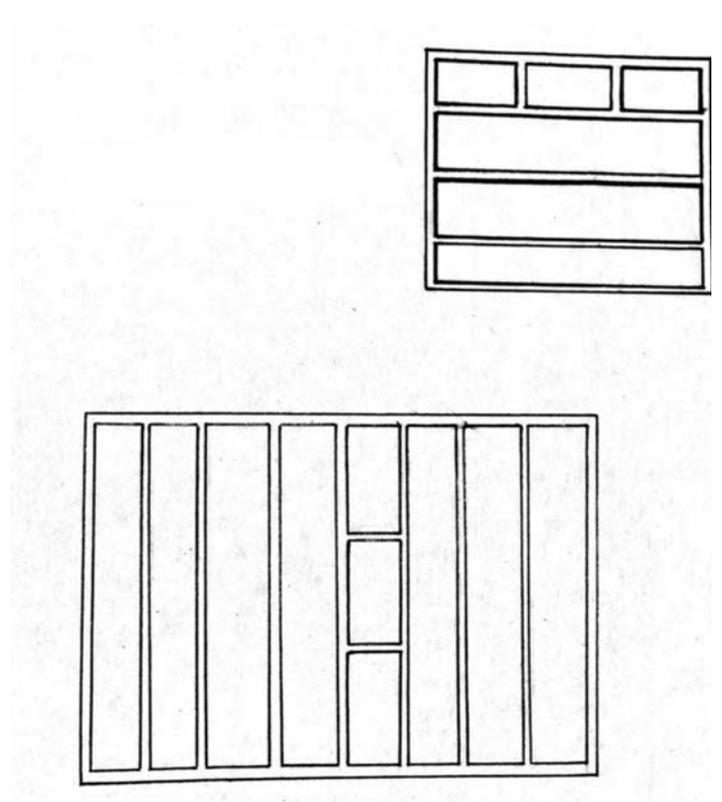
Fig. 5 – Plan of bents, ca. 1753 for front and rear buildings. Drawing by author, 2014.

The house appears to have originated as a nine-bent structure with a two-room plan, possibly built by William Pitcher in ca. 1753 (Fig. 5). It was erected on a partially excavated basement and had jambless fireplace built against the center partition (Fig. 6).⁶ A portion of the rear ell is a five five-bent 18th-century structure with one room and a jambless fireplace that was a free-standing building either in this location functioning as a detached kitchen or as an independent dwelling in another place. It does not have a basement and is sited about eight feet to the north of the house and staggered eight feet to the east of its original end wall (Fig. 5). The two structures were joined by additions constructed during the second stage of development near the end of the 18th century.

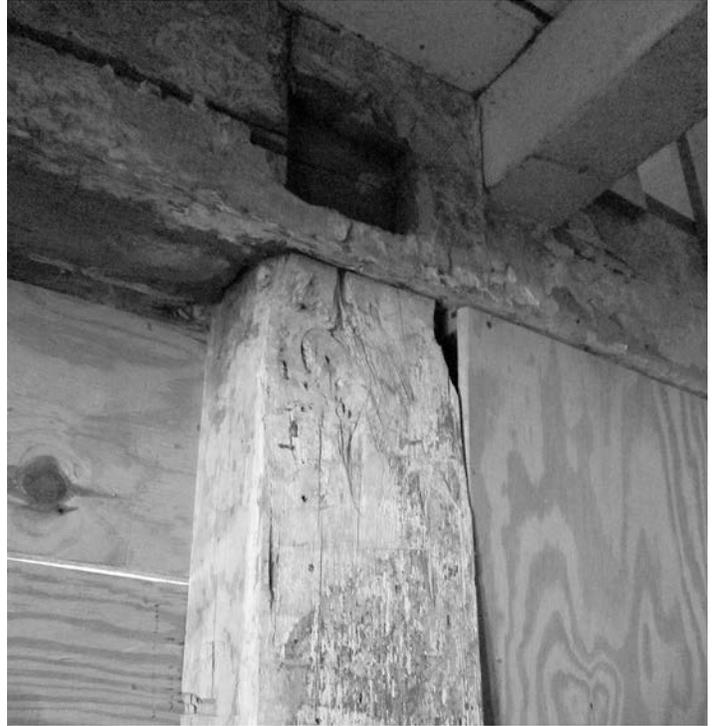
Fig. 6 – View of post in center partition (now west wall of center passage) with empty mortise for trimmer beam in beam above and ghost of jambless hood molding. Photo by author, 2014.

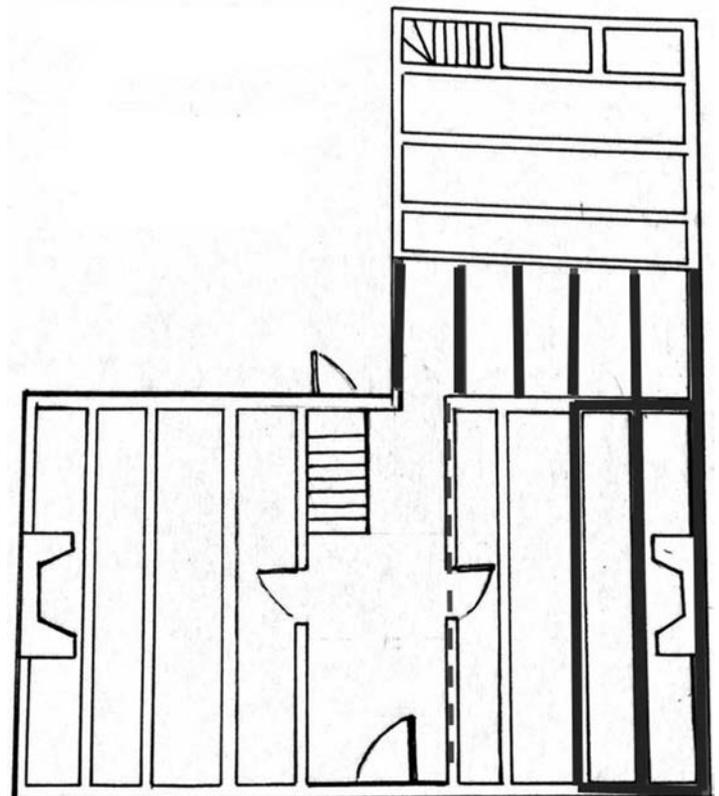
Fig. 7 – Plan of bents after renovation of house, 1775-1797. Drawing by author, 2014.

The most significant alteration involved removal of the center chimney, shifting the third anchor bent two feet east, removing the fourth anchor bent entirely, and creating a center hall (Fig. 7). This change of configuration from center chimney to center hall was a fairly common update to mid-18th-century houses in the area. To account for the space taken to create the hall, two bents were added to the east gable end of the house restoring the east room to an appropriate dimension and increasing the total length of the house from 38 to 46 feet. This extension brought the gable end in line with the east wall of the detached kitchen, if pre-existing, which was attached to the house by a hyphen of new construction (Fig. 7). The front façade was reorganized in a symmetrical manner around a new central entrance with sidelights. English fireplaces were constructed on the east and west ends and in the kitchen ell and Federal-style windows and trim were installed.

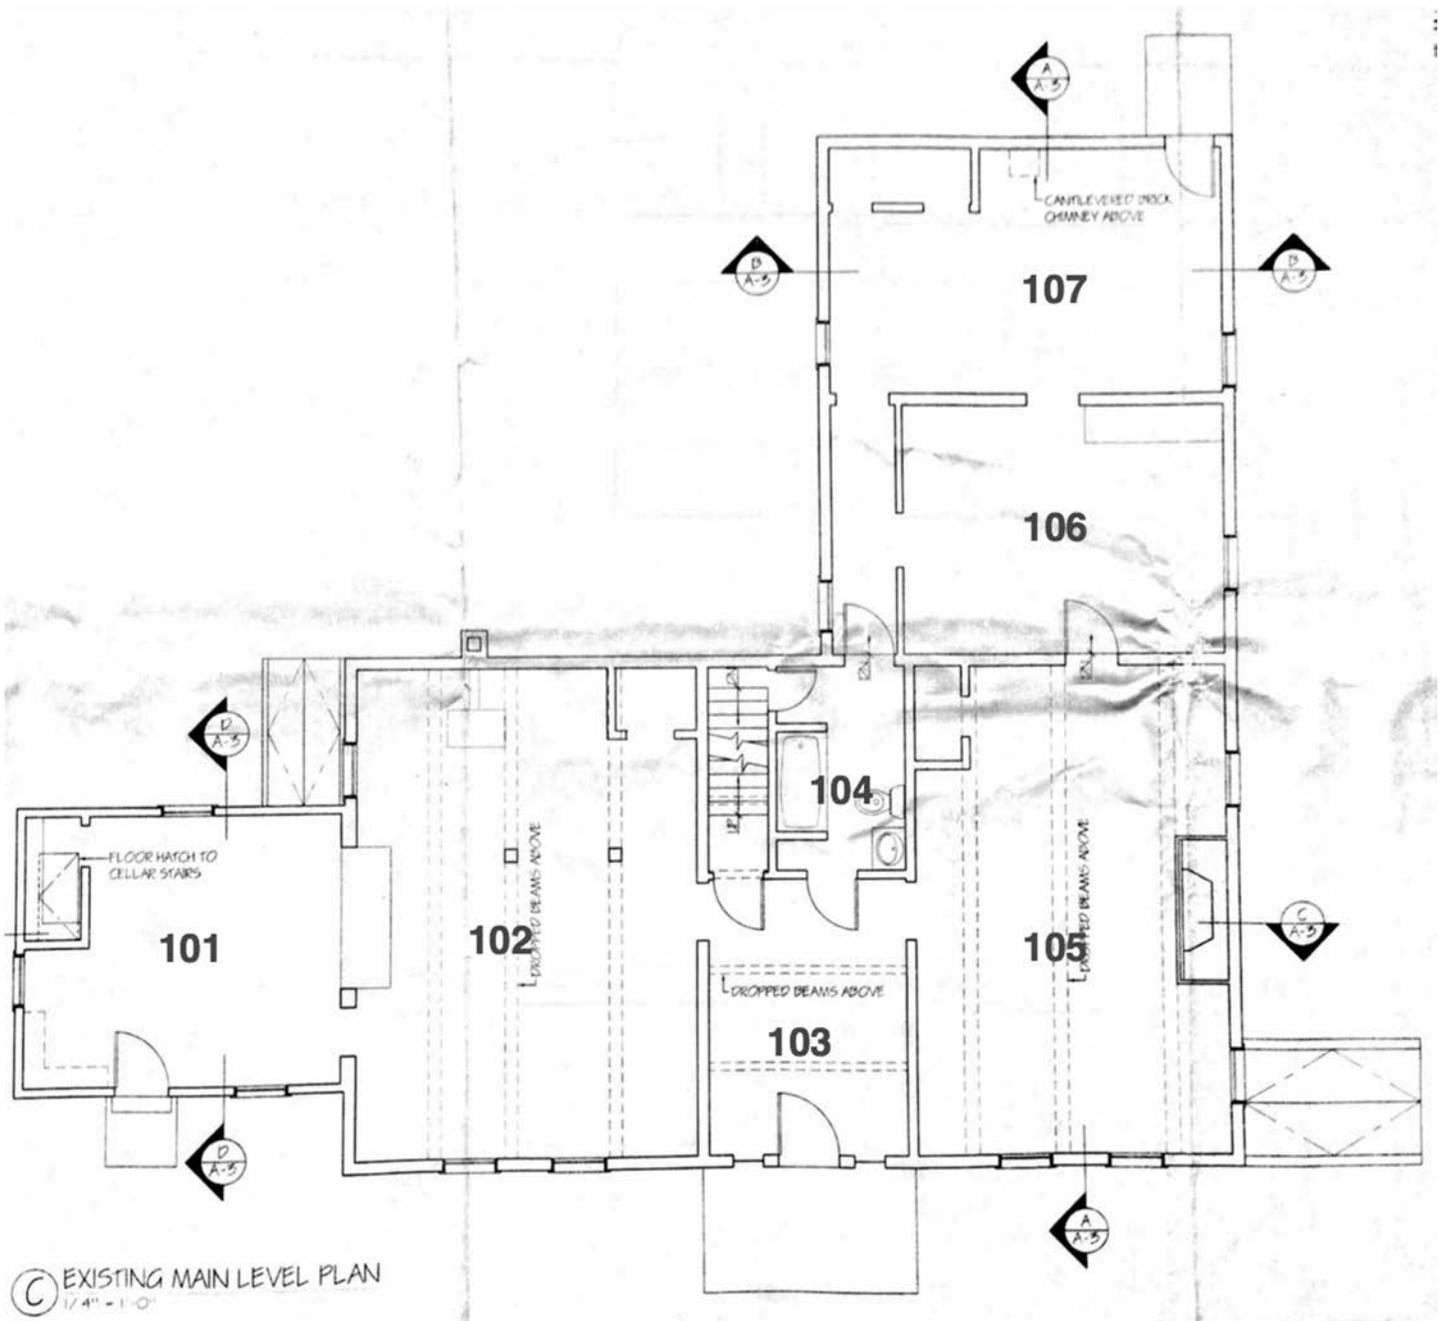
Fig. 8 – First floor plan. Drawing by Diane Reimer, 2004.

The expanded house contained two principal rooms on the ground floor (Fig. 8). Rooms 102 & 105 separated by a center hall with a stair (103 & 104) in the main section of the house with a dining room (106) and a kitchen (107) in the rear ell. Room 107 and the northern four feet

of Room 106 are contained within the frame of the pre-existing kitchen; the rest of room 106 is in the connecting hyphen. (Rooms 101 and 104 were added later as likely was the passageway along the east side of the ell connecting the kitchen with the center hall.)

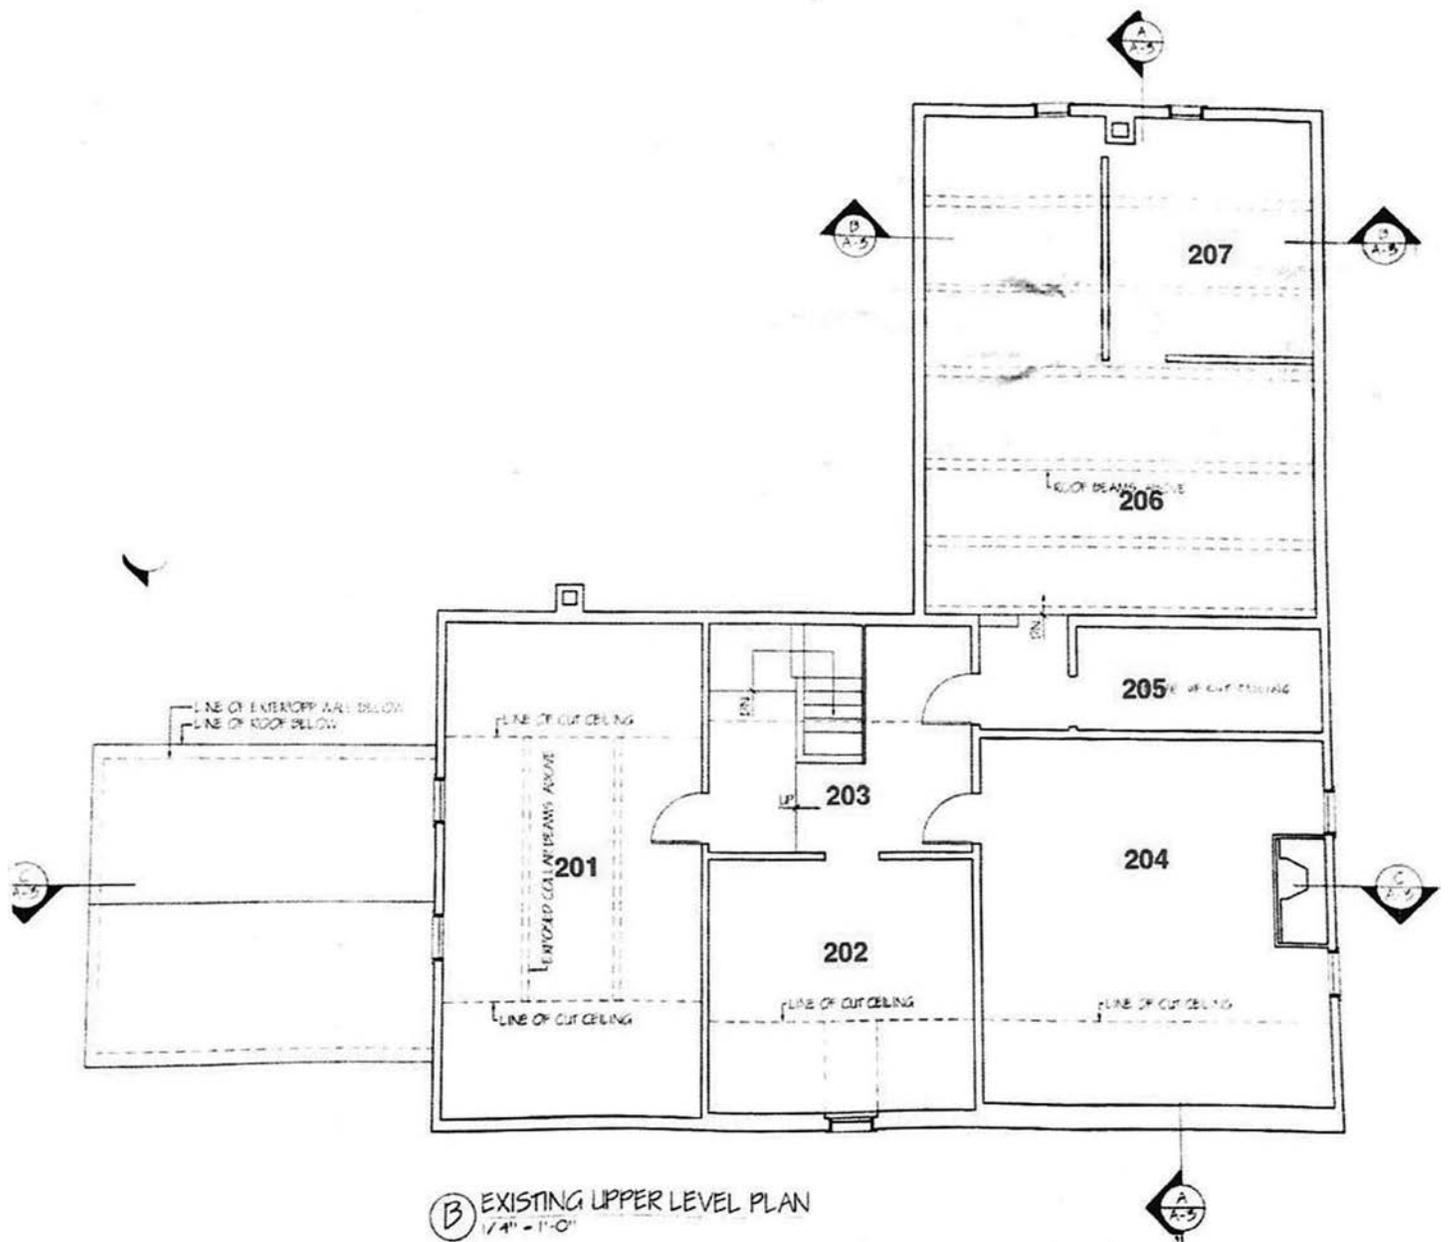
Fig. 9 – Second floor plan. Drawing by Diane Reimer, 2004.

The second story has a plan similar to the first (Fig. 9). Door hardware upstairs – HL hinges and the ghosts of HL hinges, and Norfolk latches – suggests that existing rooms were partitioned in this second campaign. The east partitions of Rooms 102 and 201 are aligned differently and the second floor level is a step lower on that side. Flooring

here has been replaced indicating a later alteration, although the reason for this has yet to be determined. Room 202, located above the front of entry hall was partitioned later. A fireplace is extant in the east room (204) suggesting that it was the best chamber. A closet was created under the north slope of the roof (205); it is accessed by a door in an awkward passageway connecting the upper stair hall (203) with the garret of the ell.

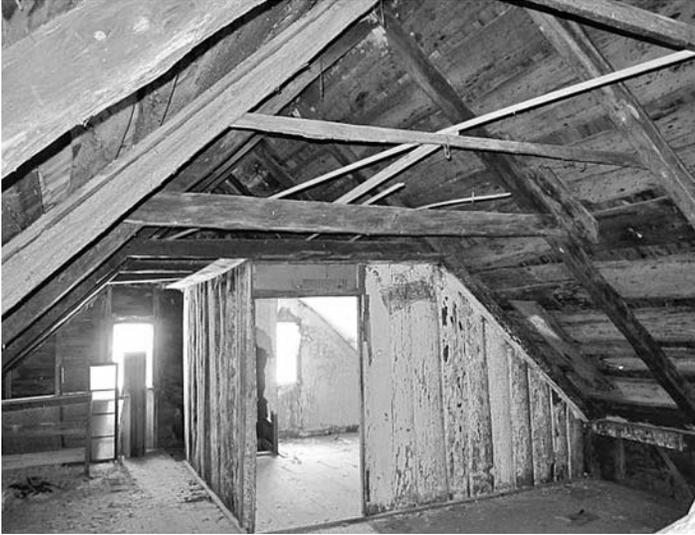
Fig. 10 – View of kitchen ell garret looking north. Photo by author, 2014.

The garret of the ell is largely unfinished space (206) with a room (207) partitioned off at the northeast corner with split-plank walls (Fig. 10). It had been accessed via a steep staircase or a ladder in the northwest corner, which was

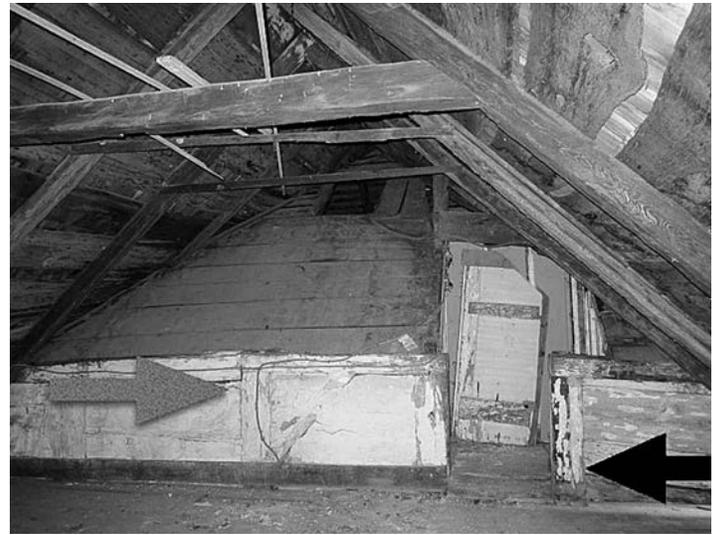
Fig. 11 – View of hyphen section and rear of house looking south. Photo by author, 2014.

the hyphen overlaps a section of the roof of the main house exposing sheathing with no evidence any roofing having been nailed to it (*Fig. 11*). This would indicate that both roofs were contemporaneous. The exposed kneewall of the house contains evidence of alterations to the building. A post to the right of the opening leading to the passageway to the front of the house was moved two feet to the east with the beam shifted to create the east wall of the center hall. The corner post of the original house is also visible to the left of the opening (*Fig. 11*).

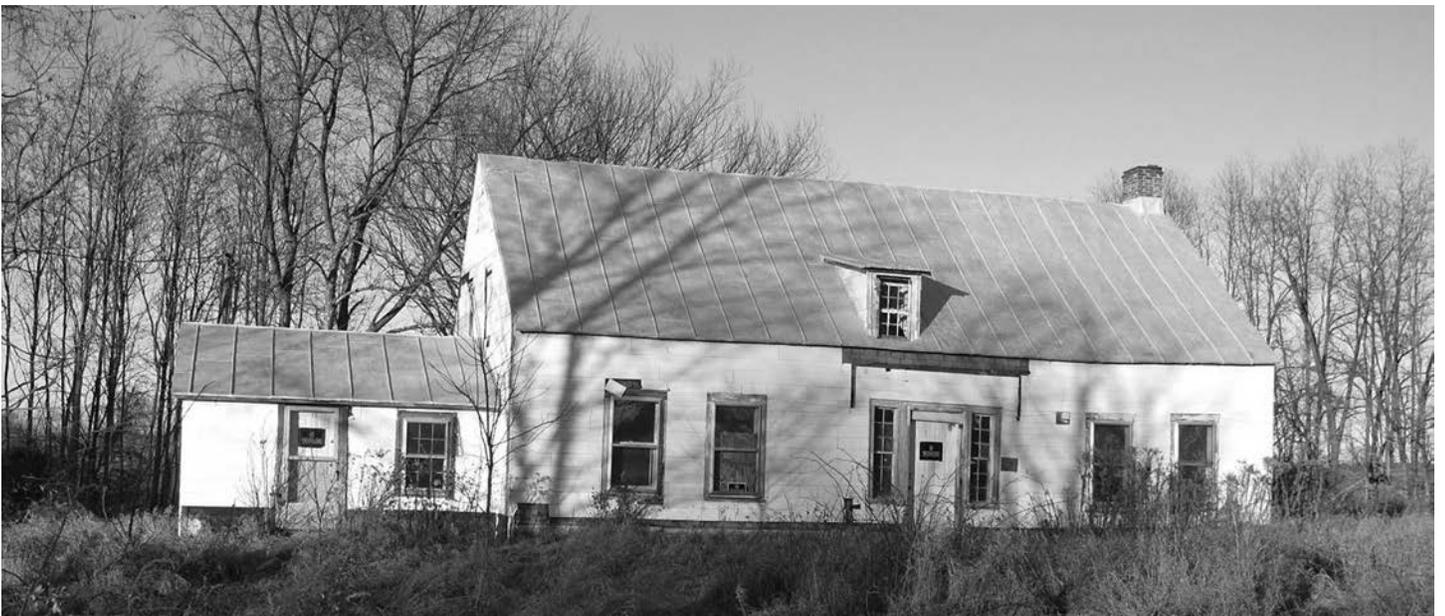
Fig. 12 – View of house from south. Photo by Neil Larson, 2015.

The last significant change made to the house is represented by the wing added to the west end of the house around 1850, after ownership of the property was transferred

to Andrew Pitcher (*Fig. 12*). In that year, the household contained, in addition to Andrew, his wife and two young children, his father and mother-in-law. The addition probably served as living space for one parent or the other. Plain beaded door trim and baseboard on the main floor rooms in the north ell reflect the taste of that time suggesting that alterations and the hallway bypassing the so-called dining room (106) were linked to creating another private space. The parents were deceased by the time the 1860 census was taken and the household consisted Andrew and Mary Ann Pitcher, their five children, an African American farmhand, age 50, and an Irish-American female domestic servant. The rough garret room above the kitchen (205) is typical of those created for farm laborers in the period.

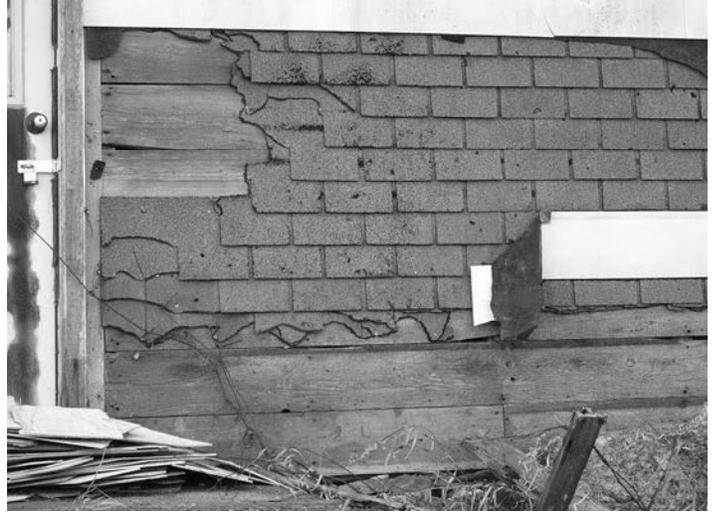
Fig. 13 – Detail of siding layers on north end of kitchen ell. Photo by Neil Larson, 2015.

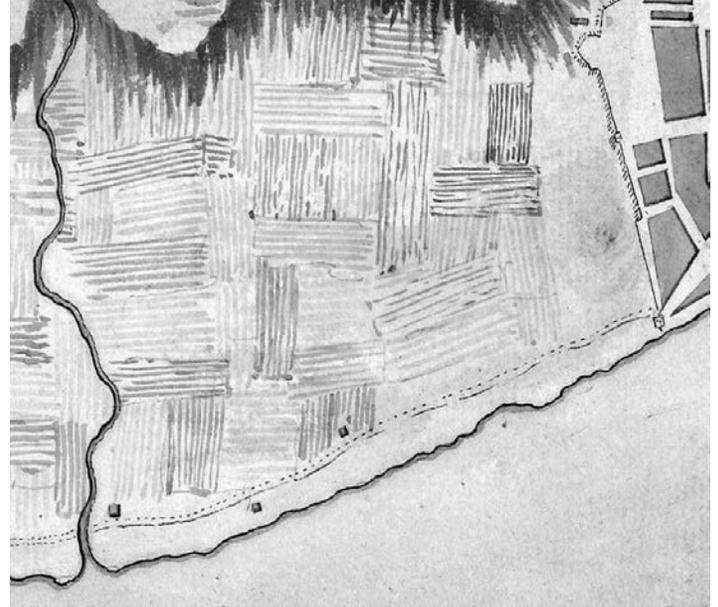
Fig. 1 – Detail from A Plan of Albany, as it was in the year 1758, by an unidentified cartographer (Library of Congress, Washington, DC).

A map of the city and its environs "as it was in the year 1758" depicts the house as one of three located along the river road leading south from the built-up portion of the city (Fig. 1). A map of the city by Robert Yates, dated 1770, depicts the house on its riverside site (Fig. 2).

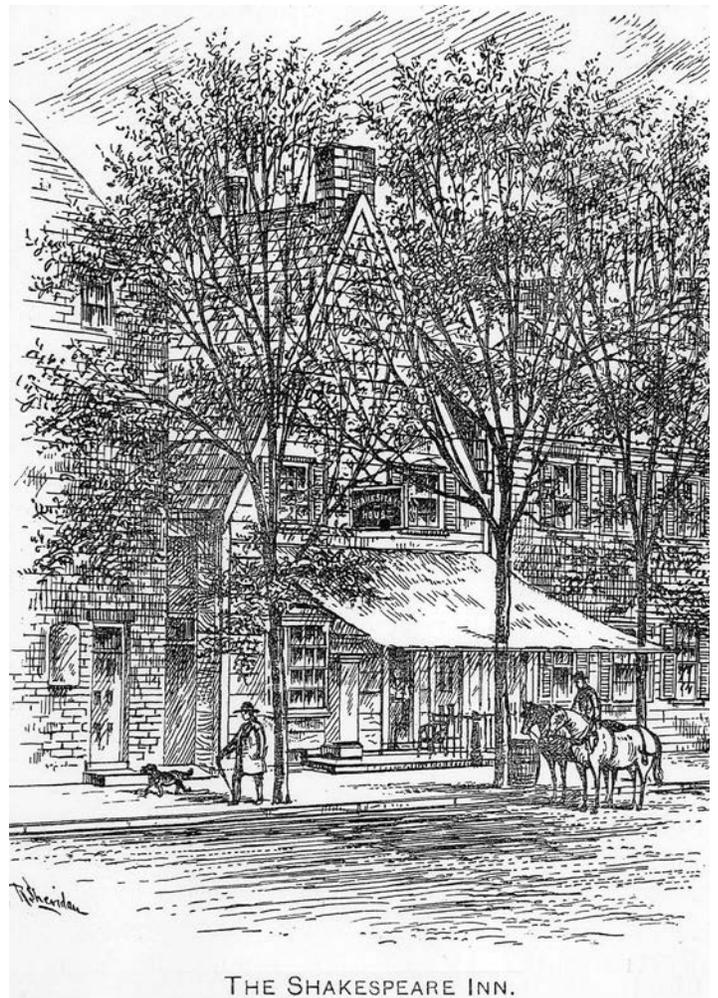
Fig. 3 – Drawing of the Bradt house, published in a supplement to The Argus of 18 July 1886. (Albany Institute of History and Art, Albany, NY).

The article is illustrated with a pen-and-ink drawing, which shows the Church Street elevation of the building (*Fig. 3*). A photograph taken about 1905 depicts the house near the end of its existence, when it was known as 114 Church Street (*Fig. 4*).⁵ In it, we can see the plate and bottom of the brick-filled stud wall constructed when the house was truncated in the early 19th century and the wide clapboards covering the north face of the building. The roof appears to have been covered with wood shingles. The back side of the east gable parapet wall can be seen as well. At some point before 1886 a second door was constructed on the Church Street elevation, likely to facilitate using the first floor as a shop.

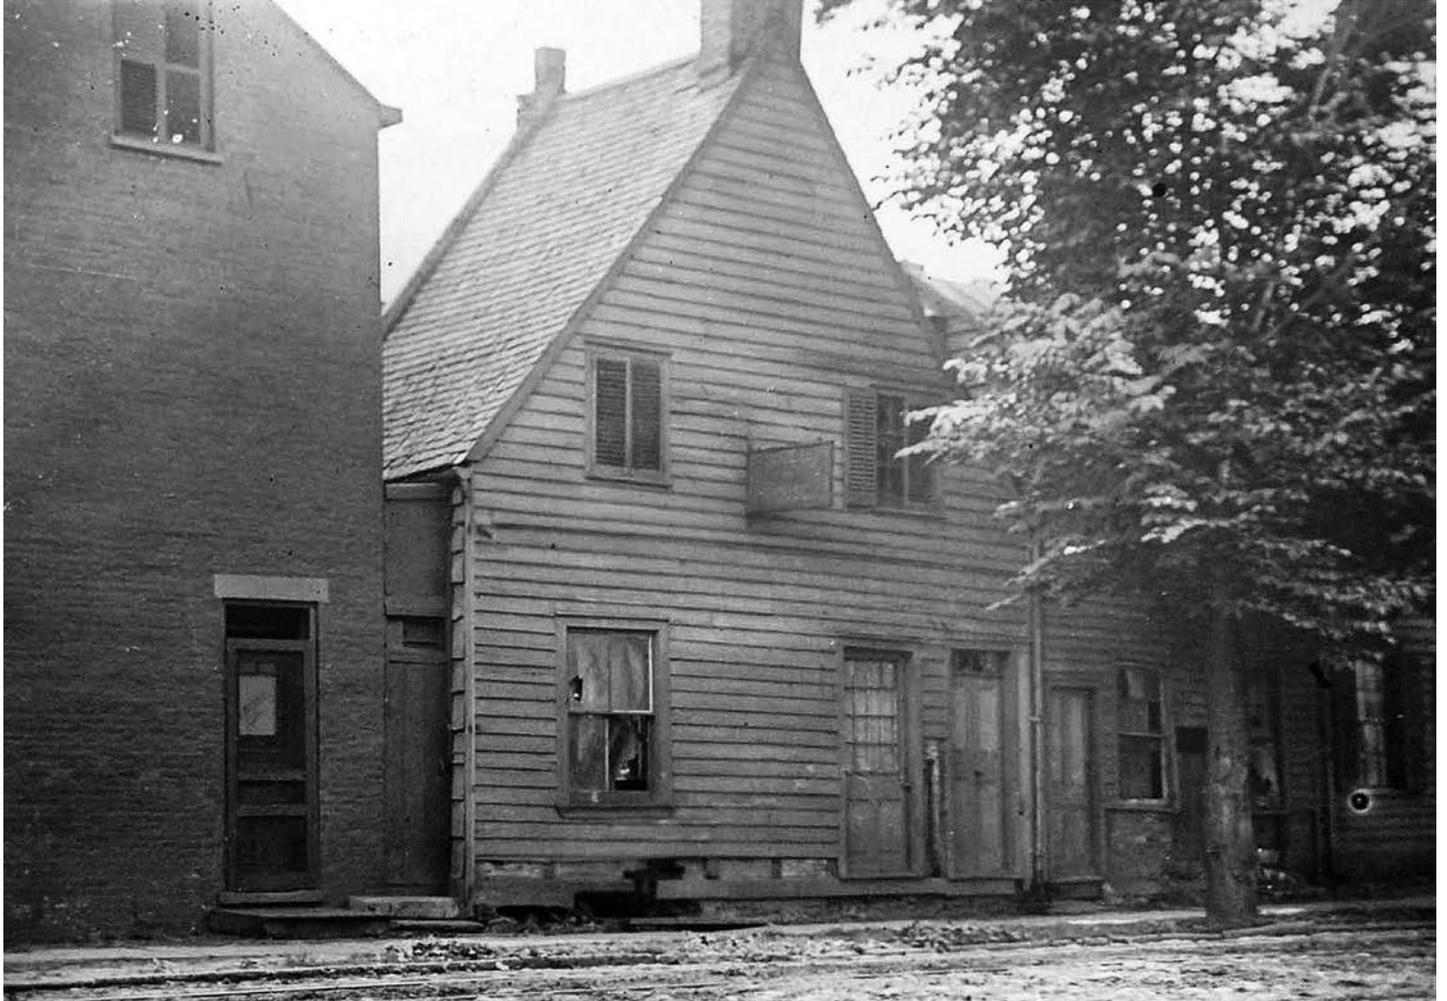
Fig. 4 – Photograph showing the Church Street side of the Bradt house, ca. 1905, (NYSL-MS, Albany, NY).

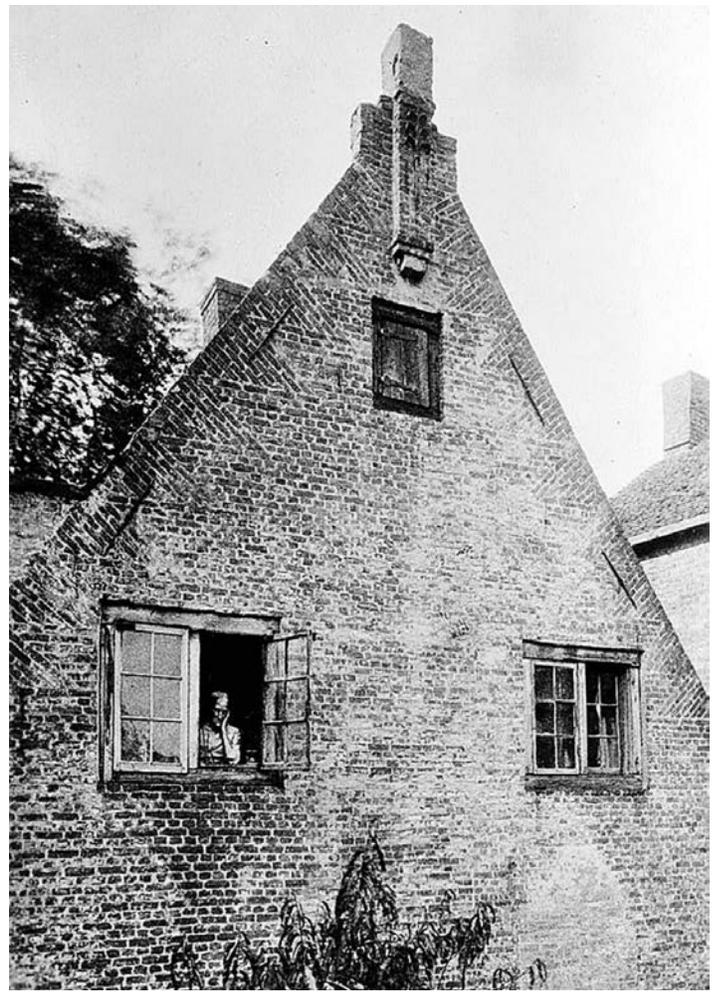
Fig. 5 – Copy photograph in the HABS collection, showing the original (east) front facade of the Bradt house (Library of Congress, Washington, DC).

In the 1980s, Rod Blackburn was first to identify the iconographic image of an unidentified house with a forelorn-looking woman in the gable-end window as showing the former street front of this dwelling, although until now the attribution and photo have not been published together (*Fig. 5*).

The appearance of this façade accords with the 1886 description reprinted above, and shows the house to have had a “spout gable” of the type most commonly constructed in Albany starting in the very late 17th century and continuing into the 1720s; the most well-known of the examples surviving into the era of photography being the Lansing-Yates-Pemberton house, which was constructed in 1710, and occupied the northeast corner of North Pearl and Columbia streets until its removal in 1893 (*Fig. 6*). A surviving example of this type is the ca.1726 Abraham Yates house at 109 Union Street, in Schenectady (*Fig. 7*).

Additional features can be picked out from the image, which is preserved in the HABS collection (as a copy photo), identified only as “Dutch Gable, Albany.”⁶ These include the pad hinges supporting the garret shutter, and moulded window frames showing the former location of their combination shutter and sash openings. Scars in the brickwork show where the original front door was (at lower right) and the second floor loft door, between the two remaining casement windows. Unlike the Lansing and Yates examples, the ironwork at the finial features three sets of “leaves” rather than two. Also differing from those examples, the builder of the Bradt house made use of simple bar-form wall ties, rather than the more commonly seen (at least in the 17th and early 18th centuries) fleur-de-lis type wall ties. This detail supports a later (that is, second quarter of the 18th century into the 1750s)

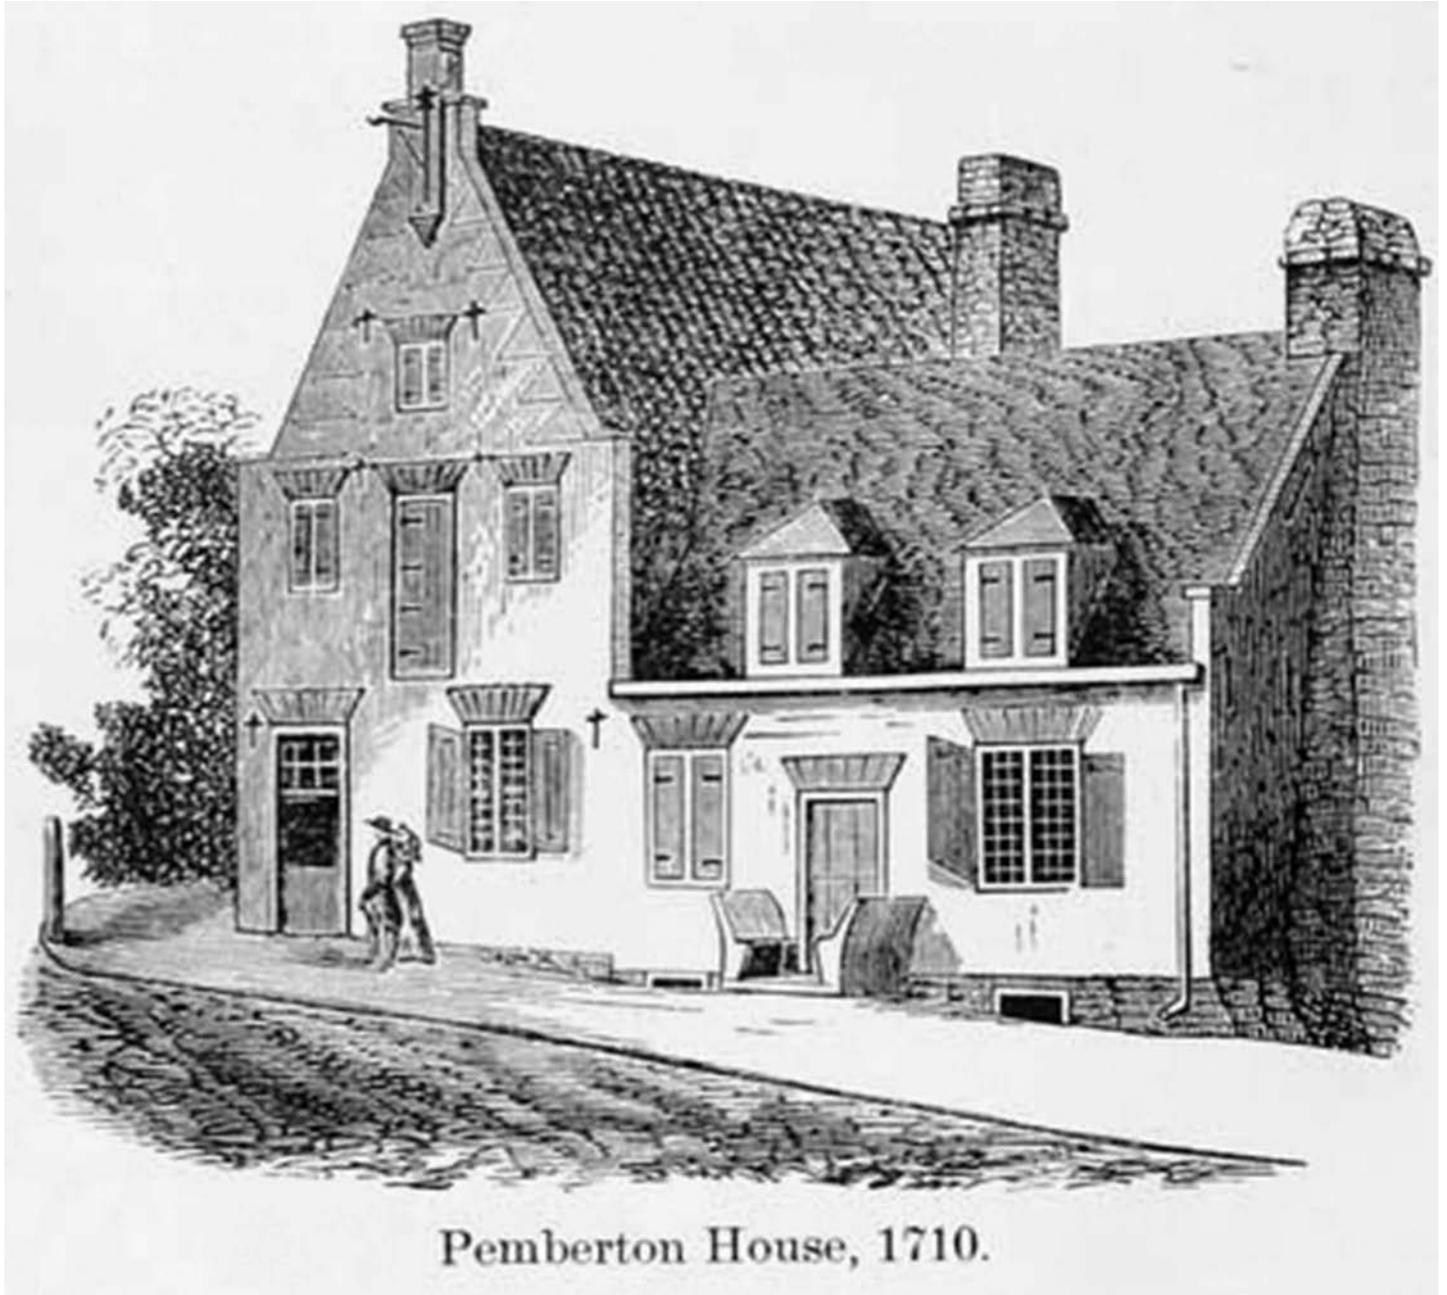
Fig. 6 – Woodcut engraving of the Lansing-Yates-Pemberton house, ca. 1840 (Author's collection).

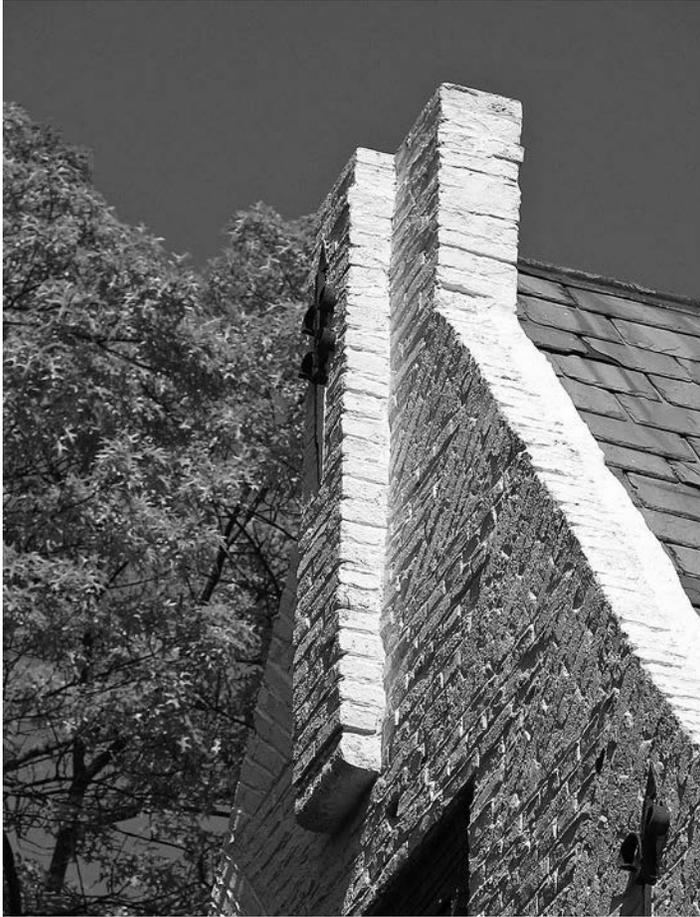
Fig. 7 – Detail of the spout gable on the Yates house in Schenectady (Author's photo, 2008).
