# Hudson-Mohawk Vernacular Architecture

## Newsletter

Vol. 1, No.1

## A Palatine House built in 1760 in Hillsdale, Columbia County

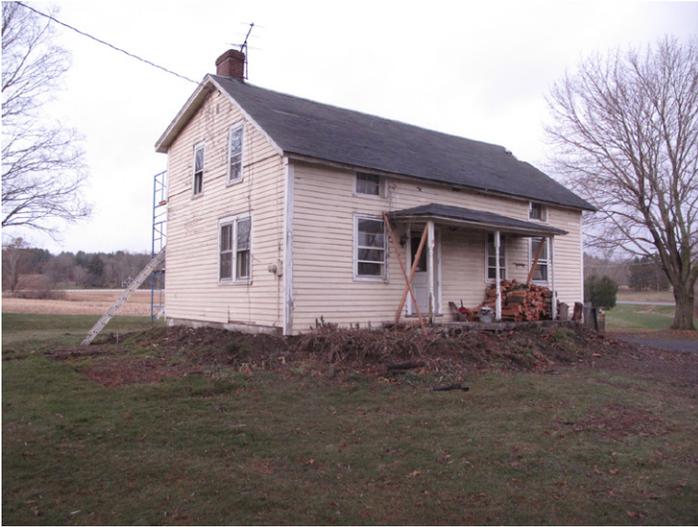
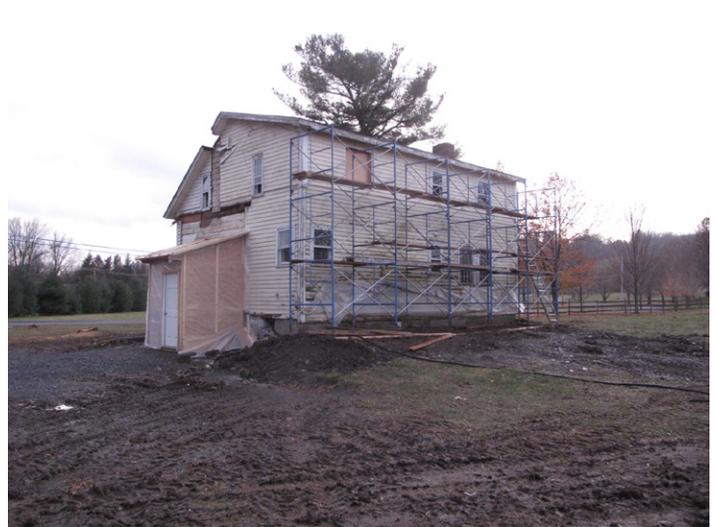
Fig.1: View from SW. The window to the right of the door originated as a second entrance. The double window on the west end replaced a doorway linking the house to a previous wing; windows in the upper story of the front façade are mid-19th-century additions. Photos by W. R. Wheeler, 2019.

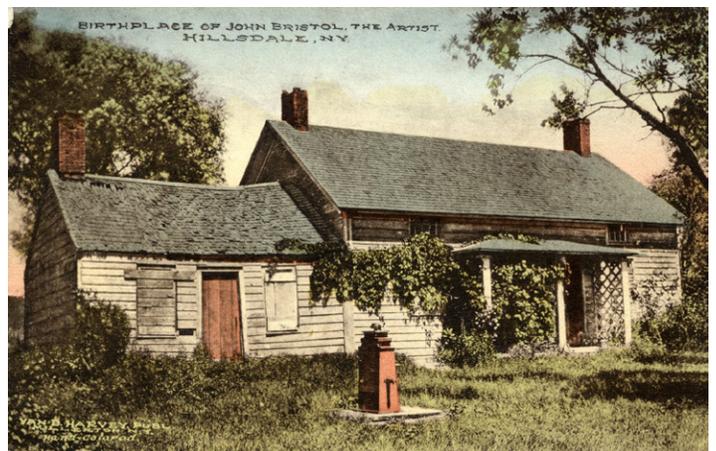
Fig.3: Postcard view of Bristol House (Sharts House), ca. 1900. The kitchen wing, no longer extant, was added in the early 1800s along with half-story windows in the house. The house apparently maintained this appearance until the end of the 1900s.

northeastern Dutchess County were destinations for many of them. The old house and its two-acre parcel were absorbed into (or restored to) the adjoining farm 1902 when John B. Bristol of New York City, a well-regarded landscape painter, sold his childhood home to Henry L. Coon, the farm's owner. A postcard image of the house from that time shows it boarded up and in poor condition. (No deed has been found, which documents when or how Abner and Lydia Bristol acquired the house, but they are enumerated in the 1820 U.S. Census for Hillsdale.)

The Bristols sold the house to Henry L. Coon in 1902 in the poor condition indicated in the postcard image. If his son Fred lived there as family history attests, improvements were made of necessity. To what extent changes were made is not obvious. The house was radically renovated by Weir Stewart, Jr. after he bought the farm in 1976 concealing historic fabric and removing previous alterations. Recent rehabilitation work for the current owners has exposed the original framing and provided historic features for analysis. In the process of documenting the building, other dwellings of similar form in the vicinity have been identified that offer the potential for a broader study of early domestic architecture in Hillsdale and an early Palatine presence.

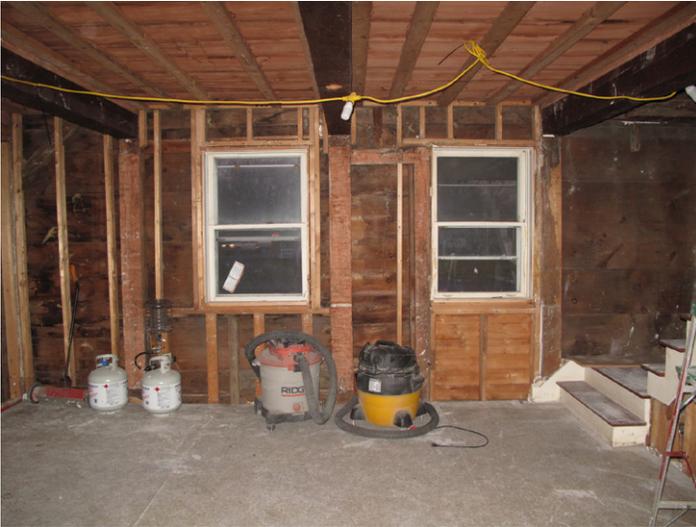
Fig.4: View looking south on east side of house showing remains of wall framing for window and door (see Fig. 5). Photo by N. Larson, 2019.

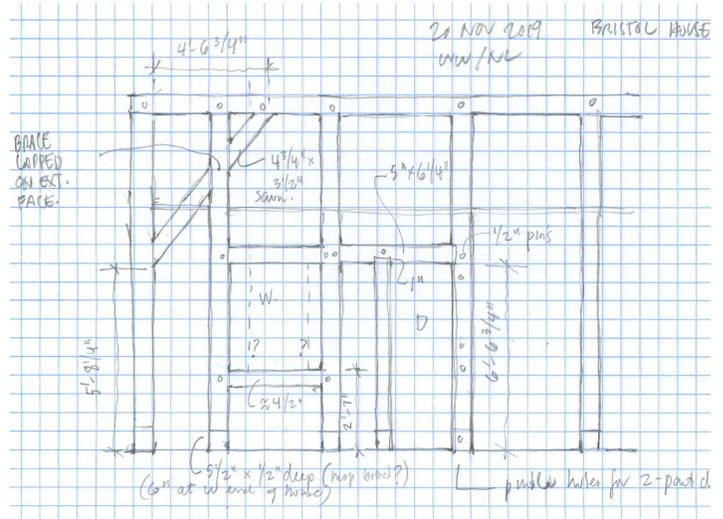
Fig.5: Drawing of framing for door and window on east side of south wall (see Fig. 4). Drawing by Walter R. Wheeler & Neil Larson, 2019.

A physical analysis of the house revealed that it was constructed using a post-and-beam bent system associated with the Dutch building tradition in the region. Some type of infill existed between the posts covered with weatherboards on the exterior and plaster on the interior leaving the interior faces of the posts exposed. Ceiling beams were planed smooth, as were the board ceilings; evidence of paint is extant. The house had a two-room plan with a central dividing partition. Each room contained a door and window on the front façade and one on each end; no windows were present on the rear wall. There were jambless fireplaces on the ends. The location of original stairs to the basement and attic garret is not clear, although there is evidence for an earlier stair on one side of the medial partition where the current stairs are located. At least half of the garret was finished as a chamber. The basement may have been only a crawl space because of the high water table.

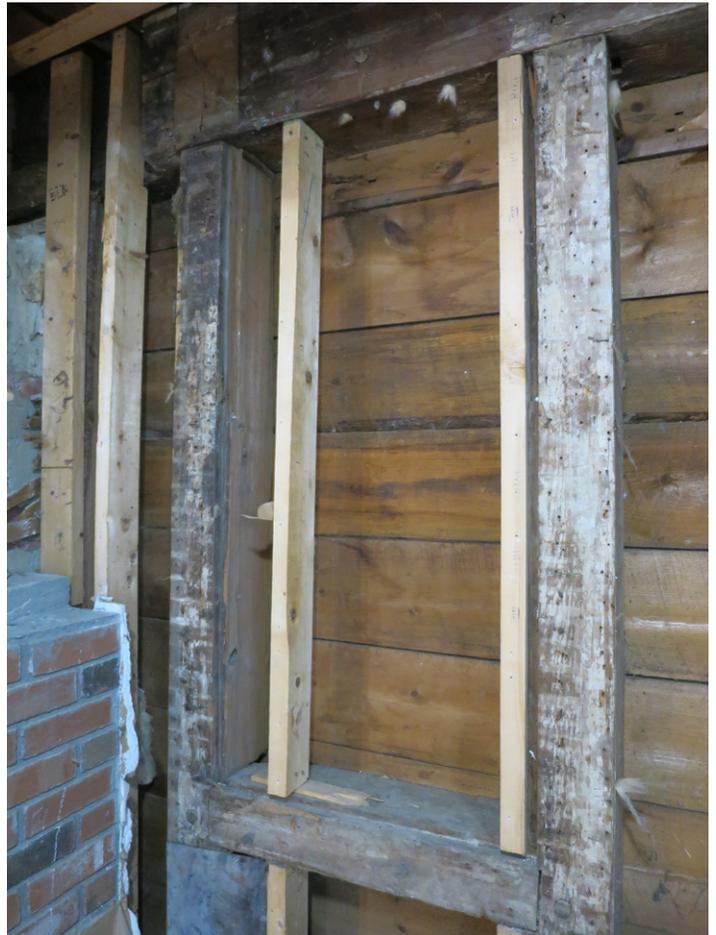
Fig.6: Detail of window frame on west wall. Photo by W. R. Wheeler, 2019.

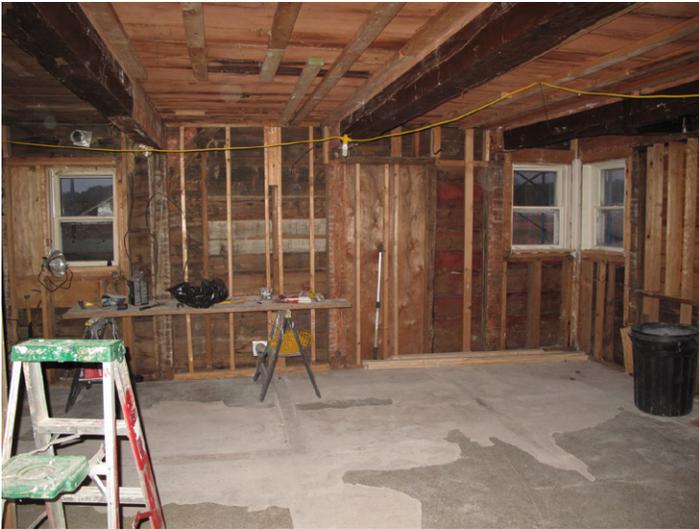
Fig.7: View looking northeast showing ceiling beams with original paint, hacking for addition of lath and plaster, and evidence for later ceiling with stained beams and gypsum board ceiling covering floorboards. Photo by N. Larson, 2019.

In a later stage, the fireplaces were removed and replaced with stove flues. The current fireplace on the west end appears to have been added still later. Ceiling beams were hacked to increase headroom and level them for the addition of lath-and-plaster ceilings; lath and plaster were added to the exterior walls as well. This renovation coincides with the early 19th-century period the Bristol family lived in the house. The ca. 1900 postcard image of the house shows a wing on the west end that was likely added about the same time. The current fireplace on the west end was shifted off-center to the rear to make room for a doorway cut in the front

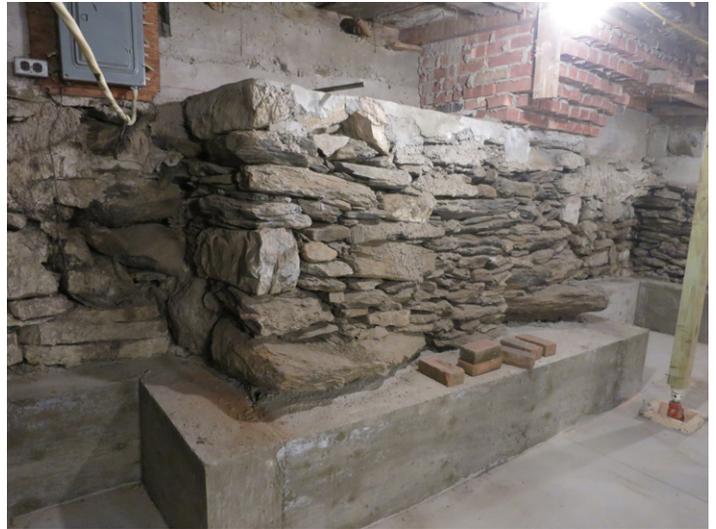
Fig.8: View of west end of basement showing stone base for chimney replacing original jambless hearth. Brick chimney is a later addition when room above was divided. Photo by W. R. Wheeler, 2019.

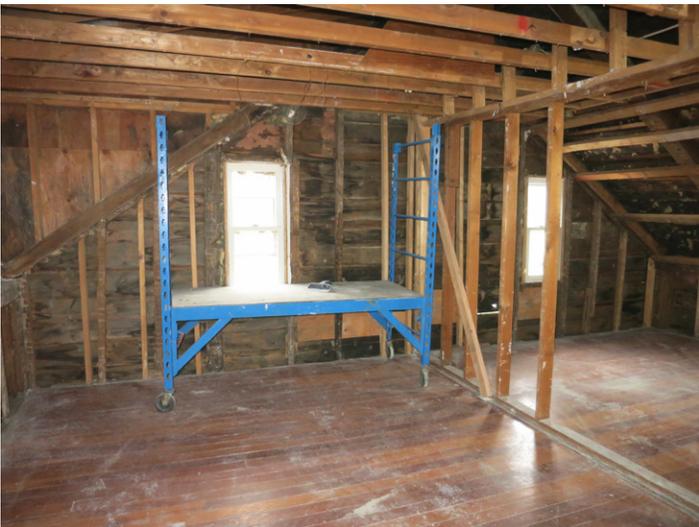
Fig.9 View of east end of attic showing where rear portion of roof was raised; original front rafters visible on right. Photo by W. R. Wheeler, 2019.

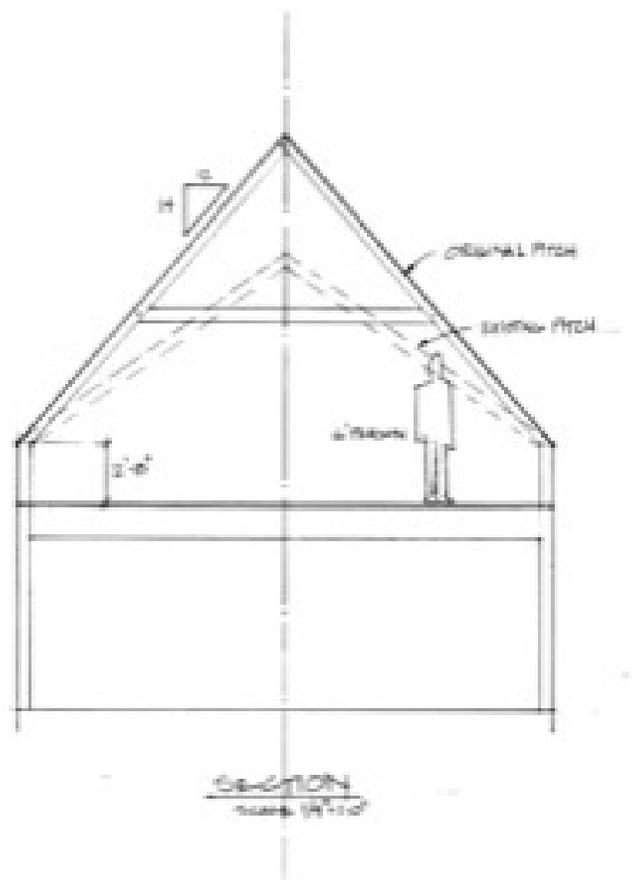
Fig.10: Section of house showing alterations made to roof based on collar angles. Drawing by Jack Sobon, 2019.

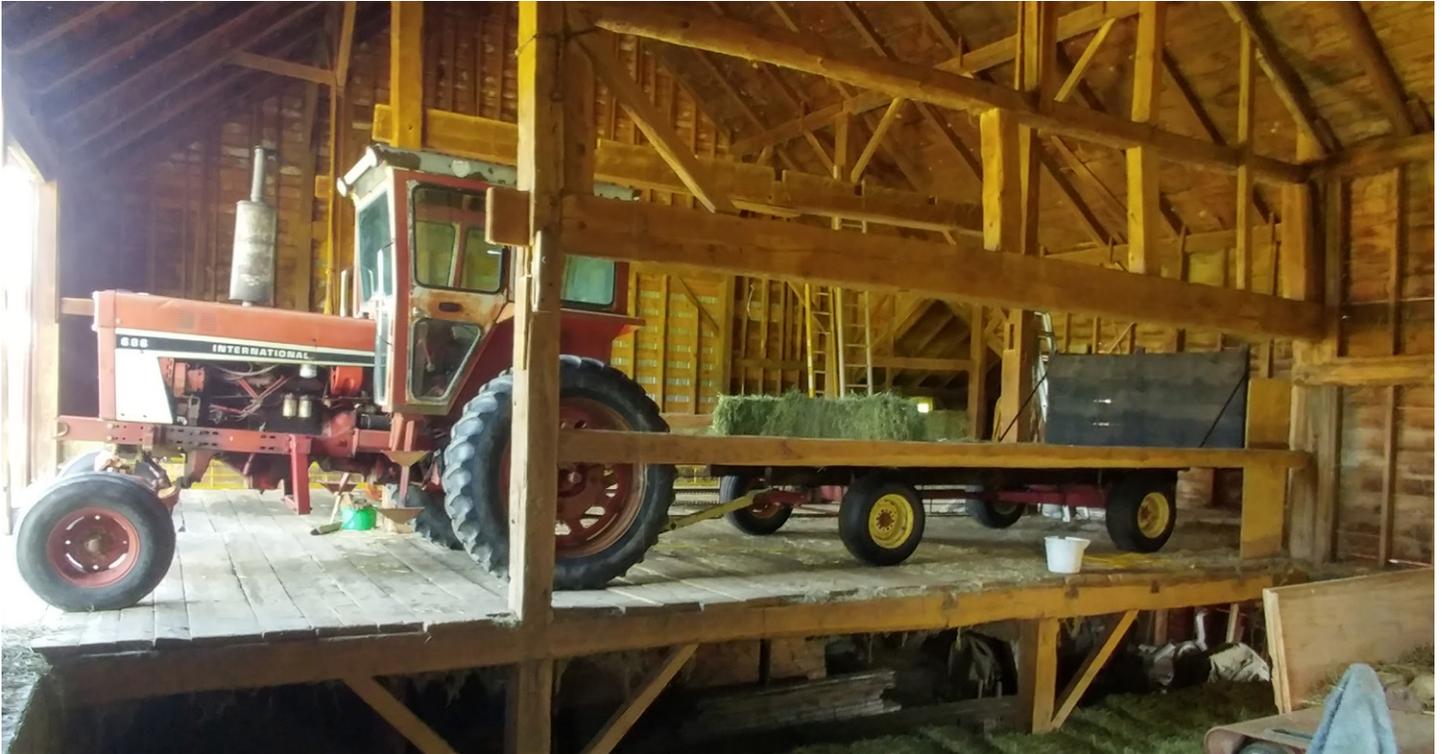
Fig.1: Interior of Eldred barn indicating H bents. Far wall is north wall. Photo by John Cannon.

In its current state, the Eldred barn is not typical of Dutch barns. There is no entrance on a gable end of the barn, as is customary with Dutch barns. The barn sits into a bank, with a basement beneath, so that the east side of the main floor is about seven feet above the ground. There are two sets of doors on sliding hinges that open onto the main floor, on the west side, between the second and third bents, and the third and fourth bents (Fig. 1).

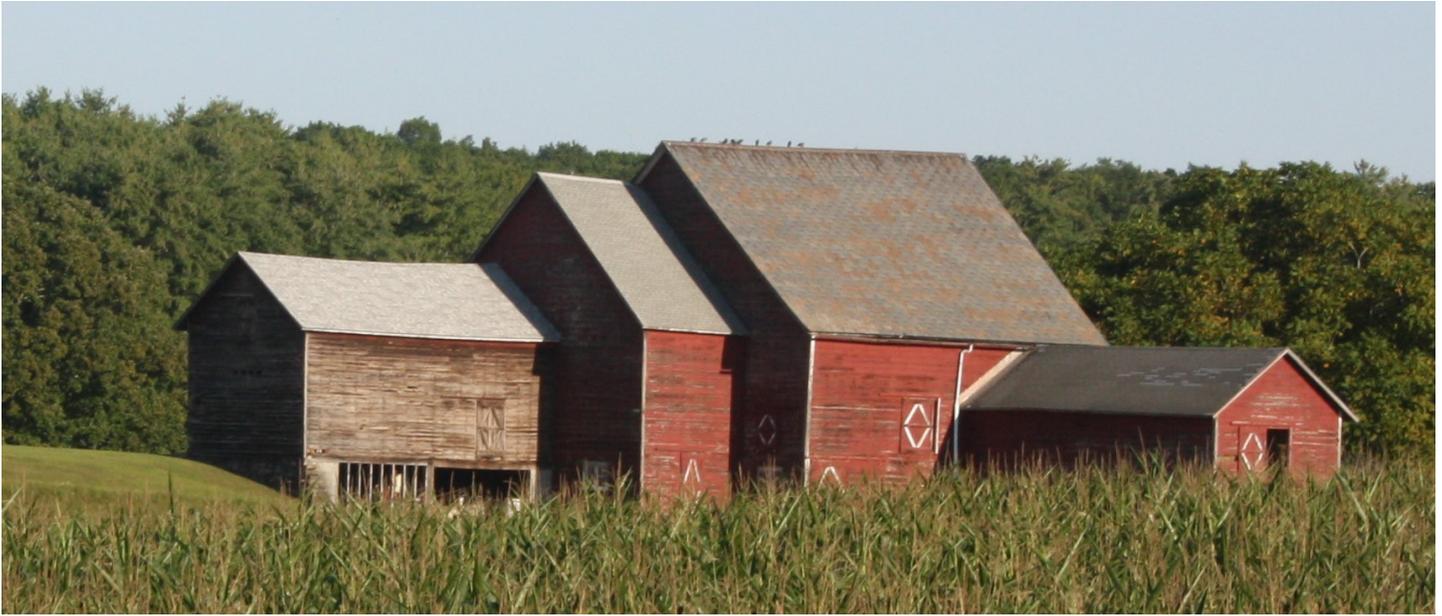
Fig.2: Eldred barn as seen looking west from Greene County Route 51, Town of Coxsackie. The original Dutch barn has the highest roof line. The cow barn addition is perpendicular to the rest of the structure. Photo by Ted Hilscher.

The original barn was 36 feet wide on the west and east elevations, and 45 feet deep on the north and south gable ends. The barn has been added to at least three times, with a cow barn wing on the east side, perpendicular to the rest of the structure (Fig. 2).

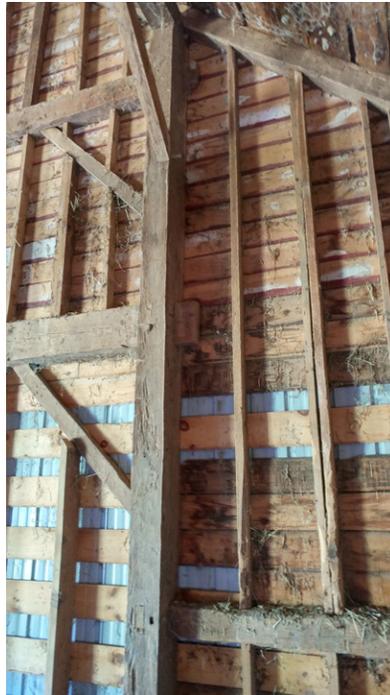
Fig.3: North wall bent, with two anchor-beams. Photo by John Cannon.

Bents 1 (Fig. 3) and 3 (Fig. 4) each have or had two anchor beams. The lower anchorbeam in bent three has been removed.

The soffits of the lower anchor beam in bent one and the anchorbeam in bent two are about ten feet off the floor, while the mortises for the lower anchorbeam in bent three and the sole anchorbeam in bent four are 78 inches off the floor.

The dimensions of bent one are smaller than the rest: the posts are 10.5 inches x 7 inches, and the lower anchor beam is 12 x 8.5. In bent two, the posts are 11.5 x 8 and the

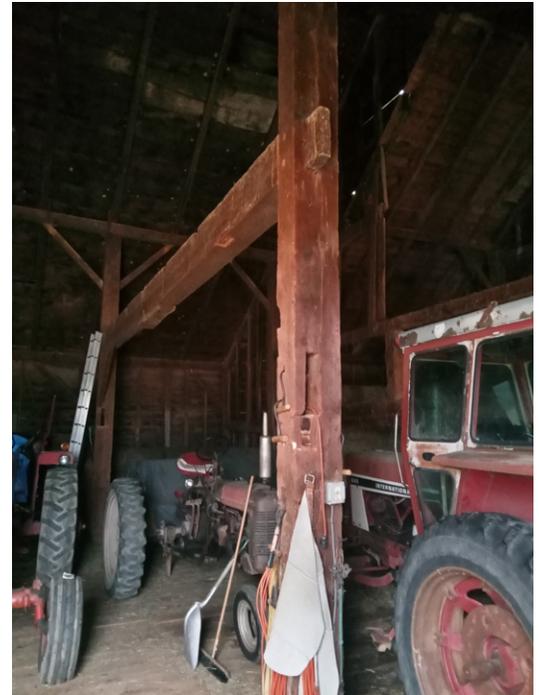
Fig. 4: Bent three, with mortises indicating a second anchorbeam. Photo by Ted Hilscher.
