**HVVA tour of Rensselaer County: The tying joint in Pittstown and Hoosick.**  
19 May 2012

**Introduction**

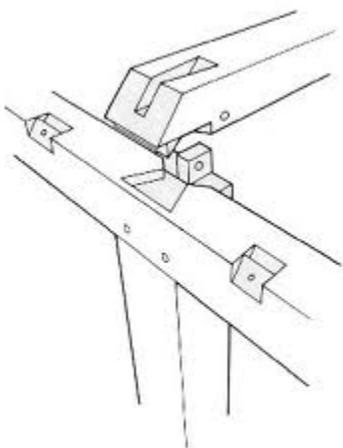
Figure 1. The three-part tying joint, seen from outside, and above.

The three-part tying joint is a connection in which the top plate of a wall, the tie beam, and wall post all intersect in one sophisticated joint. This form of joinery is much more complex than framers who used the New World Dutch system of framing engaged in, and when done well is a thing of beauty (Figure 1). The posts in this framing system are frequently flared toward the interior at the point of juncture with the other two framing members; this facilitated the fabrication of the joint without requiring that the entire post be of massive size.

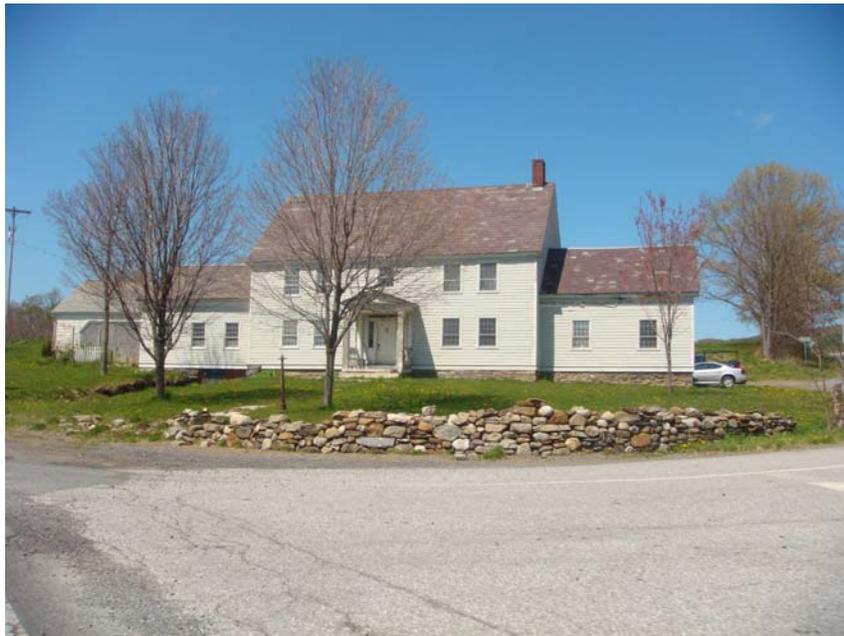
Figure 2. The Hills house, Coila Vicinity, Town of Jackson, Washington County (all pics by W. R. Wheeler unless noted otherwise).

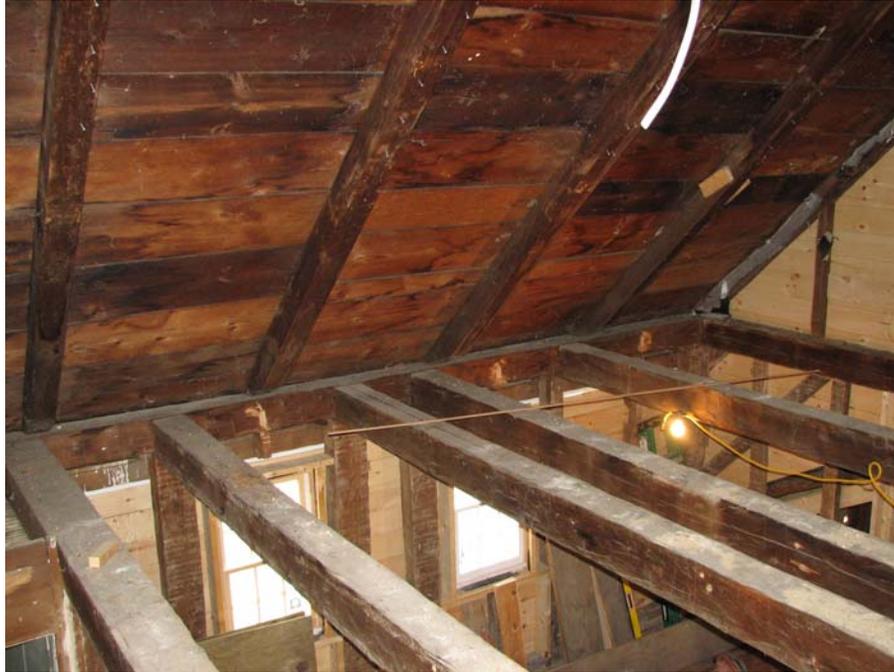
Figure 3. View in the attic of the Hills house, looking at the tops of six of the tying joints—from among 24 used in the main house and almost 30 more used in the two wings. In this one example, the use of “gunstock posts” was eschewed so that the posts could be concealed within plastered walls.

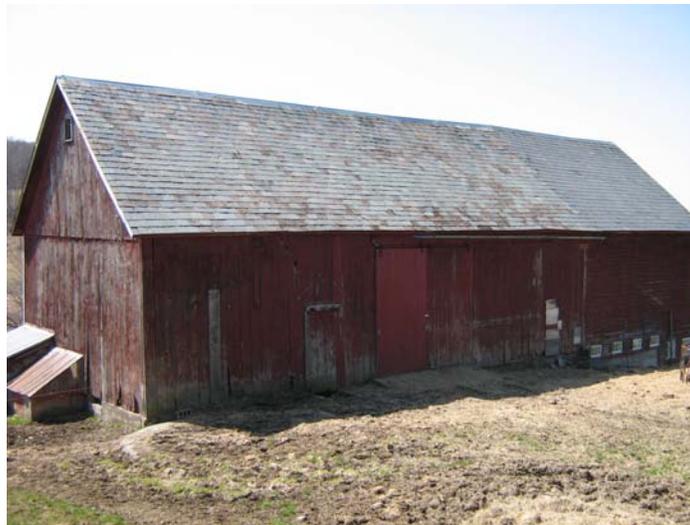
Figure 4. View of the three-bay threshing barn, with later one-bay addition to the right, on the O’Donnell Hill farm, Town of Jackson.

Another example in the Town of Jackson, on the O’Donnell Hill farm, also visited as part of our tour of Washington County in August 2010, is a three-bay threshing barn which features the three-part tying joint associated with pocketed braces (Figures 4 and 5).

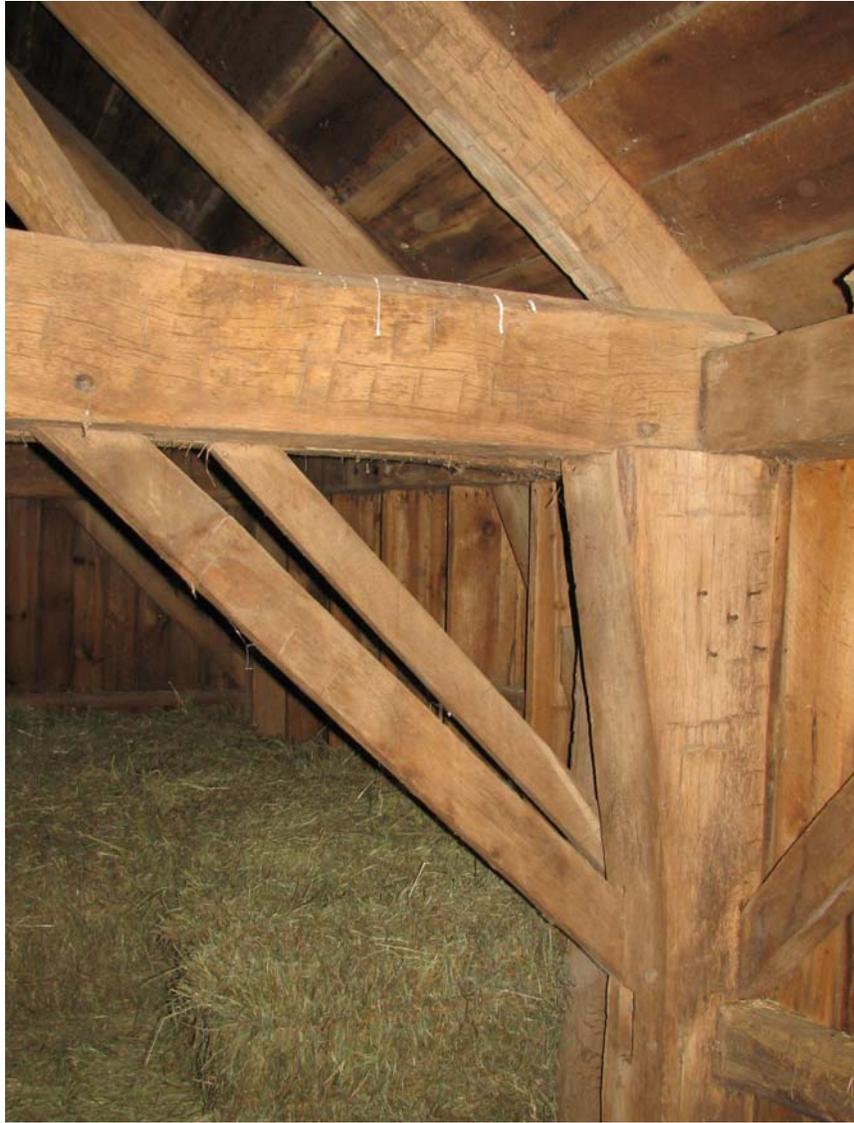
Figure 5. Typical joint in the O'Donnell Hill barn. The flared top of the "gunstock" post is particularly evident in this shot.

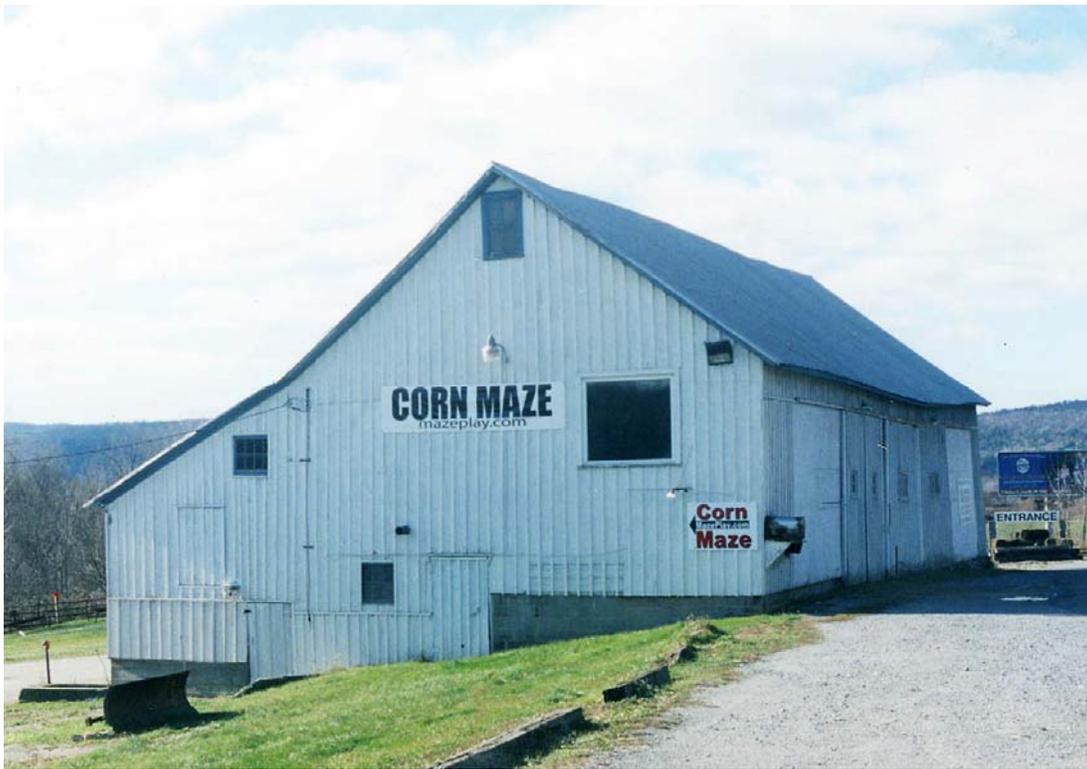
Figure 6. View of the threshing barn (Connie Kheel photo).

The Morgans own two photos of cavalry encampment on the farm of the 15<sup>th</sup> US Cavalry (dated 1906 & 1907). The photos show the English barn as well as a couple of barns that no longer exist. Next door to their home and restaurant is the English tie beam barn, the oldest known barn in Hoosick and an unusually large English tie beam barn (Approx. 74 ft. X 30 ft.). Behind the English barn is a later period timber framed structure.

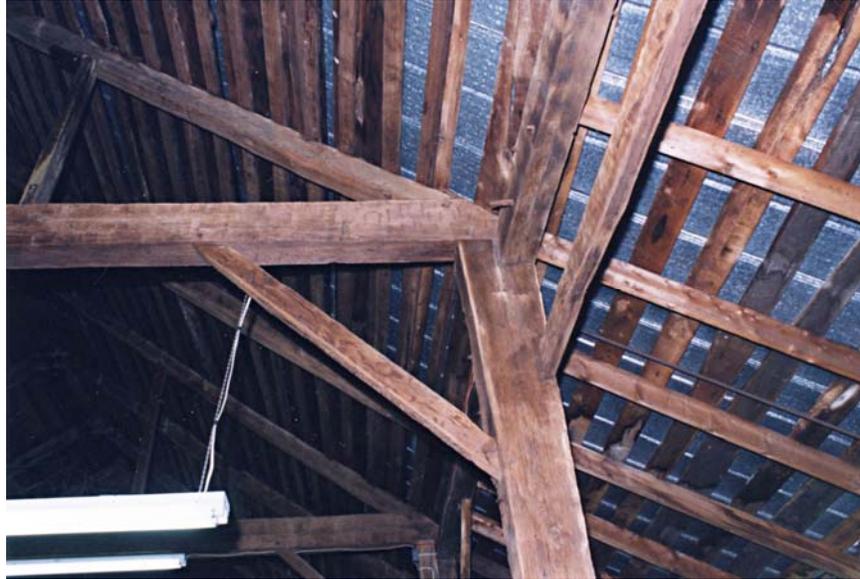
Figure 7. Detail in the Morgan barn (Connie Kheel photo).

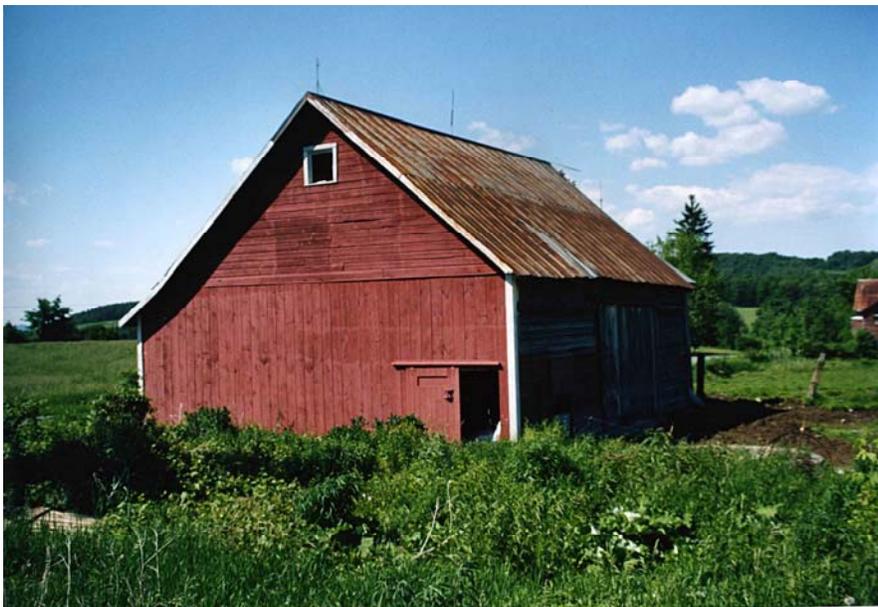
Figure 8. The Cipperly (Siemens farm) barn (Connie Kheel photo).

Carl Cipperly's English tie beam barn is on what he calls the Siemens farm. It is a property that Carl's family purchased close to 50 years ago to expand their dairy operation. It's now used for hay storage and livestock shelter. The farmhouse which went with the barn is located a small distance away and is still owned by the Siemens family. Carl's farm is about a half mile from the English tie beam barn. Carl will be able to talk about how the barn was used or was altered over the years.

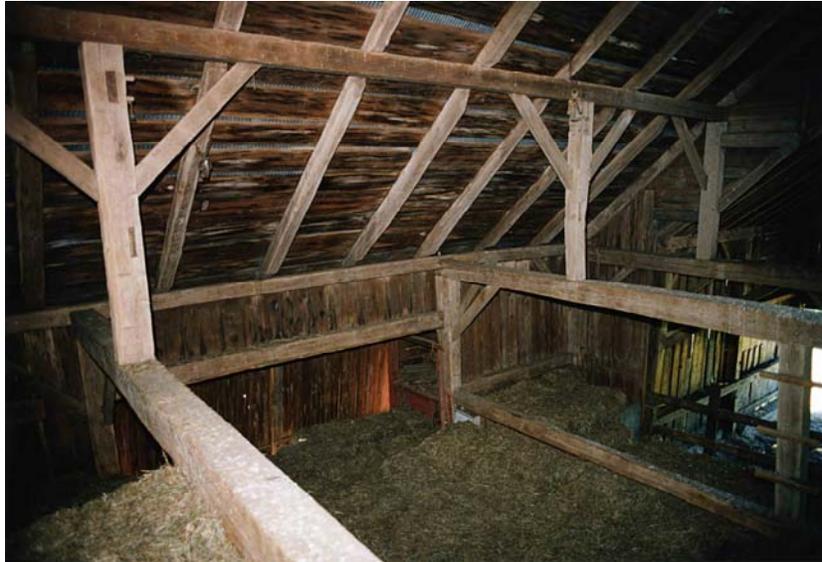
Figure 9. Interior of the Cipperly barn (Connie Kheel photo).

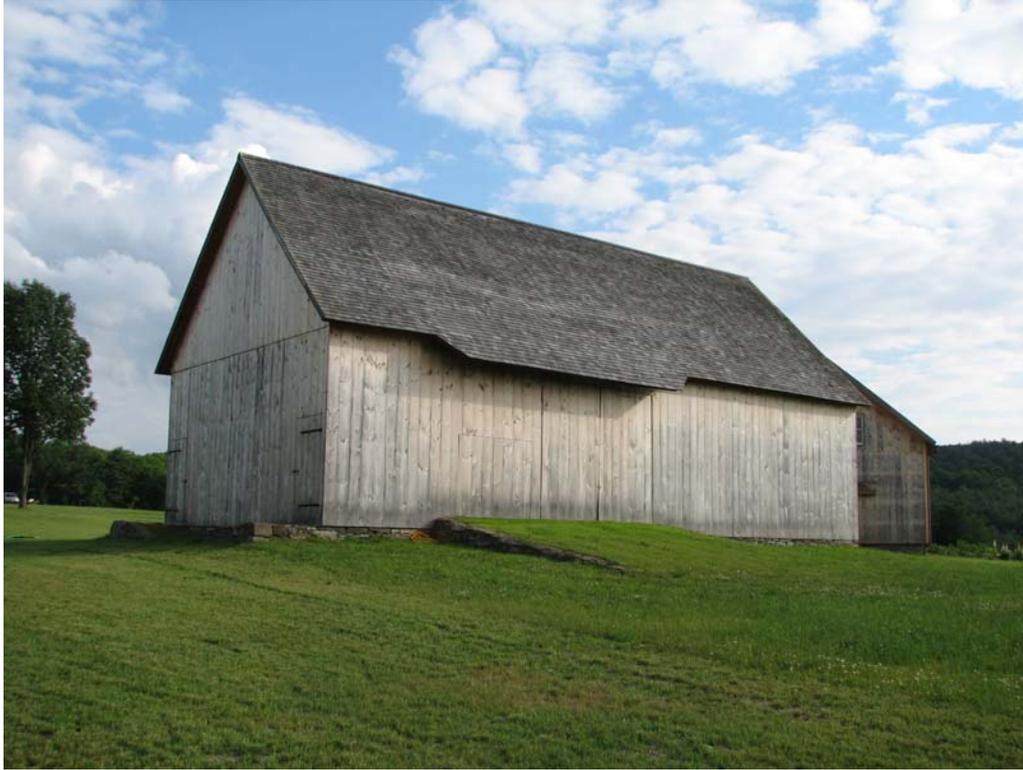
Figure 11. View of the tying joint barn at Nipmoose.

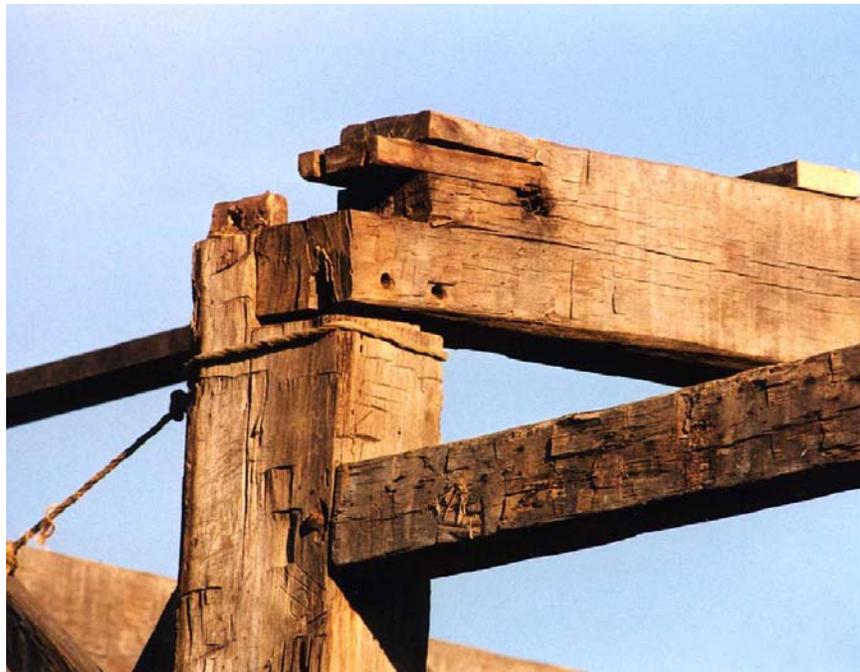
Figure 12. View of a typical joint during the restoration of the barn. Note the marriage marks incorporating a circle and slashes of the race knife, just below the lower part of the joint (Photo courtesy Connie Kheel).

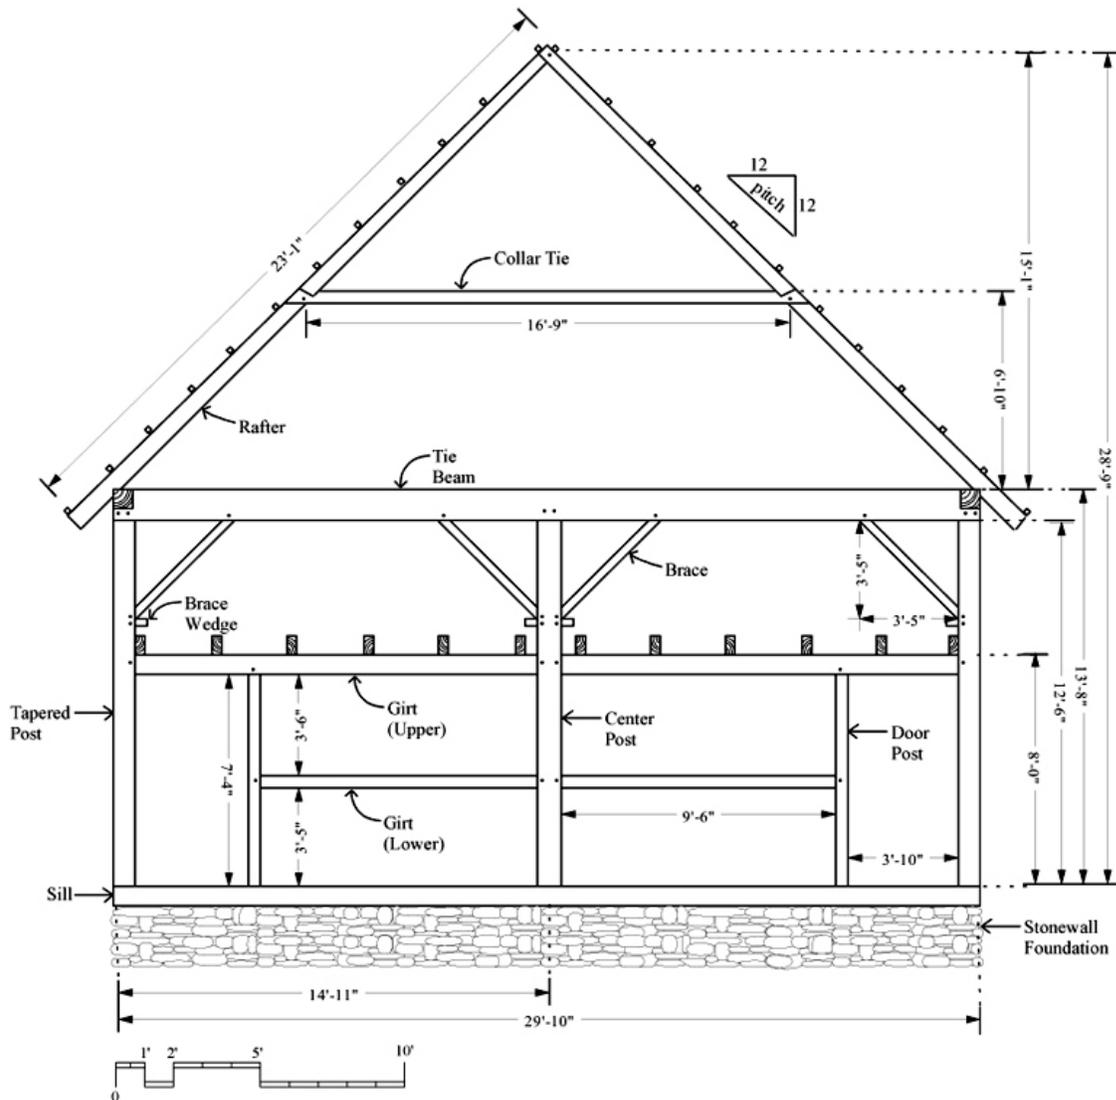
#### BEAM DIMENSIONS: WIDTH AND DEPTH

**Brace:** 5 in. wide x 3 in. deep  
**Brace Wedge:** 4 in. long x 3 in. high x 1 in. deep  
**Center Post:** 11 in. wide x 9 in. deep  
**Collar Tie:** 6 in. wide x 5 in. deep  
**Girt (Lower):** 5 in. wide x 5 in. deep  
**Girt (Upper):** Tapered 8 in. wide x 8 in. deep at base  
**Rafter:** Tapered 8 in. wide x 5 in. deep at base  
**Door Post:** 6 in. wide x 6 in. deep

**Sill:** 9 in. wide x 9 in. deep  
**Stonewall Foundation:** 2 ft. high x 2 ft. deep  
**Tapered Post:** Width 9 in.–11 in. (base and top);  
depth ranges from 12 in.–14 in. at base  
and 18 in.–19 in. at top  
**Thatch Pole:** 2 in. wide x 2 in. deep  
**Tie Beam:** 13 in. wide x 10 in. deep

Figure 13. Sectional drawing of the tying joint barn at Nipmoose (Drawing by John Cooney).

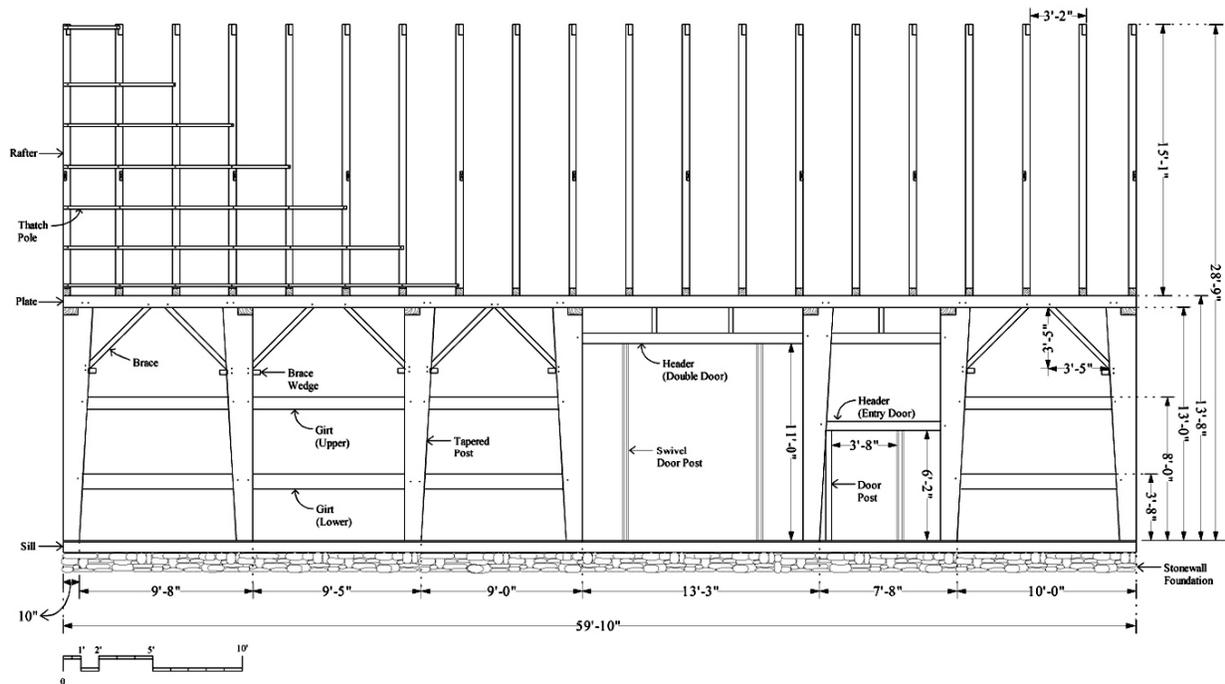
**BEAM DIMENSIONS: WIDTH AND DEPTH**

**Brace:** 5 in. wide x 3 in. deep  
**Brace Wedge:** 4 in. long x 3 in. high x 1 in. deep  
**Door Post (Entry Door):** 6 in. wide x 4 in. deep  
**Girt (Lower):** 10 in. wide x 8 in. deep  
**Girt (Upper):** 8 in. wide x 8 in. deep  
**Header (Double Door):** 8 in. wide x 7 in. deep

**Header (Entry Door):** 8 in. wide x 6 in. deep  
**Plate:** 8 in. wide x 8 in. deep  
**Rafter:** Tapered 5 in. wide x 8 in. deep at base  
**Sill:** 9 in. wide x 9 in. deep  
**Stonewall Foundation:** 1 ft. high x 2 ft. deep

**Swivel Door Post (Octagonal):** 6 in. wide x 6 in. deep (Double Doors);  
 4 in. wide x 4 in. deep (Entry Door)  
**Tapered Post:** Width ranges from 9 in. – 14 in. at base  
 to 15 in. – 19 in. at top; depth 9 in. – 11 in. (base and top)  
**Thatch Pole:** 2 in. wide x 2 in. deep

Figure 14. Side elevation of the barn (Drawing by John Cooney).

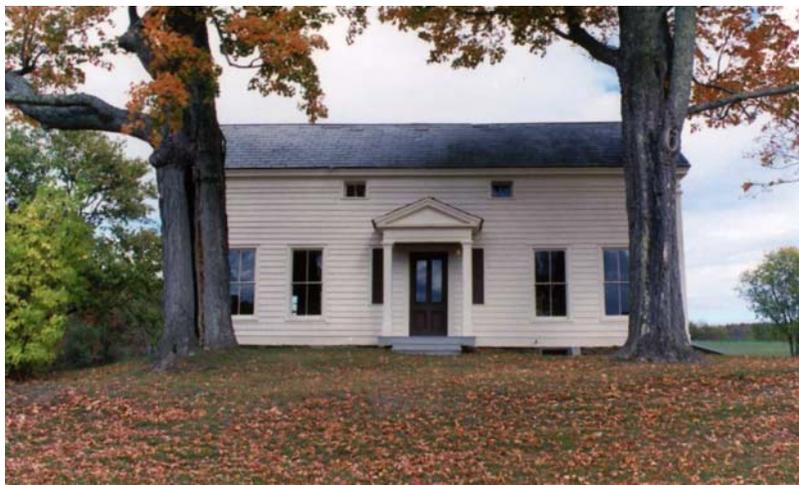
Figure 15. The house at Nipmose farm. Probably dating to the early 19<sup>th</sup> century, this house makes use of bent framing in its construction (Connie Kheel photo).
