The Society for the Preservation of Hudson Valley Vernacular Architecture

Newsletter

Vol. 12, No. 5-7

Mattys Persen House

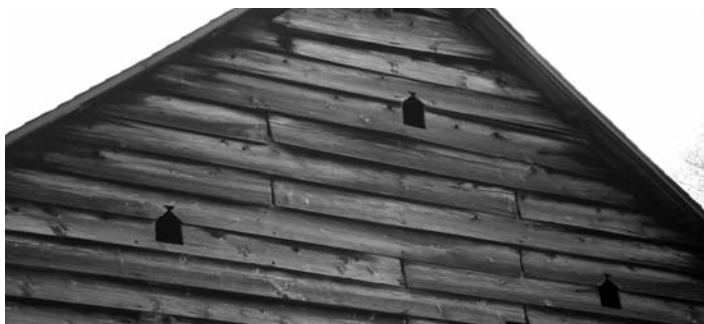
Upper end of east end wall of barn includes three marten holes that are common in the Dutch barn realm. Such holes are not normally included in exterior boards that are secured with later style wire nails.

On the north eave wall is a single section sliding type 11½ foot long wagon door. On the south wall is a two-section sliding 11½ foot long wagon door. The window just under the eaves on this wall is of course not original. On the east end wall three marten holes appear (see Fitchen).

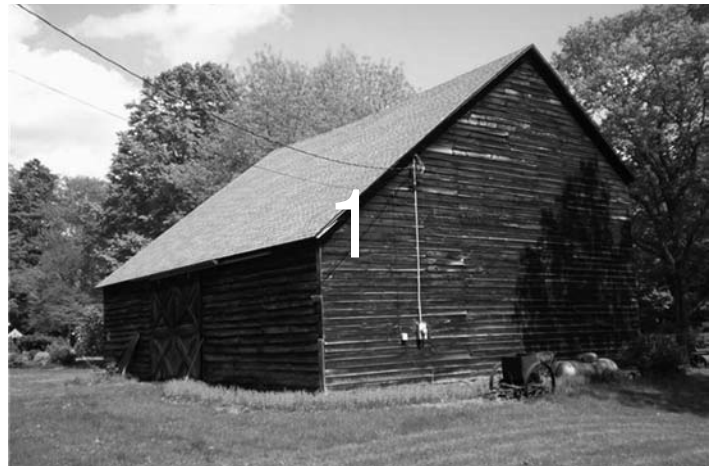
Exterior of Sickler Road two-aisle barn west of Woodstock, Ulster County. Seen is non-original novelty siding on west end wall and regular north side wall siding that is also not original. The north wall includes wagon door of sliding type that is not original.

The entire exterior is covered with non-original horizontal siding. On the west end wall appears novelty siding and on the remaining three walls there is regular horizontal

weather-boarding. All siding is secured with wire nails. The original siding was horizontally applied as indicated by the vertical interior wall studding.

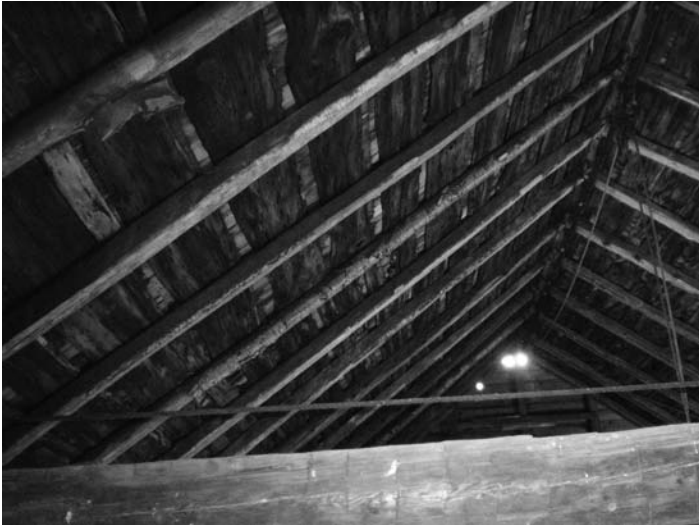
A common rafter system is seen in the Sickler Road barn. Many barn rafters are hewn and are of yellow birch. Above rafters are original roofers with natural waney bark edges. At bottom is upper tie beam of bent.

There are sixteen pairs of rafters. All rafters are hewn except two or three that were left in the round. All rafters are flat edged on the wall plates. The nailers or roofers above the rafters are very likely original. Many of them have curved natural bark edges.

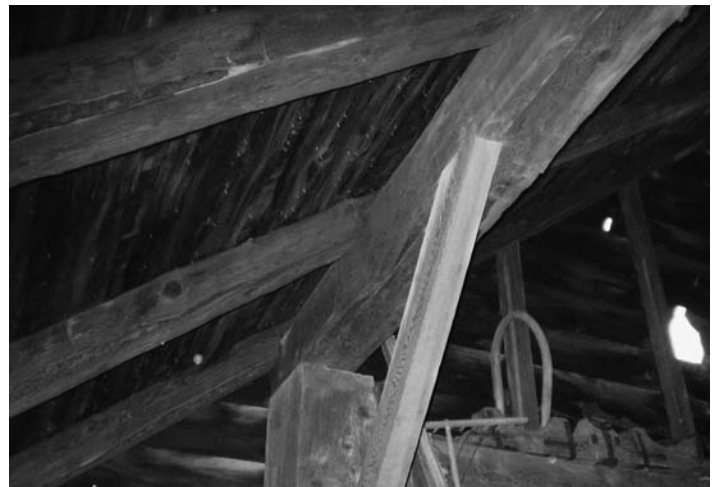
East end wall of barn is seen with a marten hole in exterior siding. Resting on top of upper tie are farm tools including old yoke. Purlin plate rests on top of main post of end wall bent and brace unites two beams. Above plate are common rafters that extend at left into side aisle.

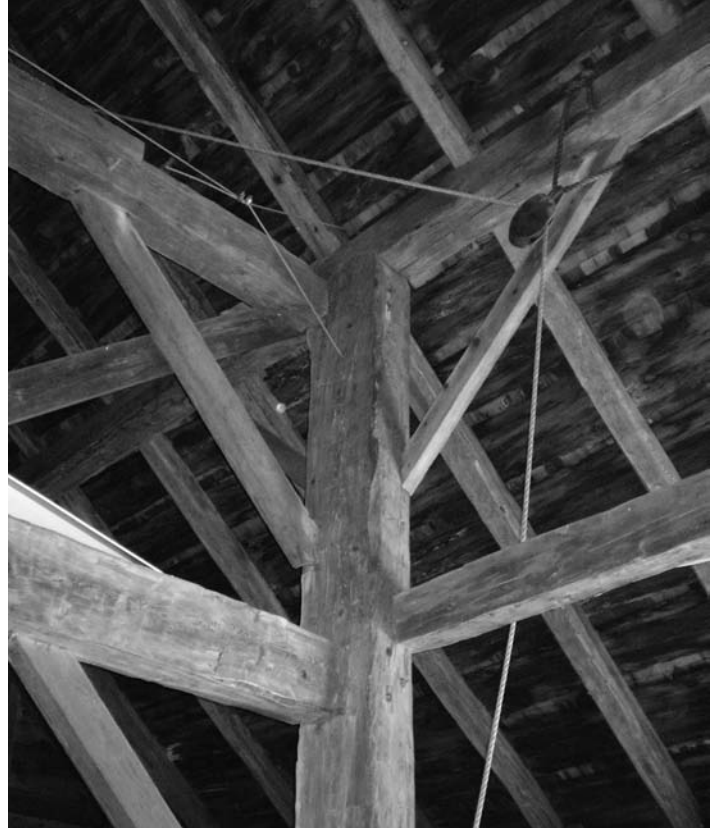
View of many timbers uniting with main post of inner bent at the west side of wagon bay. Purlin plate is seen at top of post with purlin braces seen at either side of post. At left is braced upper tie beam that joins at top of post. Below at left is braced middle tie. At right is longitudinal tie just above level of middle tie that adds stability in barn. Above purlin are common rafters.

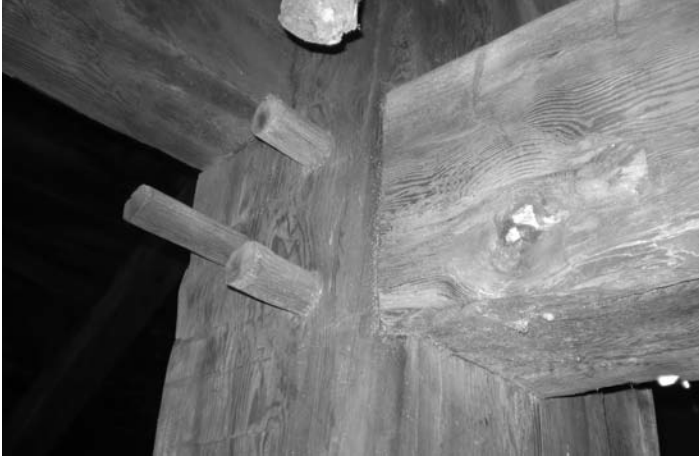
Tie at right unites to post of bent with triple pegs. High placed longitudinal tie at upper left corner joins to post. Beyond at the left is side aisle.

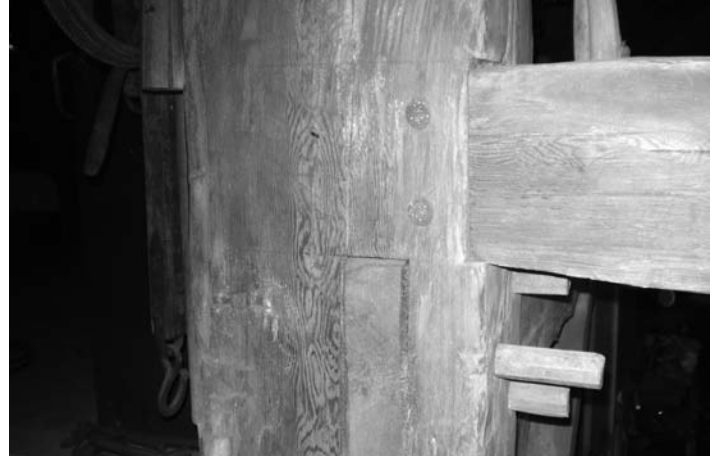
Post of inner bent is seen with outer end or housed tenon of middle tie of bent whose outer edges are chamfered. End of tie is flush with the outer face of post. Post and tie joined with three pegs. At right is longitudinal tie that joins to post with two pegs.

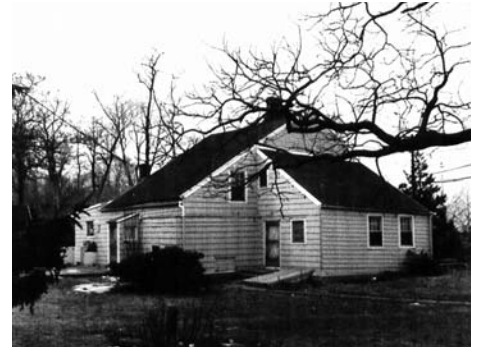
The John Wood House, view from the South East (photo taken in 1971).

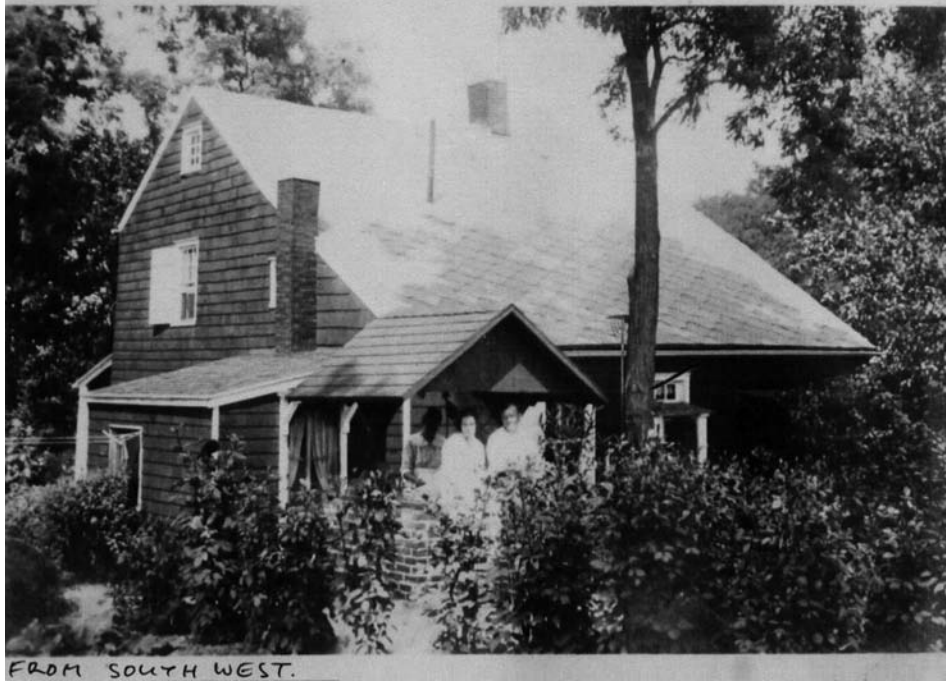
FAMILY PHOTO, JOHN WOOD HOUSE

FROM SOUTH WEST.

mid-18th century, a lean-to was built across the south side. Additionally, it was lengthened on its east end and a shed addition built against this. At that point, the north side became the front. Within the second floor of the lean-to, the south wall framing of the original structure is exposed. Several lengths of riven shingle lath (framing timbers and lath are of oak) survive. The shingle lath is gained into the corner posts, and the corner braces are set in the thickness of the lath so that the lath passes over them. This is also done in the c. 1730s Minne Schenck house at Old Bethpage Village Restoration. In about the middle of the wall are the remains of a casement window frame, of which the sill and the east jamb are missing. It may have had a mullion, but I am not clear on this. There is no evidence of infilling in the walls. The interior is lathed with riven plaster lath- that covering the interior of the casement frame has a slightly different character to the rest.

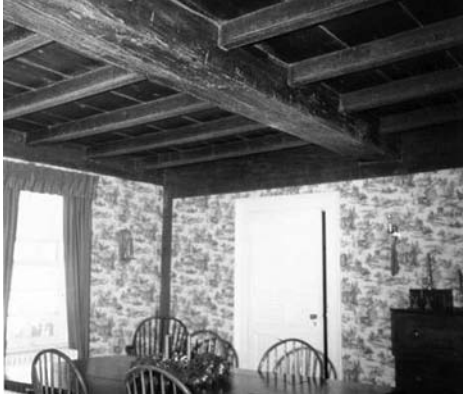
Top: The nearby Sammis House on West Neck Road, Lloyd Harbor, Town of Huntington, showing summer beam similar to the one found in the John Wood House.

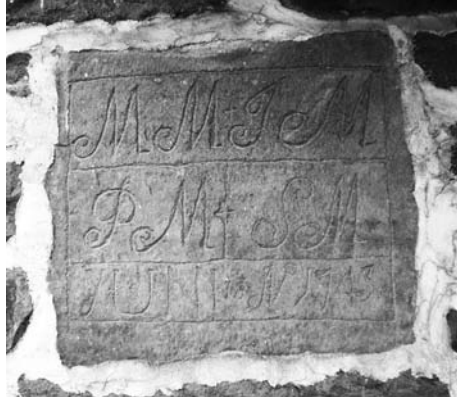
Mynderse House – Date-stone of 1743 that appears on the front wall of the Myndert Mynderse stone house facing the Hudson River. House is east of Saugerties in Ulster County.

On the Mynderse house just to the left of the main door on its front façade at the north end a date-stone of 1743 appears. Three lines comprise the stone (*top photo*). The first line has “MM JM,” the second line

has “PM SM” and the third line has “Juni 18 Ao (Anno) 1743.” The house section at the south end is thought to date earlier than this dated section. One house section has a fireplace hood beam with a height of 14 inches that is fairly large for an Ulster County house. A very interesting and unusual built-in cupboard is seen in one room at its end wall that has very old doors with wrought hinges.

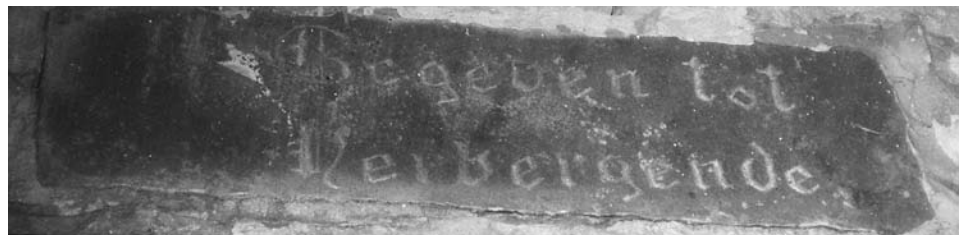
1700s Persen Inscription – Here is the mysterious inscripted stone over the door in the Cornelius Persen stone house on King’s Highway. Scholars can not seem to agree as to its exact meaning.

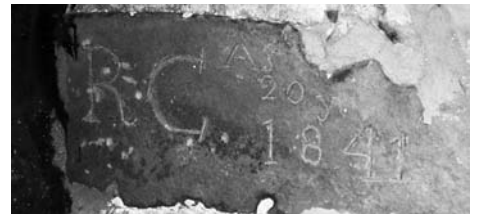
1841 Cole – The date on the rear wall of the stone house located on Blue Mountain Road, west of Saugerties, just a few miles south of Greene County. The house likely dates several decades prior to the date on the stone.

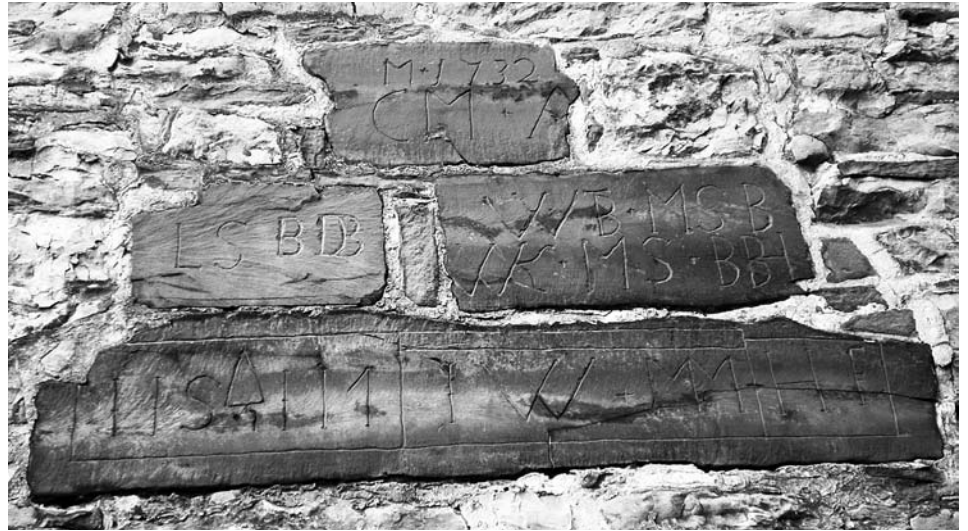
1732 Katsbaan – On the King’s Highway, north of Saugerties, is the mid-nineteenth century Katsbaan stone church that replaced a 1732 church. Five stones – four of which are seen here – appear on the north wall of the church.

Highway that is north of the big bend that veers west on Route 32 that is northwest of Saugerties. This was apparently the second Church on the site that replaced the 1732 church. Five re-cycled stones appear on the north wall of the stone church. All the stones appear about in the middle of the wall and are about ten feet from the ground.

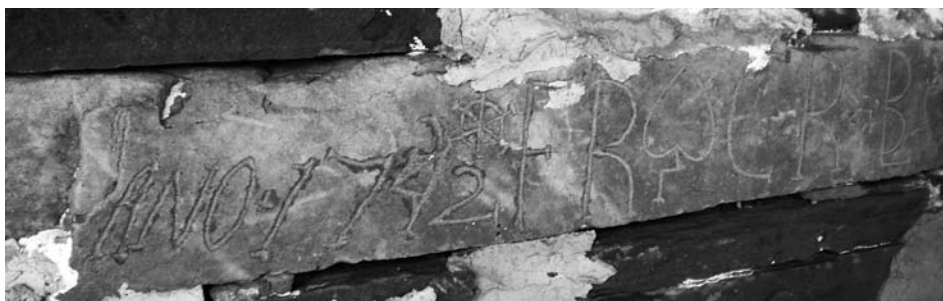
1742 Eleigh – On the rear stone foundation wall of the 19th century Eleigh-Wolven frame house appears an extremely unusual date stone with carvings of a date, initials and cryptic symbols. The house is located off Blue Mountain Road west of Saugerties.

The first building was the Eleigh – Wolven – Myers homestead off Blue Mountain Road. The homestead house is of post 1850 frame construction. Two stones incorporated into the stone foundation on the rear wall contain carvings of a very unusual nature. The stones appear about four feet from the ground. The left stone (*below photo*) is 31 inches long and five inches in width and the adjacent stone at the right is 21 inches long. It is obvious that the two stones were recycled from a much earlier building.

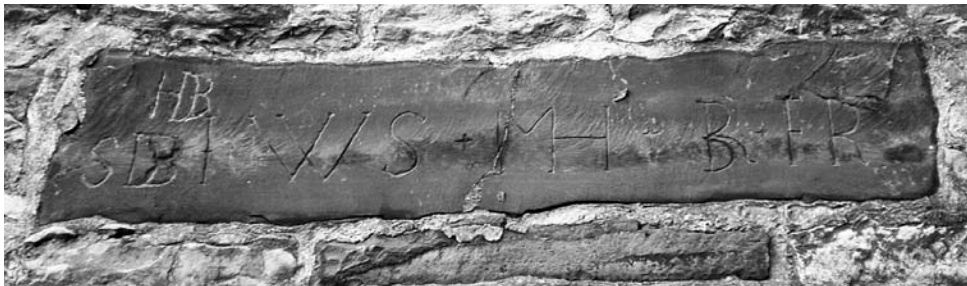
1732 Katsbaan – This is the fifth stone with various carvings that appears on the north wall of the Katsbaan church north of Saugerties.
