The Society for the Preservation of Hudson Valley Vernacular Architecture

Newsletter

Vol. 12, No. 8-10

Cornelius Cool House / Clearwater Farm

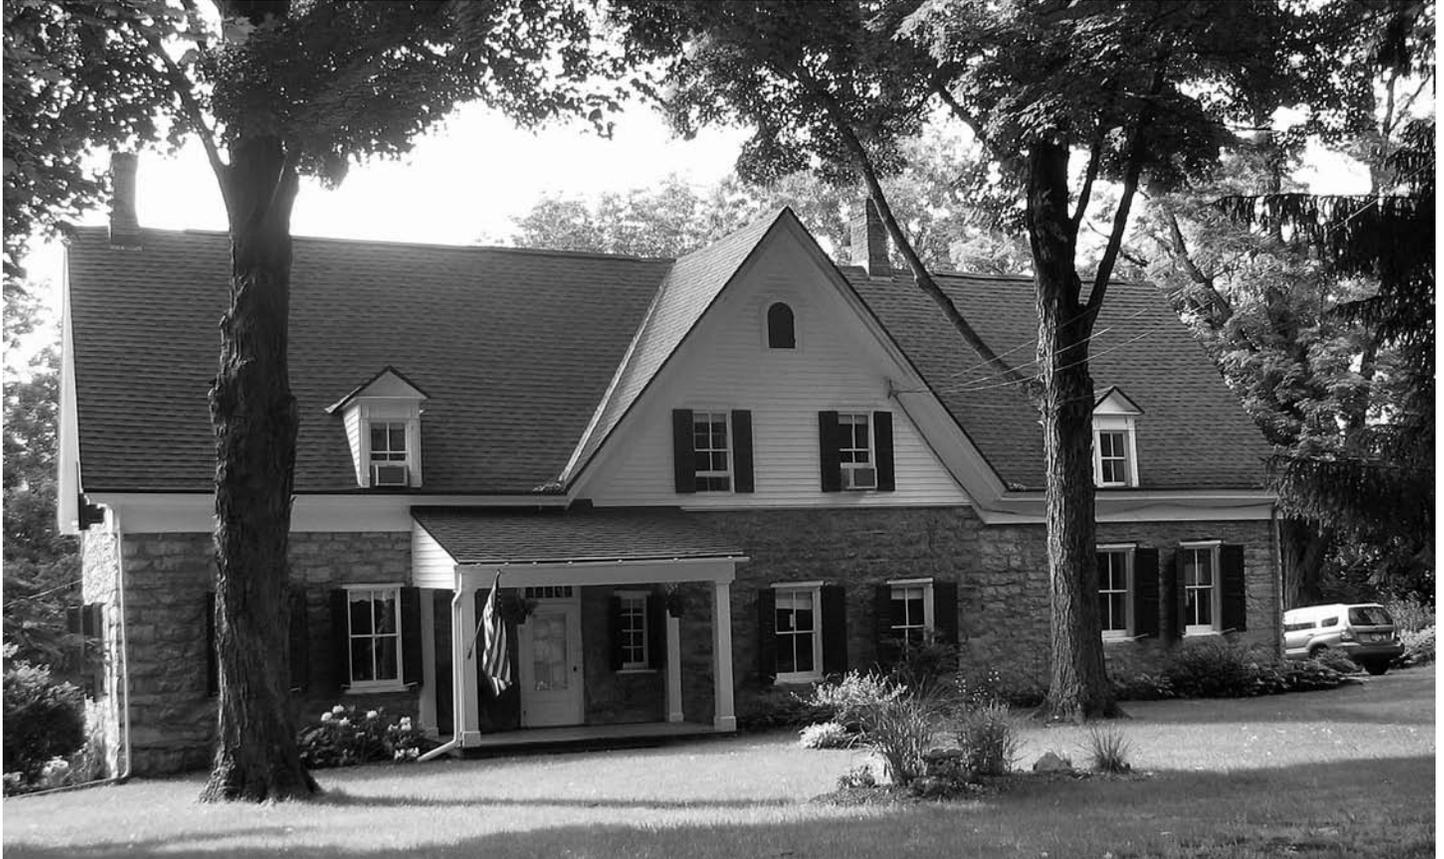
Clearwater Farm showing the East facade

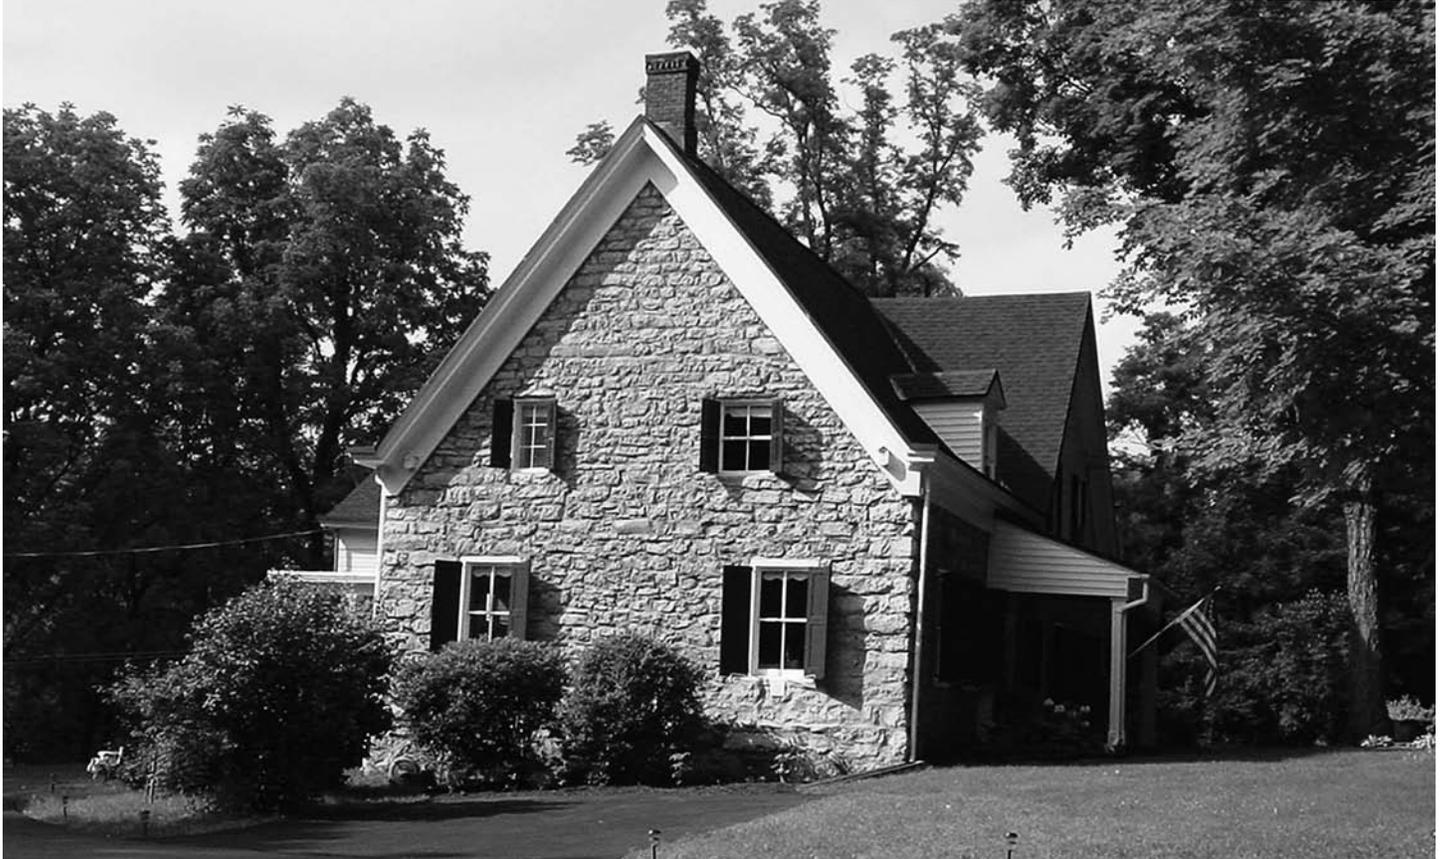
Clearwater Farm showing South gable end.

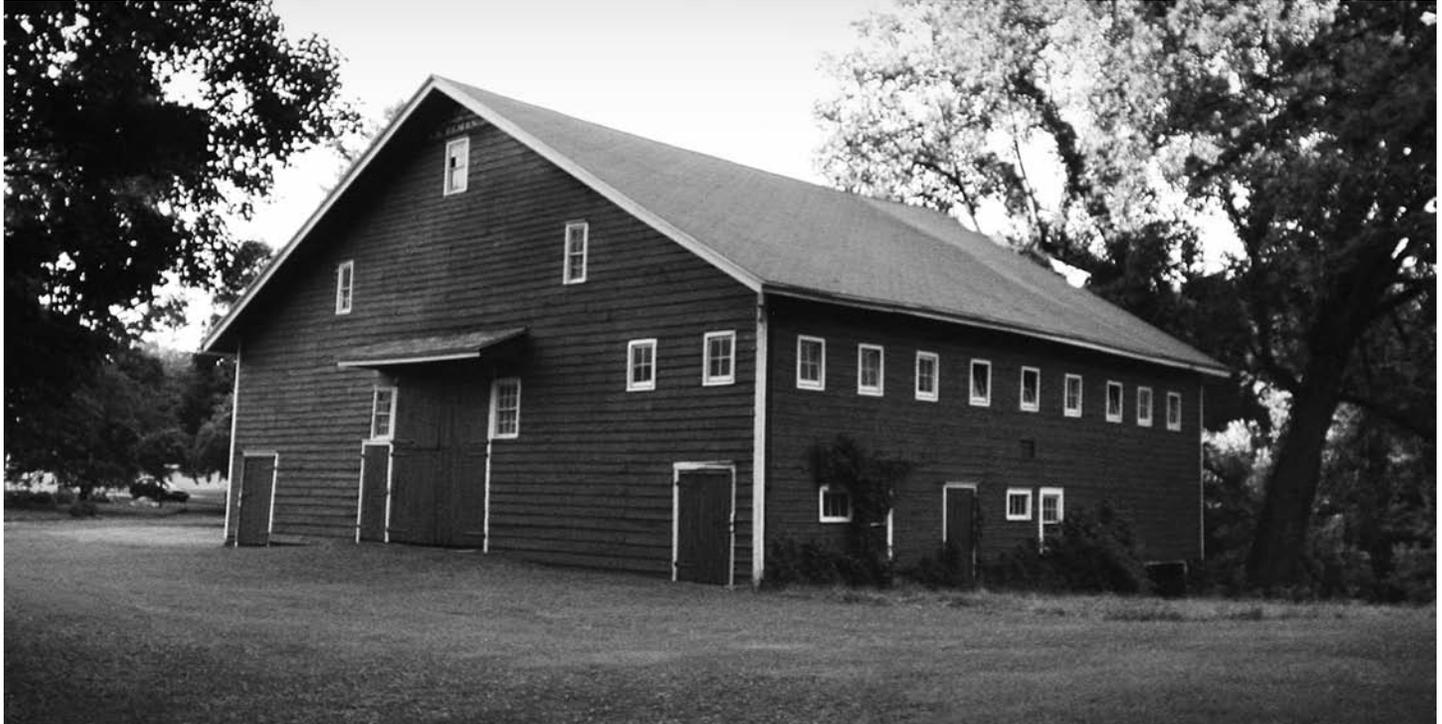
Exterior view of three-aisle Elmendorf barn is seen with all regular features of classic barn which include main wagon doors with four door leaves, overhead pentice and corner animal doors. All windows on the gable wall may be original except the two widows at the right side.

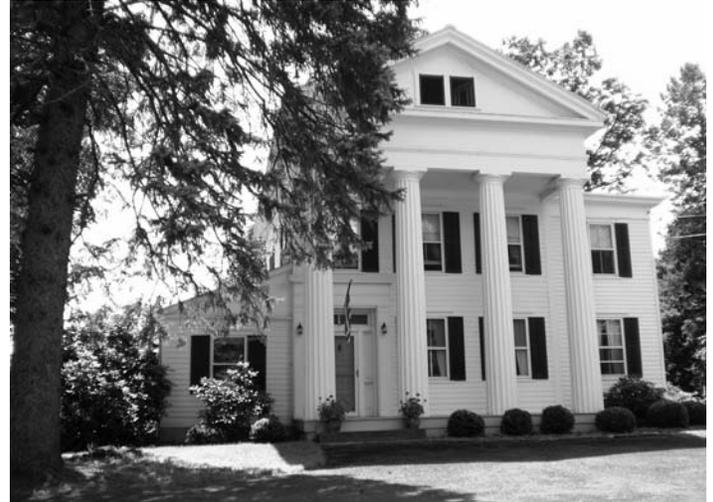
Two-story Greek Revival frame house circa 1850 sits about 200 feet from Elmendorf three-aisle barn. The triangular pediment at top and the four fluted support columns dominate the structure as defining elements of the house type. Single story wing at the left is original. Most of narrow horizontal exterior weather-boards are original.

The homestead consists of a few historic buildings. Others have been most likely lost in the past two centuries including an apparent stone house on the property. One observer believed that part of the foundation of the frame house began its life as a stone house.

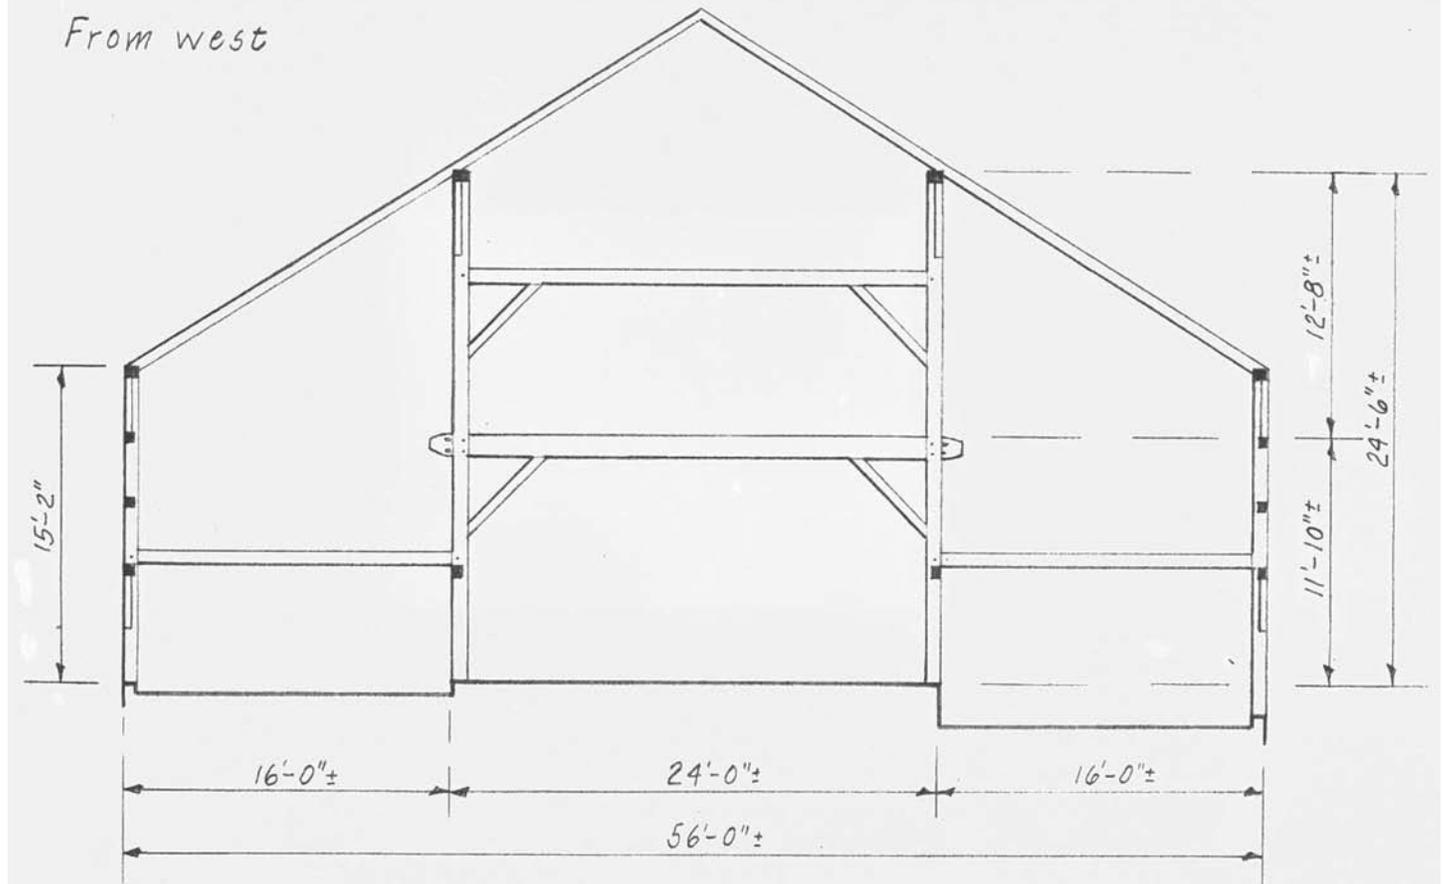
1850 Elmendorf barn, High Falls, Ulster Co., N.Y.

From west

The barn is an original condition classic three-aisle barn with a partial basement at the far end that corresponds to the wide far end bay in its basic dimensions. Only at the west end wall does a wagon door entry appear that is centered on the wall. The main wagon doors face 20 degrees south of west (nominally-west). The barn is built into a slope of ground. The stone foundation wall at the north side wall is a little shy of six feet high at its midpoint. The ground then slopes to a fair degree for about 20 to 25 feet and then drops off markedly beyond that point. Positioning on such a slope of ground is rare or almost unique for a three-aisle barn.

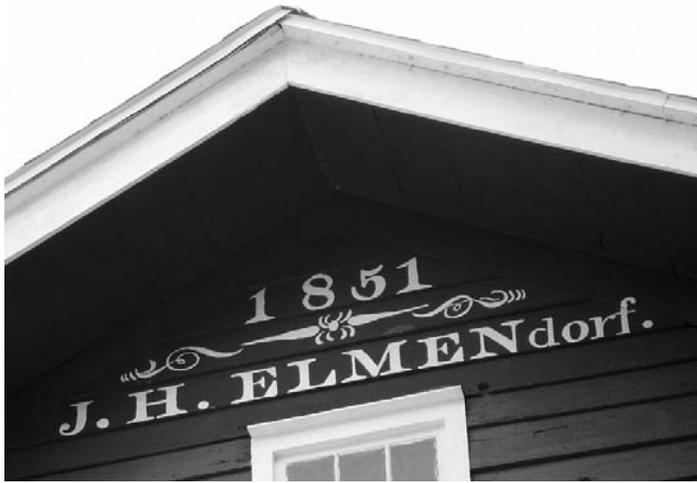
Close-up of supposed date of construction 1851 and name of homestead owner J.H. Elmendorf of the barn that appears on the west end wall of the structure.

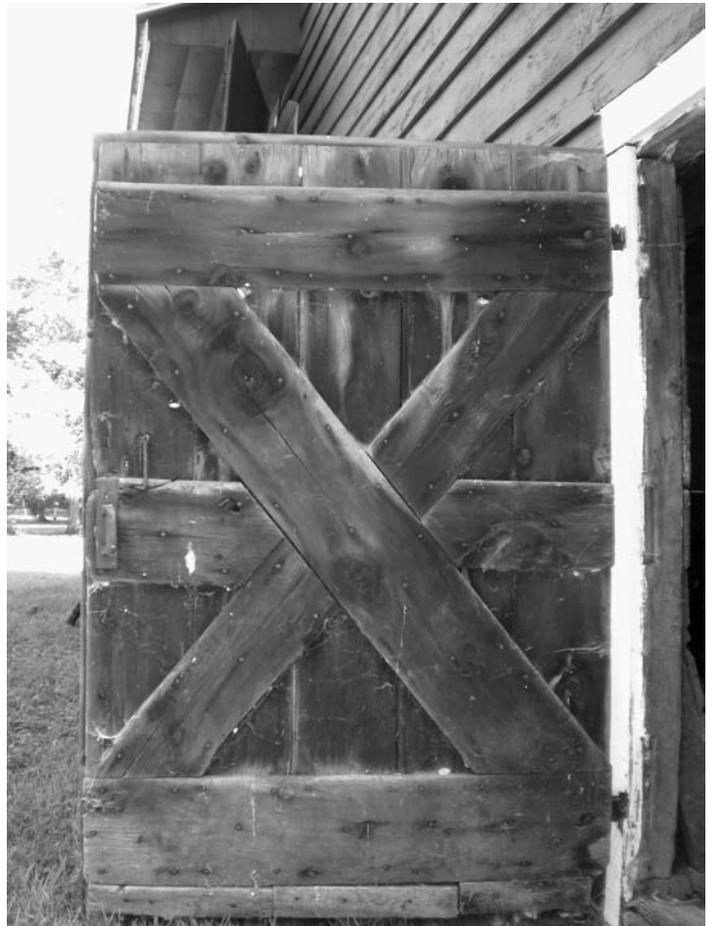
Southwest corner animal door is original and the appearance of rear door face battens is unique to the writer. Diagonal batten upper left to lower right is fairly often seen but the other diagonal (partial) battens and middle partial horizontal battens are very rare.

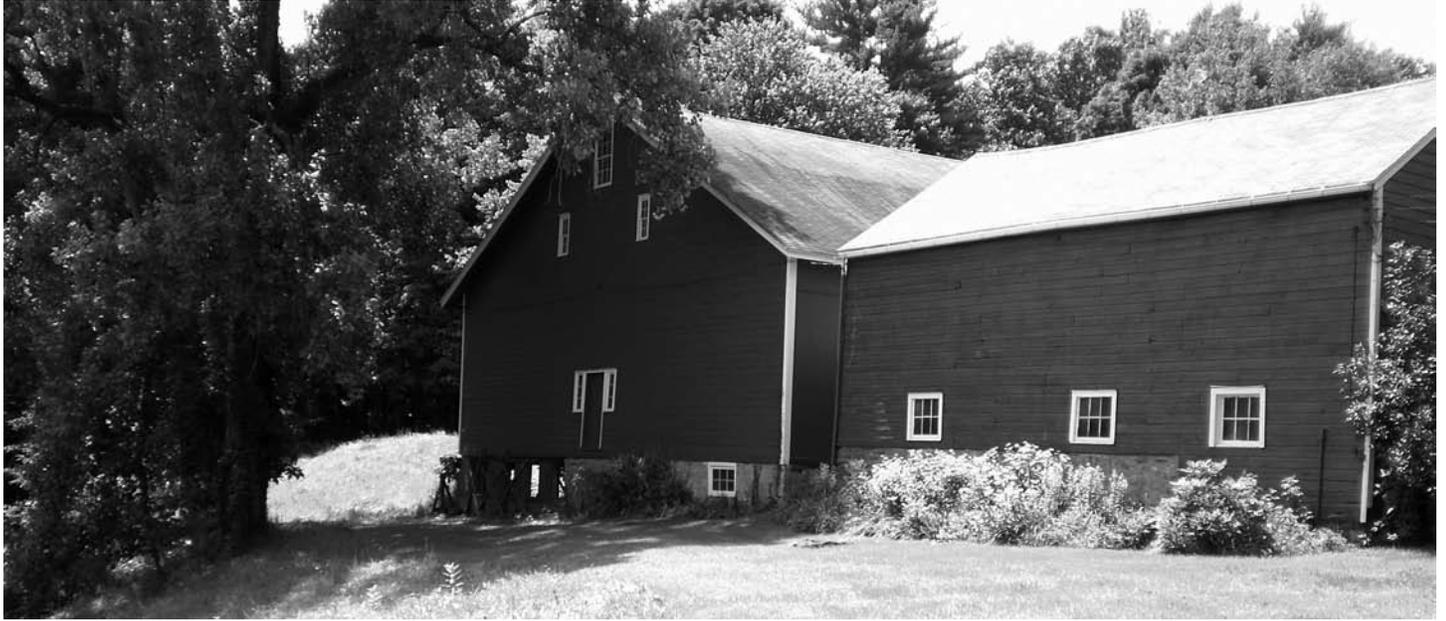
Rear walls of the three-aisle barn at the left and the one-aisle barn at the right are seen in context with the positioning of both structures to the lay

of the land. Property drops off considerably to the east of the classic barn that affords a partial basement at east end of the barn.

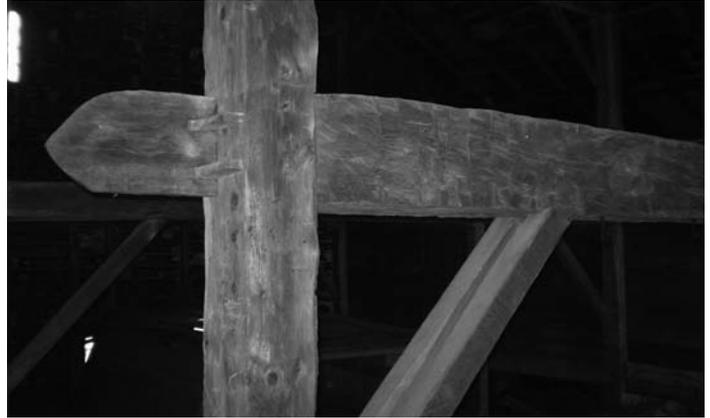
ABOVE: Middle bent is seen at its north end with anchor-beam to post juncture with prominent 19 inch long tenon extension with double wedges. Anchor-beam is oak while the post is pine.

The anchor-beam of the middle bent is quite unusual in that it was re-cycled (and flipped over) from an earlier Dutch-American barn. This is known from two aspects of the beam. Four empty mortises are found on the soffit of the beam. The existence of the mortises is indicative of the fact that the beam was an end bent in a barn where the mortises were for the placement of end wall studs that appeared above the anchor-beam. In addition, an empty mortise appears on the top surface of the beam a few feet from the extended tenon that was for the former placement of an H-frame brace. The tenon at the north end of the beam extends 19 inches and is double wedged. The tenon form is such that a wide side-ways v was formed. This form is very unusual and the tenon actually has the appearance of several of the tenons in the dated 1766 non-extant Hoornbeck-Grace five-bay barn in Accord.

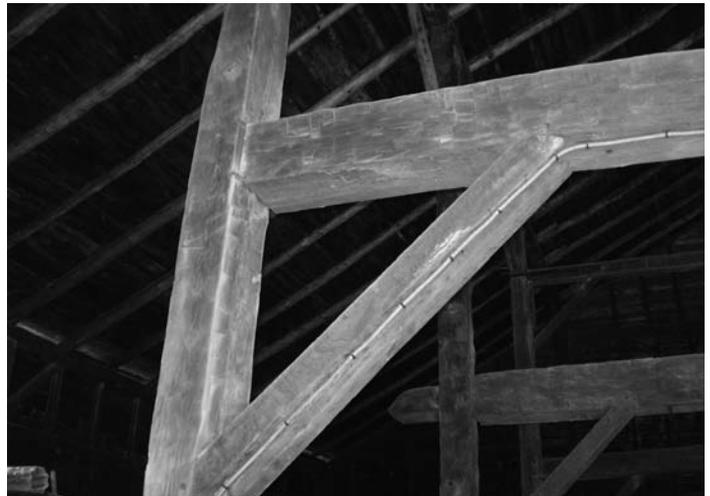
BELOW: Two partial H-frames are seen at their north ends. First inner H-frame is without an extended tenon. Note double side-by-side braces of bent. Beyond is middle bent with long extended tenon. To the rear of middle bent is last inner bent with no extended tenon. Above are seen round pole rafters of softwood likely pine.

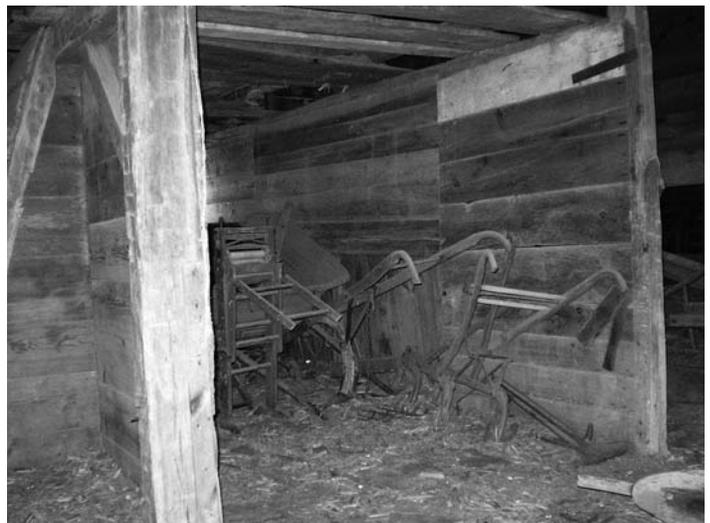
The far end bay in the middle aisle has the unique centered alley that stretches the full width of bay to the far end wall. The alley is framed by posts at each side and south wall of alley consisting of original horizontal boards is seen. Old farm implements are seen in the alley.

Longitudinal beams that join to the inner placed posts 7 feet above the floor extend over to the east end wall. These beams delimit a longitudinally placed alley that spans the entire length of the last bay or 18 feet. The inner posts are attachment points for longitudinal walls that are formed by 6 to 12 inch wide horizontal

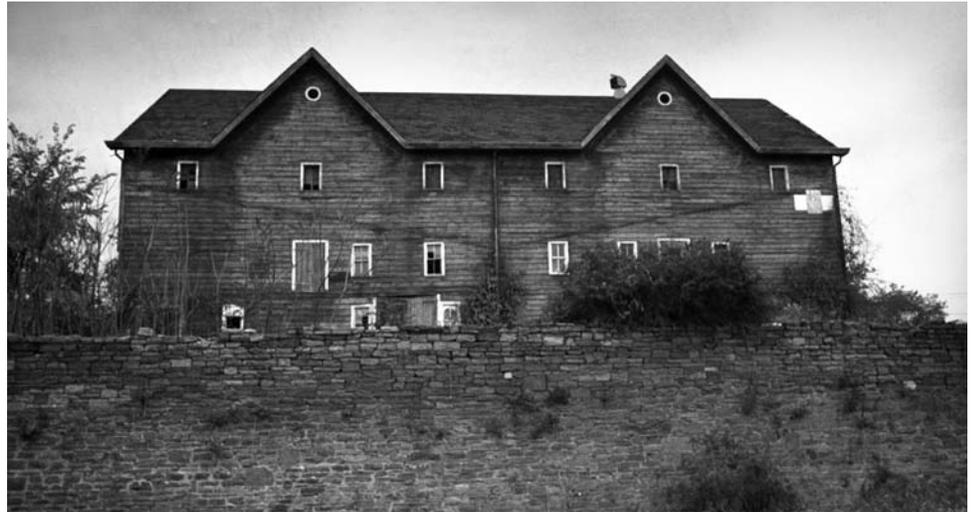
*Sadly this majestic barn met its demise when a reported storm weakened the structure beyond repair this past August. Known locally as the **McSpirit Barn**, it was located on the Sawkill Road in the Town of Ulster, New York.*
