The John Bowne House

Flushing, Queens County, New York
A Preliminary Architectural Analysis Report

Prepared by
John R. Stevens

Published October, 2003

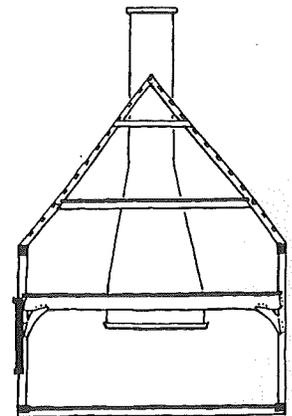
Section A-A

The bottom of the western internal anchorbeam was hewn off in Stage III for a level lath-and-plaster ceiling. This was very likely the hood-beam for a jambless fireplace. Further support for this is the evidence of braces on either end, like the hood-beam in the original part of the Pieter Wyckoff house in Brooklyn. The fourth bent from the east end also had braces. A partition had been located here. The first-floor boards are jointed in this location, and the anchorbeam has mortises in its underside, toward the west side of the beam, for the jambs of a doorway, 2 feet, 8 inches wide near the center of the partition wall.

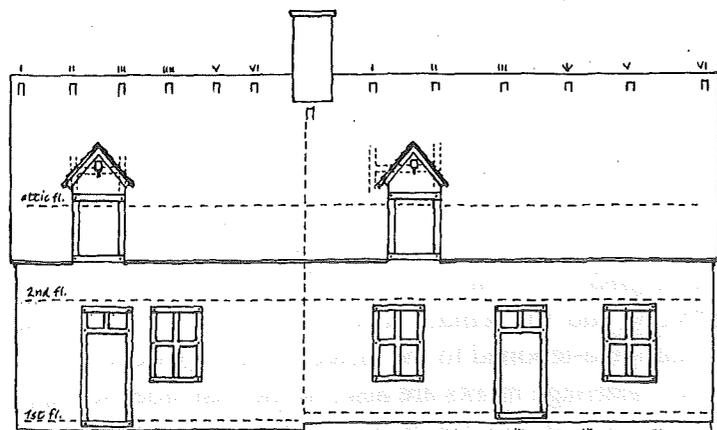
*South elevation*

Stage II The house was lengthened 21-feet to the west, either circa 1680 (**) if Stage I was built in the 1660s, or circa 1692 if Stage I was built in circa 1680. For some reason, the floor in the addition was made about 6 inches lower than the stage I section. It would seem that the leanto, about 12-feet wide, was built across the back (north side) of the house. Possibly a leanto of some kind predated Stage II. In the last few years the north wall of the house was rebuilt and the framing of the 17th century leanto was exposed. It was in extremely deteriorated condition and was mostly, if not completely replaced. Some framing elements from the east end of this north wall were saved, and their replicated counterparts can be seen from inside the leanto. The writer has not had access to drawings, photographs or reports describing and illustrating what was found and cannot express an opinion whether the leanto was all built at one time, or in stages.

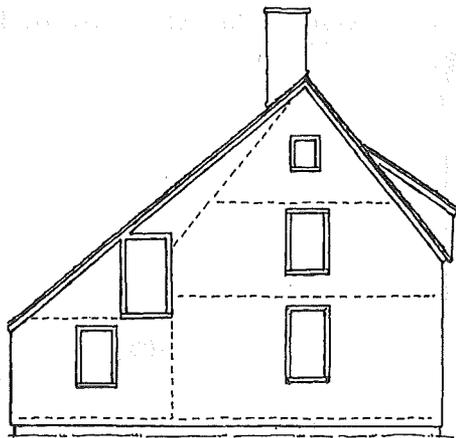
West elevation

The walls of the house were shingled. How much of the shingling is original cannot be determined, but it is evident from within the attic at the west end that the existing shingle lath and shingles pre-date Stage IV. The shingle lath and shingles of the east gable are original. Presumably much of the Stage I and II wall infill was retained, but it is obvious that much of the earlier infill of the end wall, as can be seen in the attic spaces, was replaced. Pre existing material was removed. pieces of split lath were nailed vertically to the shingle lath and daubed with clay and straw binder. The surface was worked smooth on the interior. The east gable retains its original window frame and 8 over 8 broad-muntined sash.

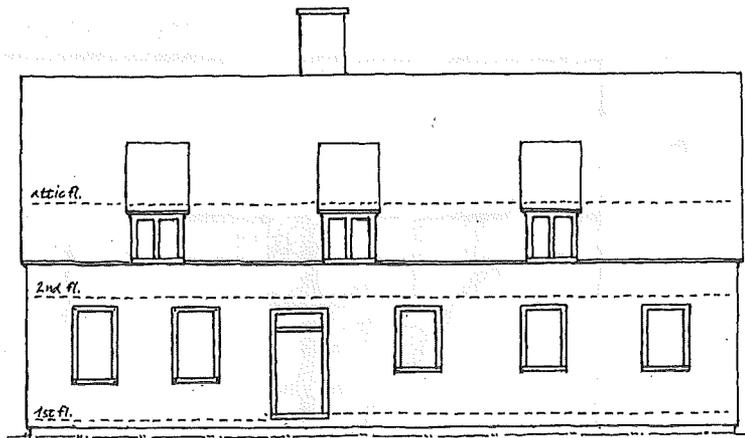
South elevation

Stage III The house was drastically remodeled circa 1750 at which time it achieved, essentially, its present appearance from the south. The existing chimney stack was removed and replaced with the existing one that has two fireplaces on the first and two on the second floors.

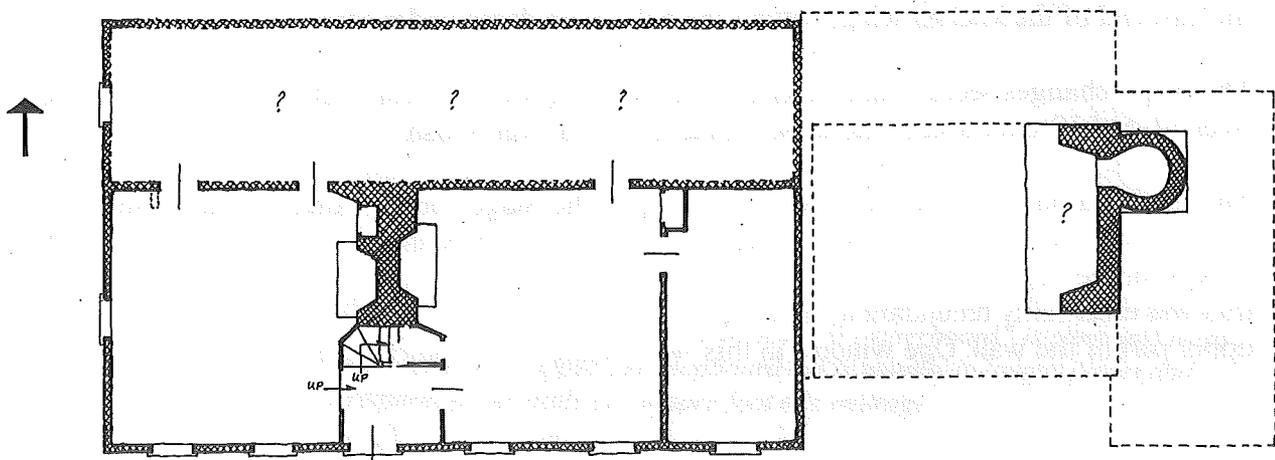
First floor

The west main room was given an elaborate treatment with a plastered ceiling and a fully paneled fireplace wall (east wall) with a built-in china cupboard. The north wall of this room is also fully paneled. There are two doorways in it, the westerly one, previously discussed, dating from Stage II. Adjacent to it is the curved-soffit anchor beam brace, the presence of which is difficult to understand. A section of paneling at the east side of the south wall survives. The rest of the south wall and all of the west wall is plastered. One would have expected this room to have been fully paneled, and the reason for this partial treatment has to be questioned. The writer's suspicion is that it was fully paneled. Why was it removed and when was this done? It is also a mystery why the anchor beam brace was left in place.

The stair hall remains in essentially original condition. The east main room has a partially paneled fireplace wall, mostly it is of vertical tongue-and-groove boarding. It originally had plastered walls and ceiling. The Stage I partition was removed and a new one constructed about 18 inches to the east. At the north end of it, facing into the large room, is a china cupboard of 18th century date which may be original to this location, but may also have come from another location. The interior of this room is heavily disturbed in an attempt to restore it to an earlier appearance in the 20th century.
