DUTCH BARN PRESERVATION SOCIETY NEWSLETTER

Side-Wall Wagon-Entry Barns in Monmouth County, New Jersey: Their Genesis and Types

By Greg Huber

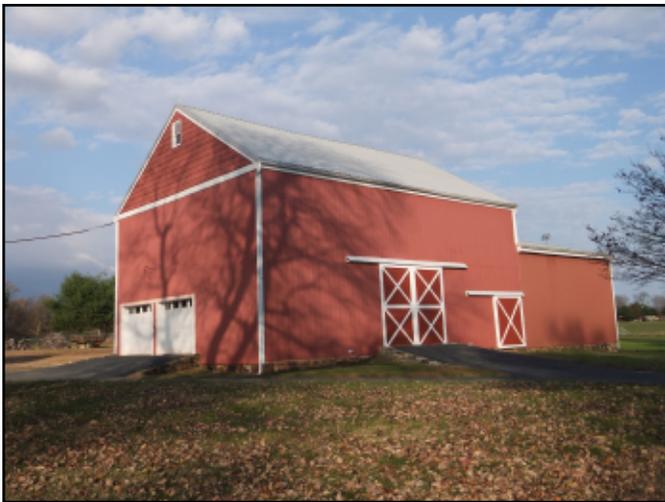
Photo 1. The Stevenson Dutch-Anglo barn on Vanderburg Road in Marlboro is an original condition eave-wall entry barn. The exterior walls are covered with modern materials. Barn built about 1830 (Photo by Greg Huber).

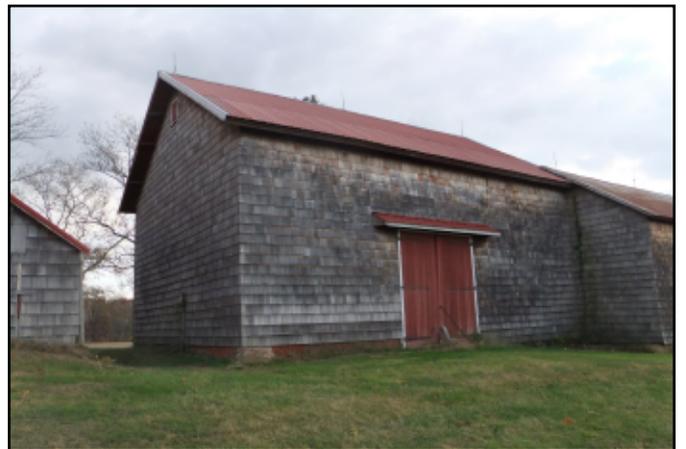
Photo 2. The Smock Dutch-Anglo eave-wall entry barn on Longbridge Road in Holmdel is on a township owned property. The barn, in excellent condition, was built c.1820 or 1830 (Photo by Greg Huber).

On their exteriors, these buildings look almost identical. The dynamics behind the genesis of the two barn forms are discussed below in greater detail. The author is familiar with seven of the Anglicized barns (Photo 2); three are "Americanized barns," that is, they had basements. Another barn (at Colts Neck) has not been examined on its interior; its type remains unknown.

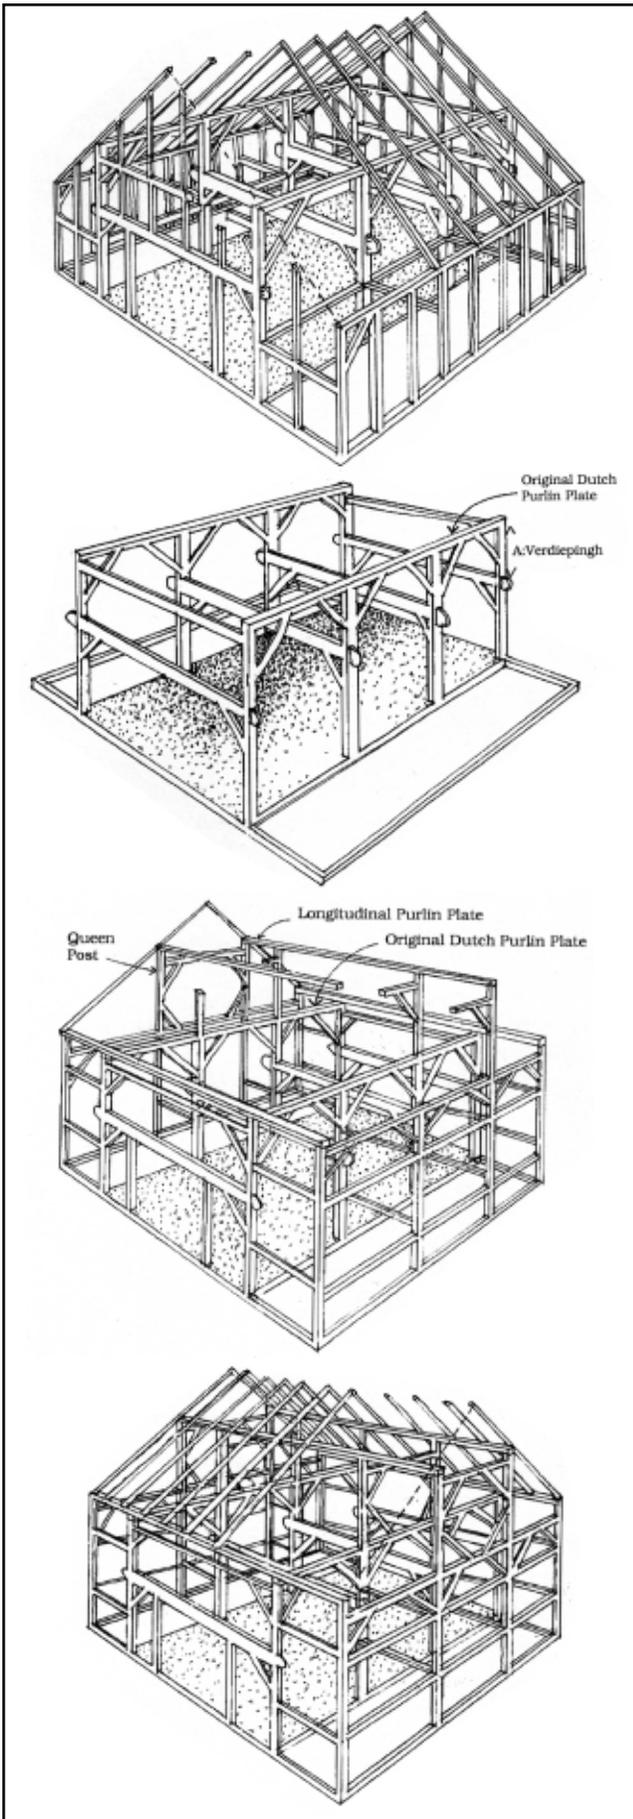
Figure 1. Four steps in the Anglicization of a NWD barn (Illustrations by Peter Sinclair).

It is important to know the technical procedures by which three-aisle barns were altered, resulting in side-wall wagon-entry Anglicized barns (Figure 1). Many of these conversions were discussed in an article by the author that appeared in *Material Culture*.⁷ It should be emphasized that these roofs were not simply picked up and

rotated ninety degrees and then placed down on newly-constructed structures with side-wall wagon entries; the term “rotated” is a misnomer. A more appropriate word would be “reorientation.”

Fourth, a new roof support structure was built. Queen posts were erected above the upper ties of the end bent and above the existing purlin plates of the original Dutch section of the barn. These posts supported the new barn-length purlin plates (Photo 3), on which the rafters were placed. Many of the rafters were recycled from the original barn; new rafters were often mill-sawn. In the original three-aisle barns rafters were parallel to the H-bents, whereas in the converted hybrid or Anglicized barns, the rafters were perpendicular to the H-frames. The location of the wagon doors remained the same relative to the H-frames, but were now located in the side or eave walls of the barn.

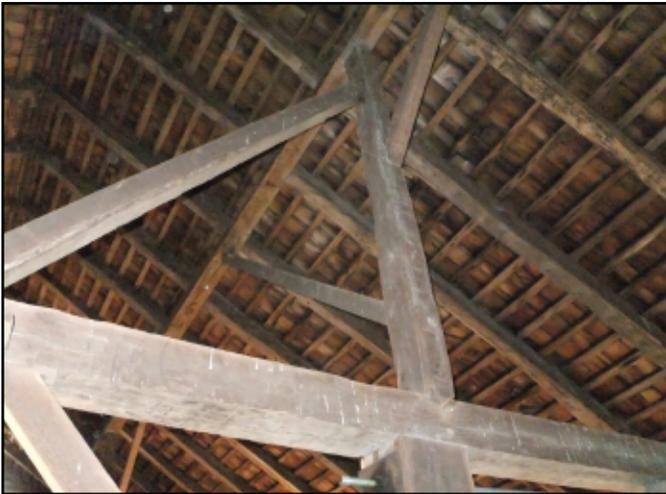
Photo 3. The Stevenson Dutch-Anglo Barn on Vanderburg Road in Marlboro; this barn illustrates the use of two levels of purlin plates in eave-wall entry barns. The vertical queen post supporting the "Anglo" purlin plates is supported by the "Dutch" purlin plate seen at the bottom of the photo (Photo by Greg Huber).

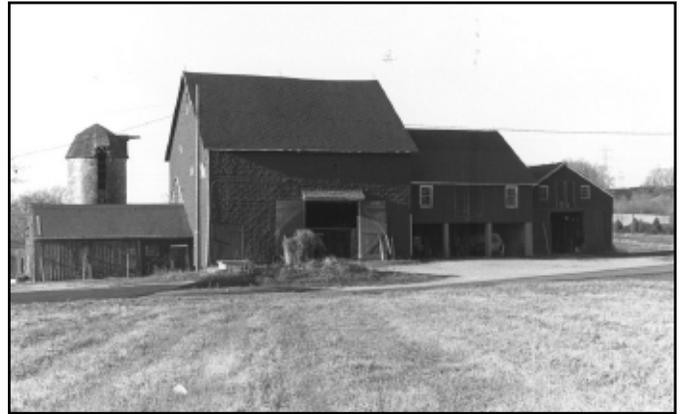
Photo 4. The Schanck Anglicized barn on Conover Road in Marlboro. This barn has the largest inner bent anchor-beams of any Dutch related barn seen by the author in either New York or New Jersey, one being just shy of 25 inches. The original three-aisle barn was built about 1790 to 1800 and was converted c. 1850 (Photo by Gail Hunton).

Jersey that consists of just two bays (Photo 4). The farmstead is now administered by the township and maintained as open space. The barn is in a reasonable state of repair, but one section of the rear roof slope is deteriorating. The H-frames are still in excellent condition.

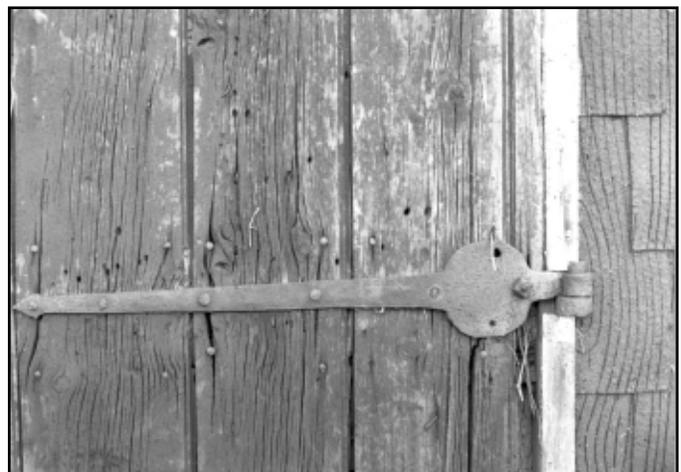
Photo 5. Classic Dutch-style hinge with pancake disk at the proximal end of hinge. Pad hinges such as that seen here were used throughout the Dutch-American settled areas (Photo by Gail Hunton).

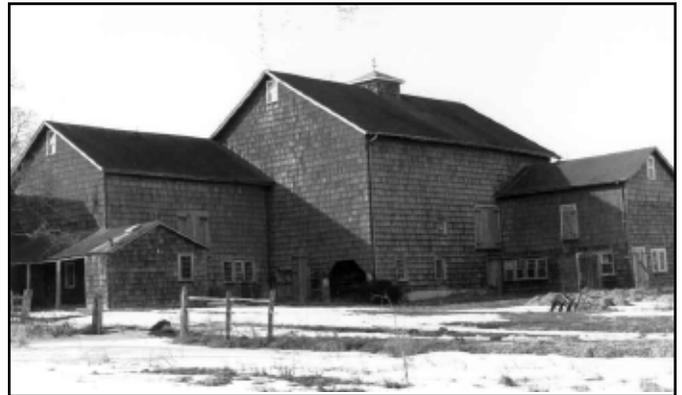
Photo 6. Array of barn structures at the Schenck homestead. Main Americanized barn with basement is seen in the middle; frame additions at each side (Photo by Gail Hunton).

Despite the fact that this barn with a basement was an Americanized hybrid construction, it was one of the most distinguished barn structures in the entire NWD cultural hearth. A brief article on the barn was published in the June 1992 issue of *Timber Framing* "Mammoth in Monmouth County".¹³ The barn frame made use of the largest timbers seen in any barn in New York or New Jersey seen by this author. It was first visited in August 1991 and extensively documented on 4 July 1992. The barn was unfortunately lost in a fire in the fall of 1998 (Photos 6 and 7).

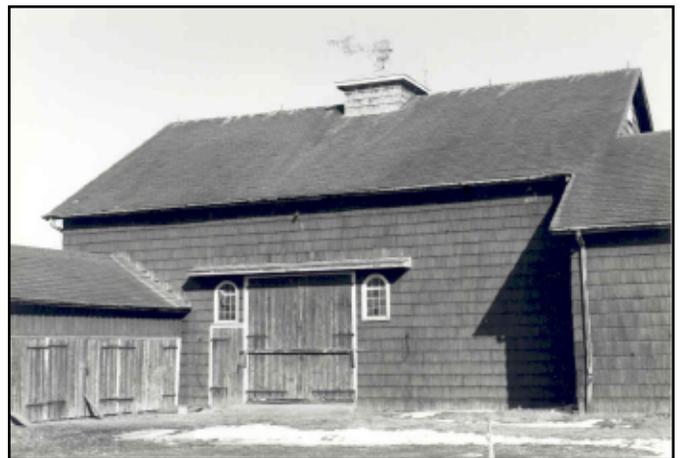
Photo 7. The Schenck Americanized eave-wall entry barn on Holmdel Road in Holmdel. This structure had the largest timbers the author has seen among Dutch related barns in either New York or New Jersey. The middle bay with its H-frames was part of three-aisle barn built circa 1780; the barn was converted c. 1850. It was lost in a fire in the fall of 1998 (Photo by Gail Hunton).

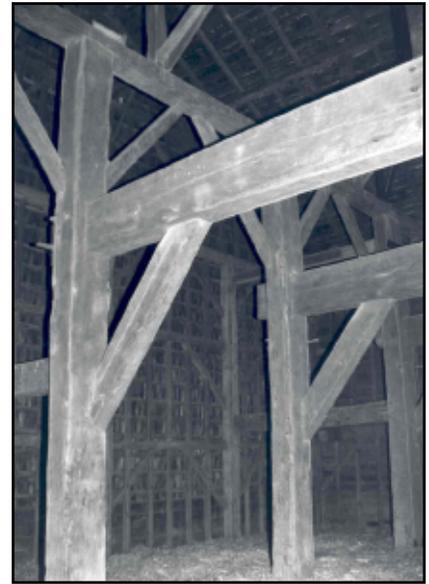
Photo 8. A second view of the Schenck Americanized barn, the "Mammoth in Monmouth County", with view of part of three inner H-frames. One H-frame post was over 20 inches in width, making it the largest post in any Dutch related barn known to this author. Inner anchorbeams were each over 20 inches in height (Photo by Gail Hunton).

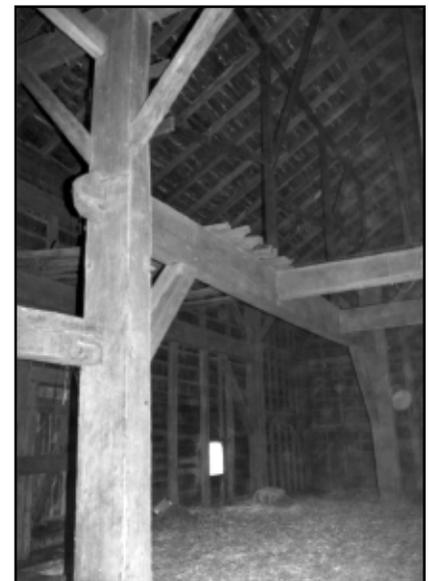
Photo 9. The Schenck barn, view of first inner H-bent. Two horizontal beams at the right side of the photo joined to the middle anchor-beam, thought to have been about 26 inches in height at its midpoint (Photo by Gail Hunton).

The H-frame braces were also of large size, measuring 1'-0" by 8". The widths of the shoulders cut into the posts to accept the anchorbeams were 2¹/₂" wide, also large; the normal range of shoulders in barns is 1¹/₄" to 1³/₄". The Dutch purlin plates were large at 1'-11¹/₂" by 7¹/₂" and the purlin braces measured 7¹/₂" by 5". The bottoms of the braces were attached to the H-frame posts only 5¹/₂" above the tops of the anchorbeams. The lower transverse side aisle ties were truly massive at 1'-1" by 9" (Photo 9), larger than the anchorbeams in some barns.

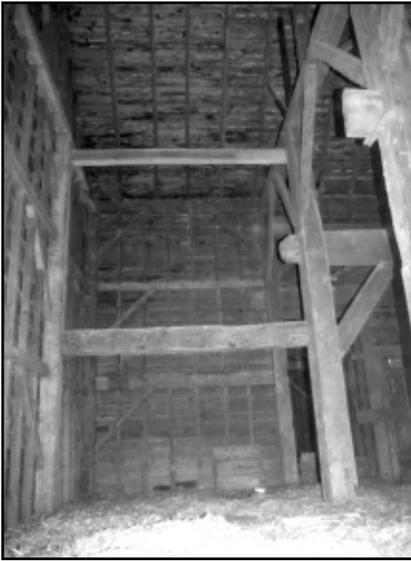
Photo 10. One of the end bays in the Schenck barn. Note the very large lower transverse end bay tie that may have been original to the three-aisle barn. The tie was 13 inches in height (Photo by Gail Hunton).

timbers, but such an exercise would be futile. If a building can ever be called pre-eminent, then the Holmdel Road barn was near the top of the list. A few remnants were saved after the fire, and may someday be dendrodated. The author took about twelve photos of the barn; Gail Hunton of the Monmouth County Park System took a number of others in the early 1980s (Photo 10).

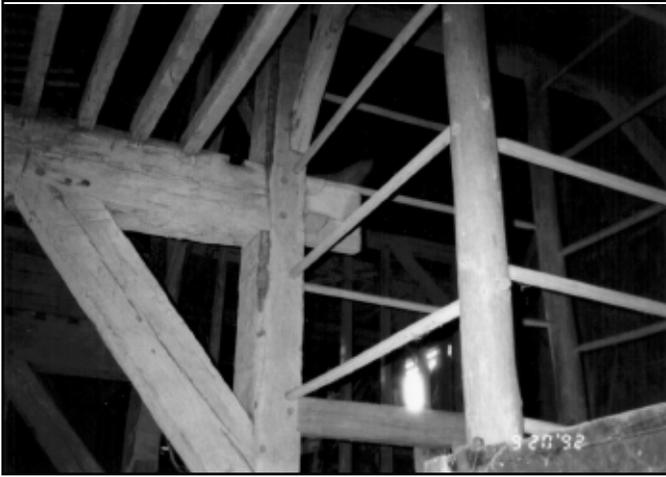
Photo 11. Hay hole in the Hendrickson barn (Photo by Greg Huber).

One feature of this barn was so unusual when first seen that the author thought it might be an "internal hay barrack" of some sort. It was later learned that this feature, commonly encountered in Pennsylvania fore-bay barns, is known as a "hay hole" (Photo 11). In the Hendrickson barn it extended from the floor of the second story level to the roof peak and consisted of three six-inch diameter sapling poles, plus an H-frame post, assembled to form a four-sided structure. Each side had a variable number of horizontal spars; one side had 15. At the bottom of this was an opening in the floor. Compared with the hundreds of examples of this feature that the author has since seen in Pennsylvania barns, the Hendrickson barn hay hole was the largest. Its dimensions were 5'-6" by almost six feet; most of these struc-

tures found in Pennsylvania barns are about 3'-6" square. The structure acted as a funnel or shoot for the dropping of farm crops from the upper levels of the barn within one end bay down to the basement level so that farm stock could be fed. It is not known why the farmer included such a massive sized "hay hole" structure in his barn. He may have copied other area barns, but not likely Dutch related ones.

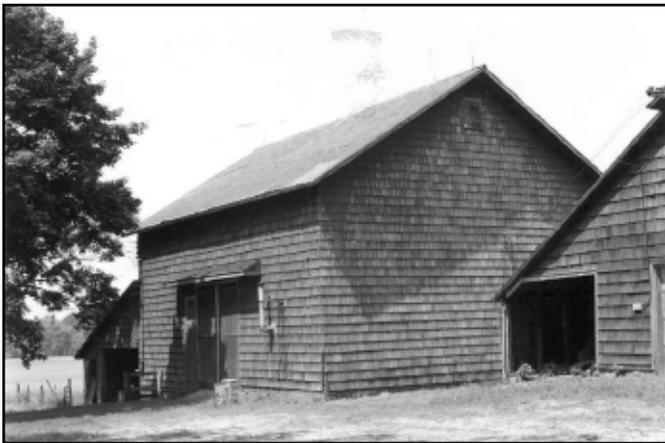
Photo 12. The Smock Dutch-Anglo eave-wall entry barn. Framed farm structures appear at each side of the main barn (Photo by Gail Hunton).

Several hundred feet from Longbridge Road in Holmdel sits the Smock three-bay Dutch-Anglo barn. The Township of Holmdel owns the barn together with a number of acres of land. The barn stands about 195 feet from a NWD frame house. The house and barn are in direct alignment. The barn was documented on 4 January 1992 (Photo 12).

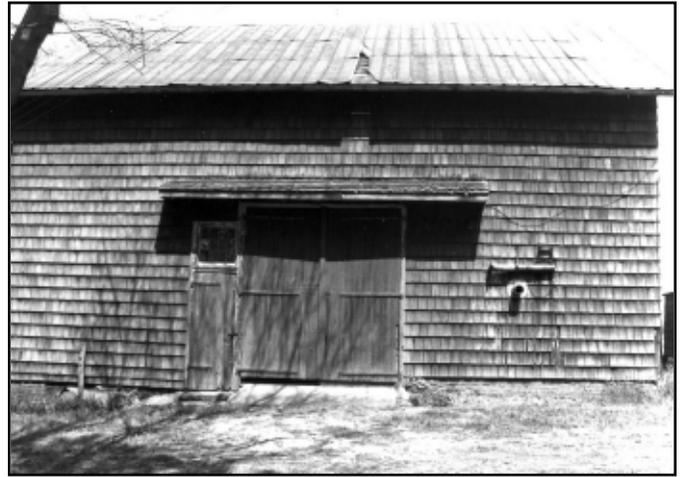
Photo 13. The Smock Dutch-Anglo barn; a close-up view of the sidewall wagon doors with flanking human door at the left side. The barn has a pentice roof projection that protects the doors from the weather (Photo by Gail Hunton).

The end walls of the barn measure 36'-4" wide and it is 46'-6" in length at each side-wall. The eave wall is about 20 feet high and the roof peak measures 32 feet from the ground. The exterior cladding consists of wood shakes. The slope of the roof is moderate and the foundation consists of local "peanut" stones and brick. The wagon doors are the swinging type (Photo 13).

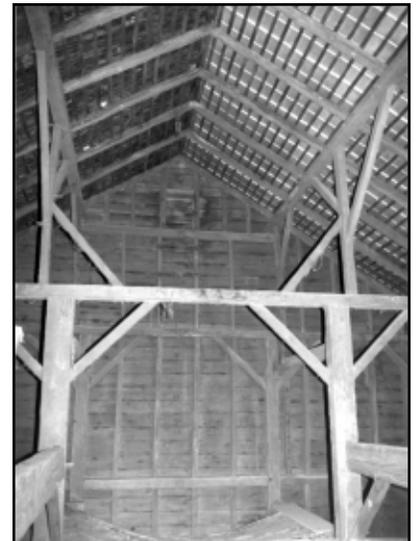
Photo 14. View in the Smock barn; the "Dutch" purlin plate at the top of the H-frames in middle of photo. Vertical queen posts are supported by these plates, and in turn support the upper purlin plates seen at the sides in the upper half of the photo (Photo by Gail Hunton).

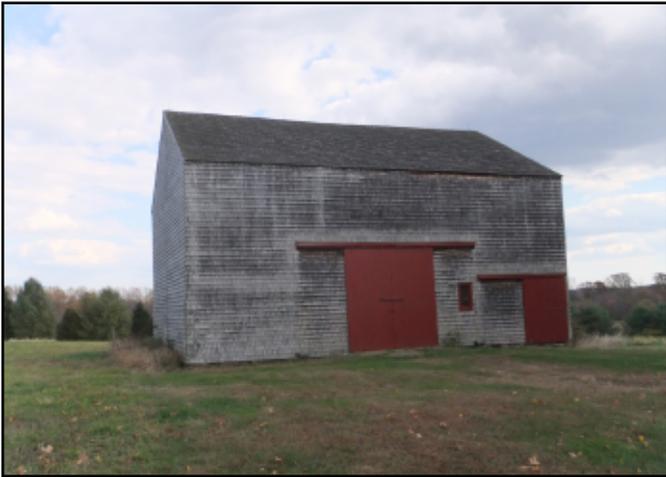
Photo 15. The Williamson-Sickles Dutch-Anglo barn on School Road East in Colt's Neck has three "Dutch" bays in the middle bay of this three-bay barn. This barn was likely built c. 1830 (Photo by Greg Huber).

Exterior dimensions of the barn are 48'-5" (eave walls) by 36'-2" (end walls). The height of the eave walls is about 20 feet and the height of the roof peak is about 29 feet. The exterior cladding is wood shakes but these cover older horizontal weatherboarding (Photo 15).

The barn has three Dutch bays. The middle aisle or nave is 24'-7" wide; the average width of each Dutch bay is about 12 feet. One Anglo end bay is 10'-8" wide while the other is 12'-8" in width. Eighteen pairs of rafters define the roof structure.

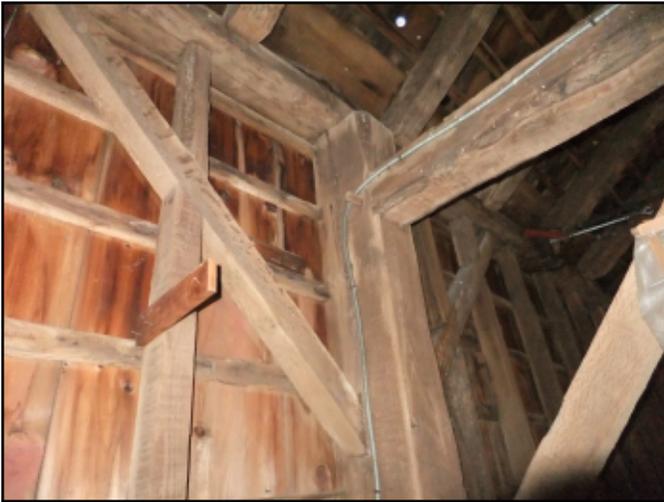
Photo 16. View of the Dutch-Anglo barn on Vanderburg Road in Marlboro with heightened eave-wall H-bent post that rises above the level of the "Dutch" purlin plate seen at the upper right. This feature proves that the barn was originally built as a Dutch-Anglo barn. Note horizontal slats where exterior wood shakes were originally nailed (Photo by Greg Huber).

The two oak inner anchorbeams average about 14" in height at their midpoints. All the H-frame anchorbeam tenons, including those of the bents adjacent to the eave walls, extend about seven to eight inches and are double wedged. The tenons are, curiously, rounded at their projecting ends; most often, anchorbeams of oak have extended tenons with squared ends. On the vertical side faces of the anchorbeams are slots for insertion of sapling poles to support crops stored above. H-frames posts that average 10 1/2 by 8 1/2 inches are unusual in that they are mill-sawn. Single raising holes are located 2'-6 1/2" down from the tops of the posts of the inner Dutch bents. The raising holes are located only about six inches from the posts' tops at the end bents. This disparity of raising hole placement is not unusual. The *verdiepingh* is 6'-11" in height. Mill-sawn purlin braces are quite small at only 4" by 3 1/2" and H-frame braces that are each about 6 1/2" by 4 1/2" are mill-sawn. In the great majority of NWD barns these braces are hewn (Photo 16).

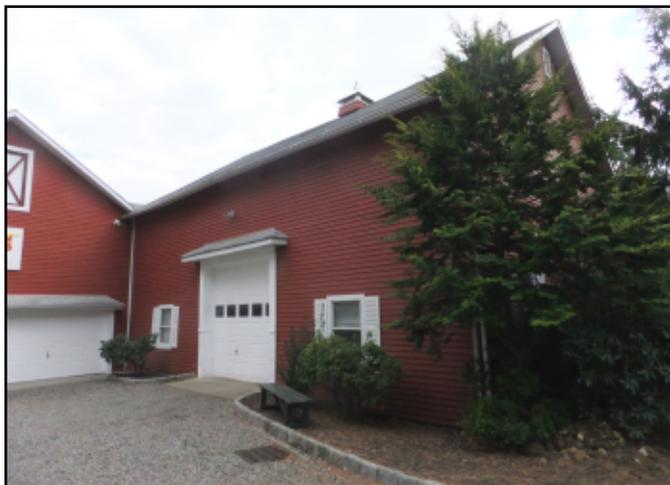
Photo 17. The Smock barn on Hillsdale Road in Colt's Neck is a previously unknown eave-wall entry barn type. The layout of its H-bents suggests a construction date of c. 1800 (Photo by Greg Huber).

Only a few details of the Smock barn on Hillsdale Road in Colt's Neck could be recorded on 4 January 1992. Entry to the barn was not then possible but some of its interior traits could be discerned. The barn, which has no basement, appeared to be in good condition at that time. The place is now known as Four JG's Vineyards (Photo 17).

It is not known if this barn was constructed as a Dutch-Anglo barn or an Anglicized version of the hybrid barn form. The main side-wall entrance faces five degrees west of south. House and barn are almost in direct alignment and the barn is about 212 feet from the house. The distance from barn to the main road is roughly 750 feet. The barn was covered with metal siding about 1990. Its exterior dimensions are 34'-6" at each end wall and 44'-10" along the eave walls. The height of the eave walls is about 18 feet; that of the height of roof peak is estimated to be approximately 29'-6". Judging from the end wall length (and if it was originally of three-aisle form), it is likely that the barn was of three-bay construction.
