July – September 2013

Newsletter

A Local Landmark Lost: The David Knapp House Yorktown, Westchester County, New York

Monmouth County, New Jersey and Its Three-Aisle Barns – Hendrickson Barn

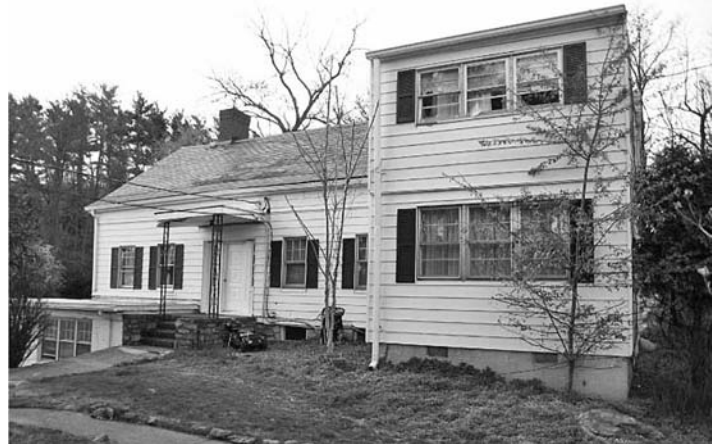
Fig. 1 – View of house from southeast, 2009.
Photo by Sullivan Architecture, Thornwood NY.

Intriguing history and construction details can lurk behind the most unprepossessing facades in the Hudson Valley. A case in point was provided by the Knapp house that stood for over two hundred years on Old Crompond Road in Yorktown, New York (Fig. 1). Sheathed in aluminum siding and subjected to disfiguring alterations, this house stood unappreciated for many years until it was demolished in 2012 for a commercial development project.

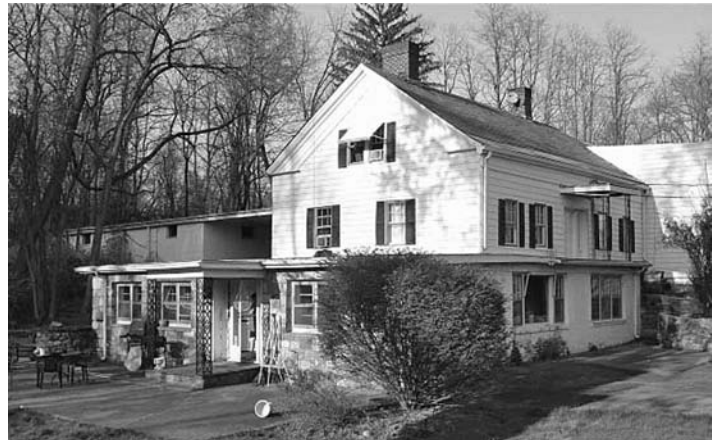
Fig. 5 – View of house from southwest, 2009. Photo by Sullivan Architecture, Thornwood NY.

Later Carrera expanded the basement level that had been exposed at grade on the west end of the house for a restaurant and added stone walls and a wide terrace for dining and dancing (*Fig. 5*). Carrera and her husband, J. Dodd Martensen, created a residence in a post and beam barn behind the house, which also was used as a roller skating venue and bar. (The barn stood in altered form until it, too, was recently demolished.) Built into the hillside to the west of the barn was a root cellar with stone walls and a ceiling supported with massive wooden logs (*Fig. 6*). Photos dating to the 1960s provided by later owners indicate that the house and the surrounding pastoral landscape remained largely unchanged until the area was redeveloped commercially in the following decades, at which time the house was divided into three separate apartments and all of the surviving interior historic detail was stripped out and discarded.

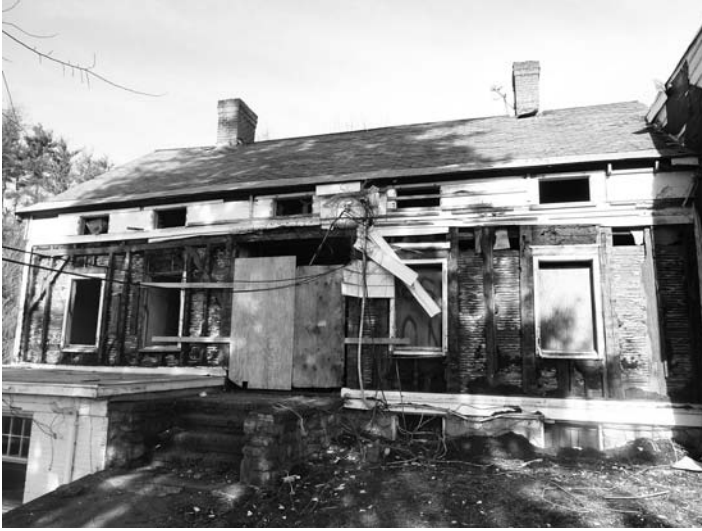
Fig. 7 – View of front facade from south with siding removed, 2012.
Photo by J-F De Laperouse.

Numerous details such as the asymmetrical spacing of the windows on the front façade, the tall frieze windows, the absence of substantial corner boards and the awkward return of the frieze boards on the sides of the house indicated that this structure might not have originated as a Greek Revival-period house. Indeed, when the aluminum and clapboard siding was removed from the front wall, it was revealed that the house was built using two framing systems (*Fig. 7*). To the right- or east-side of the central doorway the house was constructed with Dutch H-bent construction with roughly hewn main posts spaced 4 feet apart and intermediary studs installed as nailers for the plaster lath. The 9-inch tall, smoothly planed and painted tie beams joined to the posts with through tenons were held in place with two pegs (*Fig. 8*). Windows had been inserted between the main posts but facing notches on the inside faces of central two posts suggest the former presence of a doorway. The bottoms of the posts were all cut off at some point, presumably due to rot, and replaced above the sill beam which appeared to be a minimally flattened log.

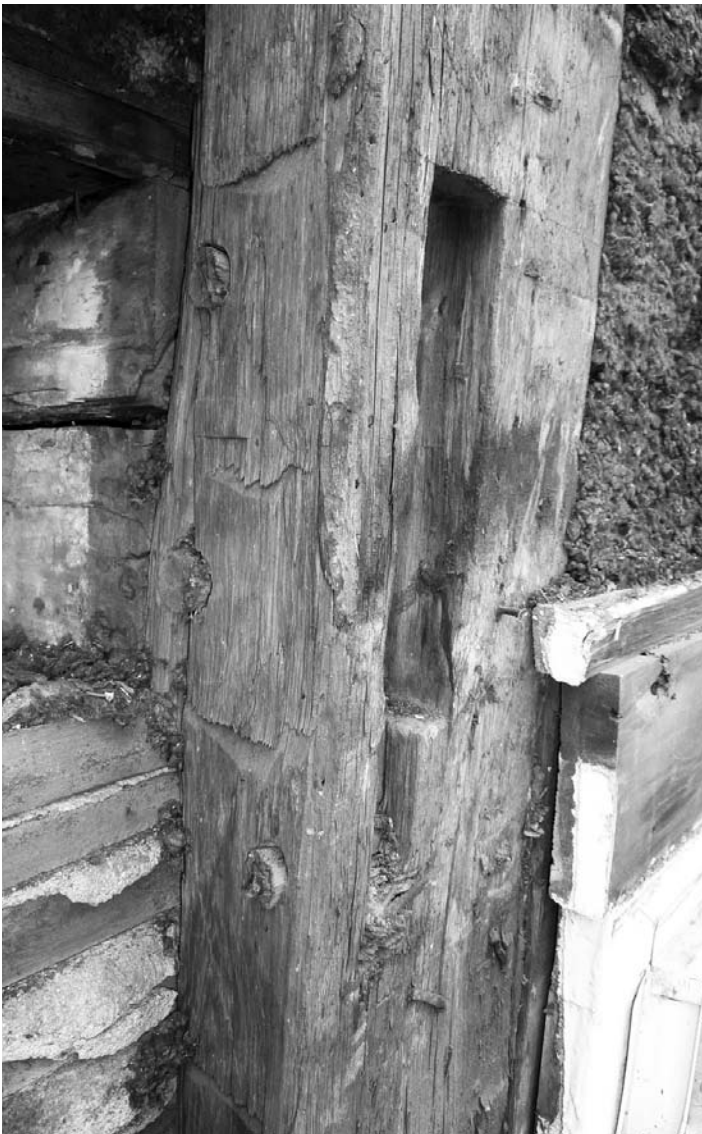
Fig. 8 – Detail of H-bent joint on east side of front façade, 2012.
Photo by J-F De Laperouse.

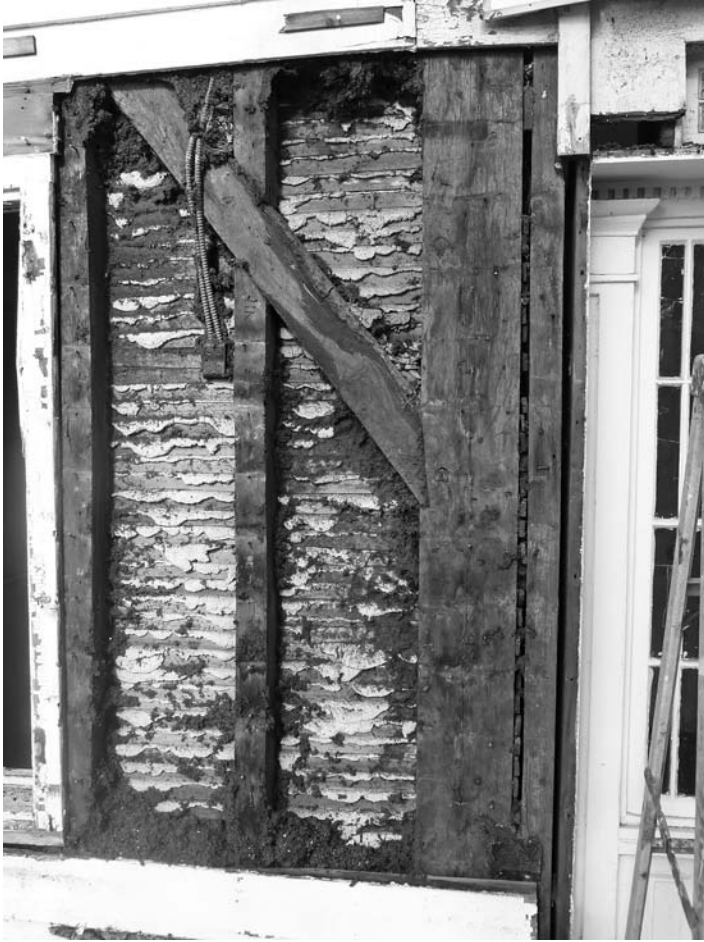
Fig. 9 – Detail of framing on west side of front façade, 2012.
Photo by J-F De Laperouse.

On the west side of the house, however, framing typical of the 19th-century was employed using hewn principal timbers and sawn studs and braces (*Fig. 9*). The braces in the two upper corners featured through joints with diminished housing and all of the joints were scribe-marked with deeply chiseled numerals. The large hearth with the beehive oven mentioned in the 1931 article was found behind a false wall on the basement level and beneath fireplaces that served both rooms above (*Fig. 10*). While the large hearth had been refaced with modern bricks, old bricks laid a very weak lime mortar were found in the beehive section and in the fireplaces above. Although the chimney flues above the first floor had been rebuilt, the fireboxes on the first floor were in danger of collapse.

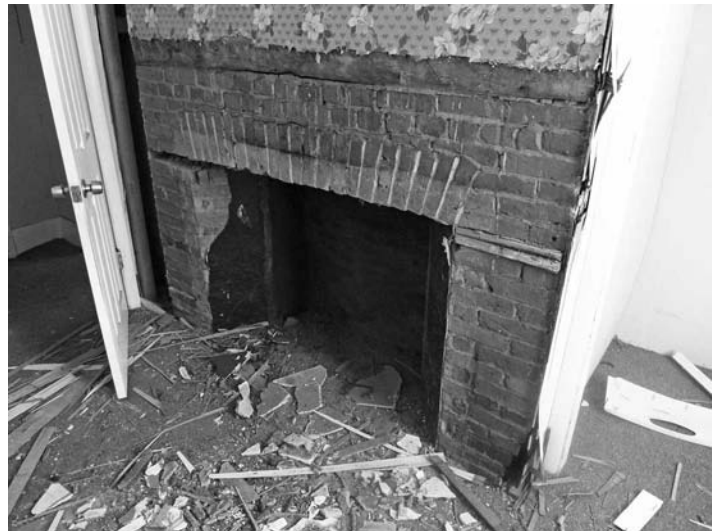
Fig. 10 – View of fireplace in front room on first story, 2012.
Photo by J-F De Laperouse.

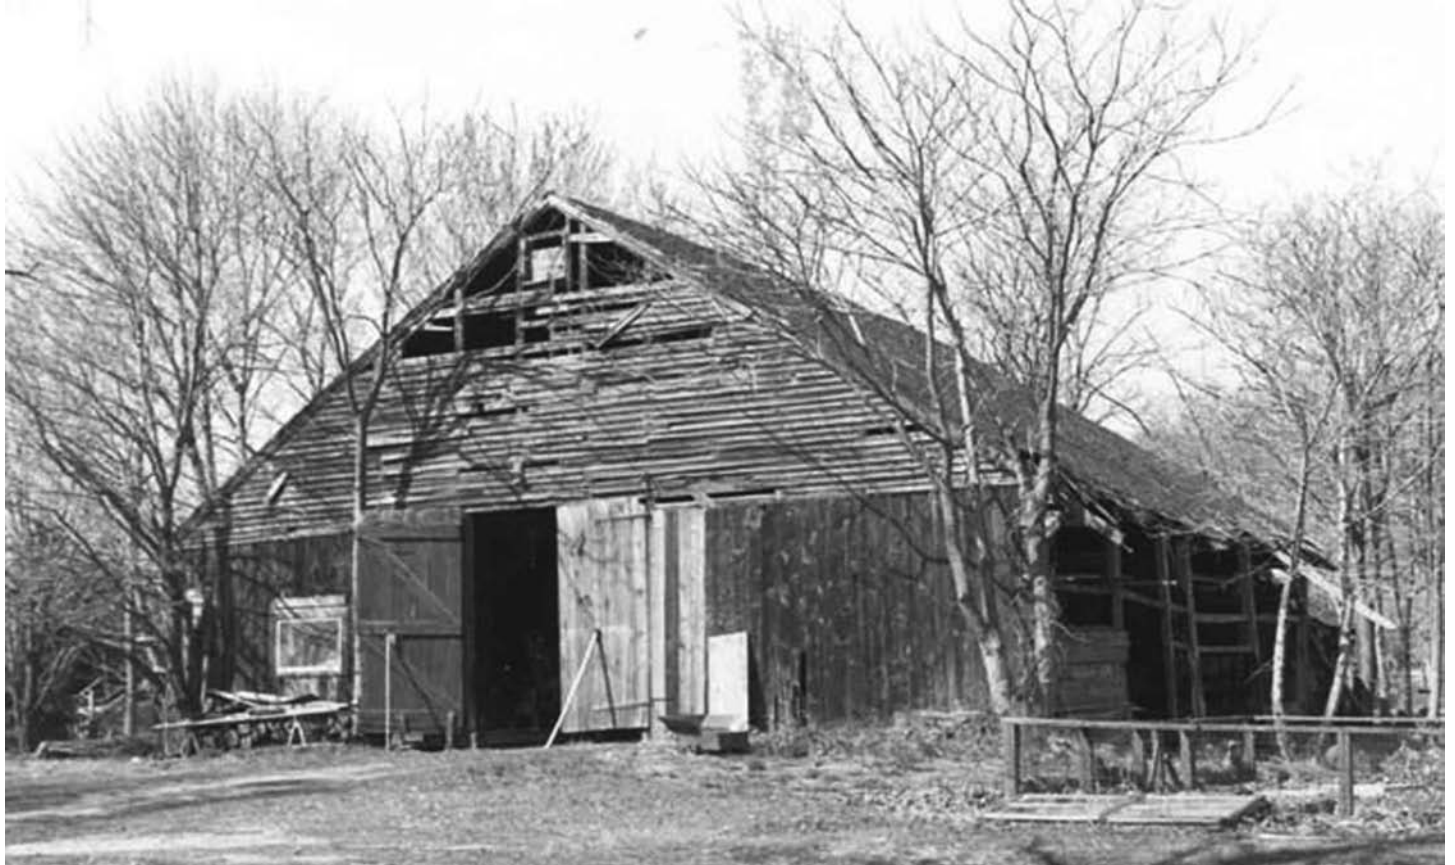
Fig. 1 – The Hendrickson three-aisle barn, Crawford Corners Road, Holmdel NJ, c. 1790.
Note deterioration of eave wall on the right. Photo by Gail Hunton, 1981.

Located about 400 hundred feet northeast of Crawford Corners Road in the Pleasant Valley area of Holmdel near Hop Creek, the Hendrickson barn was an excellent example of a late-eighteenth-century three-aisle barn (*Fig. 1*). The author visited the barn in 1991 with Gail Hunton,

The house side end wall of the barn originally had horizontal weatherboards but the sidewalls curiously enough appeared to have had vertical siding. This last feature occasionally occurred on three-aisle barns in both New York and New Jersey. Hunton’s 1981 photo shows that swinging type wagon doors were affixed at the front end wall (*Fig. 1*).

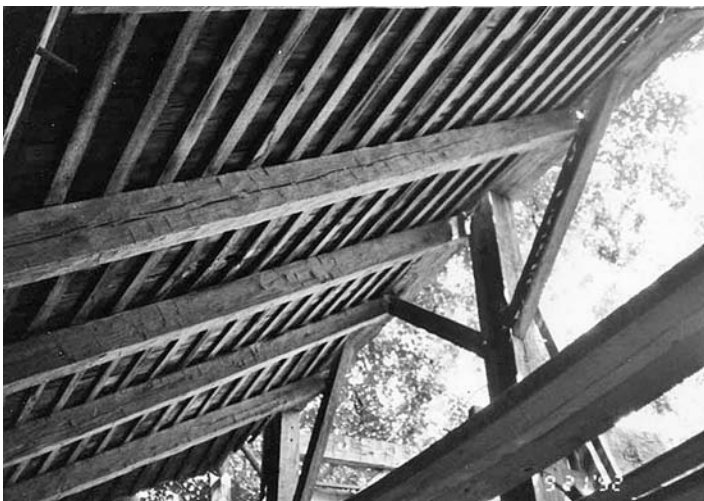
Fig. 2 – View of rafters remaining over one side aisle; sections above the purlin having collapsed onto floor of barn. View includes two H-frame posts with their attendant purlin braces. Photo by Greg Huber, 1992.

Virtually all timbers in the Hendrickson barn were oak. Not all the barns in the county were constructed with oak timbers; a few were made of tulip wood. Thirteen pairs of hewn rafters constituted the Hendrickson roof structure (*Fig. 2*). The tapered rafters measured 6 by 4½ inches in cross section (cs) at the top and about 8 by 6 inches (cs) at the bottom. The bottoms were bird’s mouthed on to the wall plates (*Fig. 3*). An iron spike (10½ inches long) secured one rafter to the plate, which likely was the case at other rafter to plate unions. Notches were cut about mid-way to be received onto the purlin plates. The author has no record of how the tops of the rafters were joined, but probably with a pegged fork-and-tongue joint.

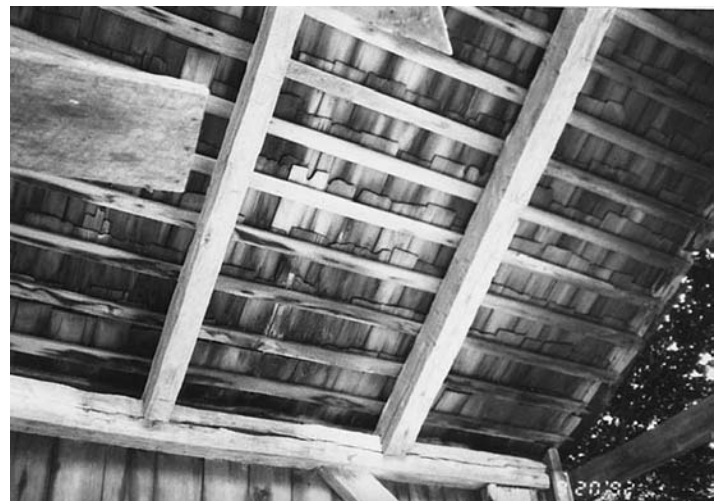
Fig. 3 – View of underside of roof showing rafters, wood shingles and oak lath. Note bottom ends of rafters are fish-mouthed onto wall plates. Photo by Greg Huber, 1992.

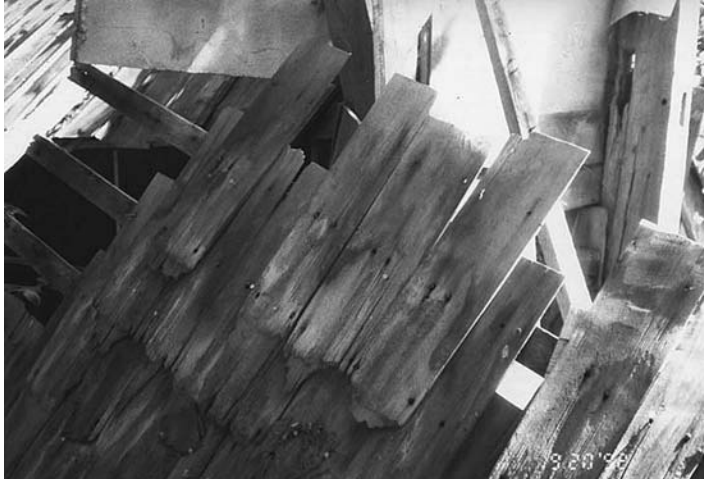
Fig. 4 – View of original roof shingles with sections exposed to weather reduced to nubs. The shingles were secured to roof lath with wrought nails. Section of roof covering shown here had fallen to ground. Photo by Greg Huber, 1992.

Amazingly, many original wood roof shingles were found secured to lath with wrought nails (*Fig. 4*). Several retained

their full original 32-inch lengths with widths varying from 6½ to 8 inches. About 10 inches of the shingle was exposed to the weather. A layer of asbestos shingles overlaid the wood shingles, probably added in about 1950, and unless there was an undetected or previously discarded layer of roofing in between, the wood shingles would have been in service for about 160 years. The author attempted to have the species of wood of the shingles identified but, unfortunately, two authorities came up with two different tree species, both common in the western United States. The whole story is a very convoluted but fascinating one and merits detailed attention in a future article.

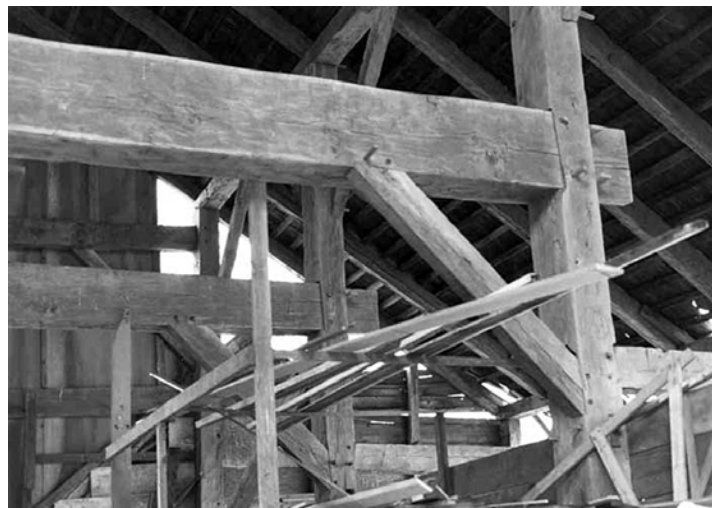
Fig. 5 – View of interior showing joint sections of two H-frames and part of one side aisle. Note distinct square profile of anchor-beam tenon extensions. H-frame braces secured at each end with double pegs. Photo by Gail Hunton, 1981.

The heights of each inner anchor-beam were greater at their midpoints – 18½ to 20 inches – than at their joints with the posts – about 16 to 18 inches. Through tenons extended 10 to 12 inches beyond the posts and were square in profile, which is standard for oak anchor-beams. The tenons were double pinned and double wedged (*Fig. 5*). One wedge was 18 inches long. Anchor-beam joints had diminished haunch or angled connections. Braces were hewn. Inner braces averaged about 8 by 5 inches (cs) and were double pegged at each end; it appears that these braces were single pegged at one end wall.

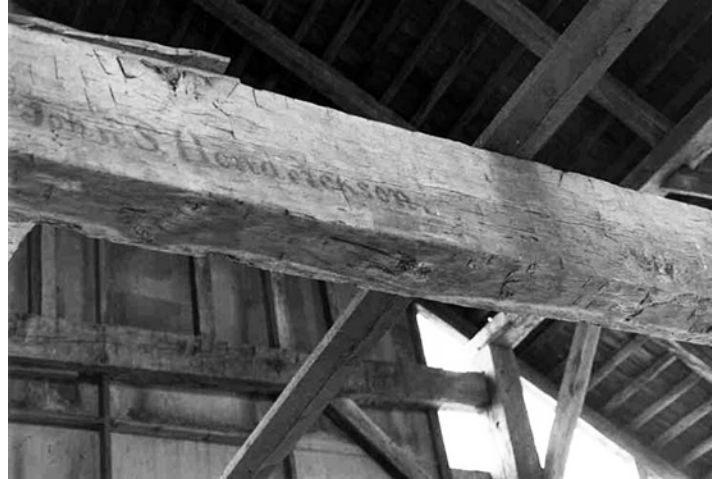
Fig. 6 – View of the name of John S. Hendrickson painted on the vertical side of an inner anchor beam. Photo by Gail Hunton, 1981.

The reference or lay-out face (the side where all bent components are flush in the same plane) of each inner H-frame was oriented towards the end of the barn facing the house. This is the case (as opposed to lay-out faces facing away from the house) in a good majority of Dutch-American homesteads. This condition at the Hendrickson farm may also lend some credence to the idea that the barn was on its original site. No two-foot scribe marks were found on any of the anchor-beams. On the vertical face of one inner anchor-beam in lampblack the name of John S. Hendrickson appeared (*Fig. 6*).

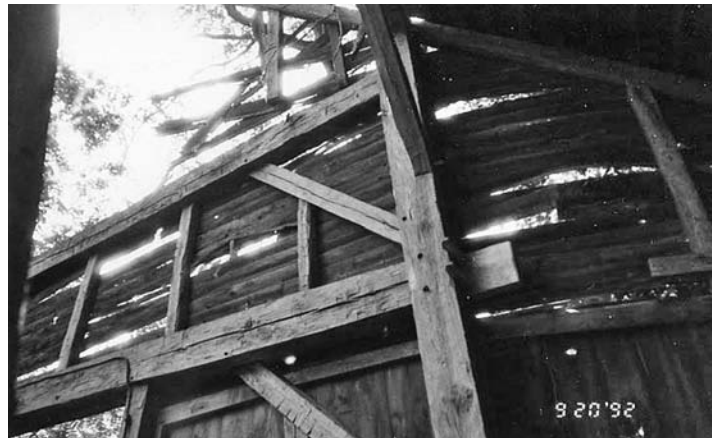
Fig. 7 – View of house-side end wall showing anchor-beam with square through-tenon and anchor beam brace at its right end. Above anchor beam is an upper tie beam and brace positioned near the top of the post. Photo by Greg Huber, 1992.

The one intact end wall anchor-beam (at the house side) was about five inches shorter in height near its mid-point than the inner anchor-beams (*Fig. 7*). The end bent anchor-beam had its mittelmanse hole in plain view. This hole was on the soffit in the middle of an end wall anchor-beam for insertion of a vertical pole or mittelmanse that held the two wagon doors in place when either or both were in a closed position. The two doorposts on which the wagon doors were hinged were original and were separated by 10½ feet. Each post had three recesses or batten gains for each wagon door half. The end wall bent had an upper tie beam 4 feet 10 inches above the anchor beam. It had long braces at the ends; such braces were not always used.

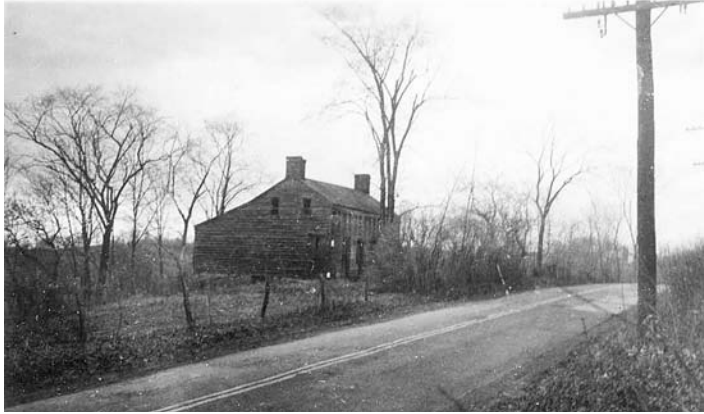
Fig. 1 – View of House #1 believed to be looking north-northwest (all photos and drawings by Carl Erickson, 1956 unless otherwise indicated).

My guess is that House #1 was located on or near Route 9 in Chatham or Ghent – I'd like to hear from anyone who can identify it for me. It was a story-and-a-half wood-frame house (Fig. 1). From Carl's plan we can guess that the lean-to seen to extend across the back of the house was integral to its initial construction (Fig. 2). The cross wall, extending from front to back of the house, may be an indication that it was constructed in two phases or for two dwellings or uses; a stair to the second story was located in the room on the left. Neither the photograph nor the floor plan allows us to definitively identify the arrangement of doors and windows on the front elevation, but it seems that there may have been more than one door on the road-side elevation (Fig. 3).

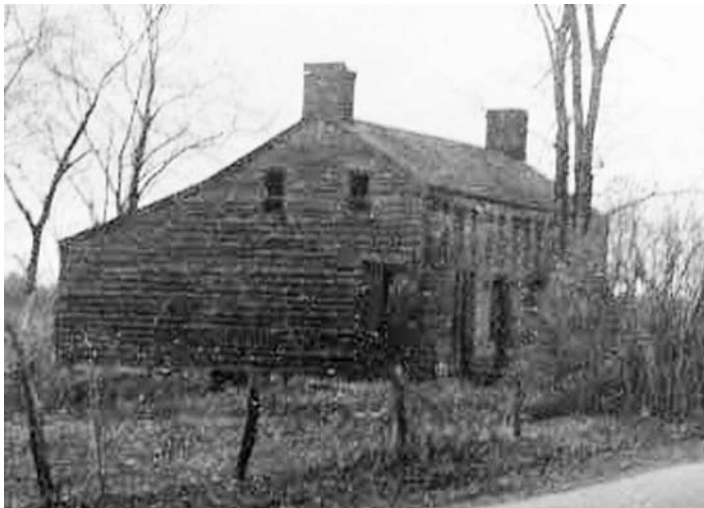
Fig. 3 – View of House #1 enlarged.

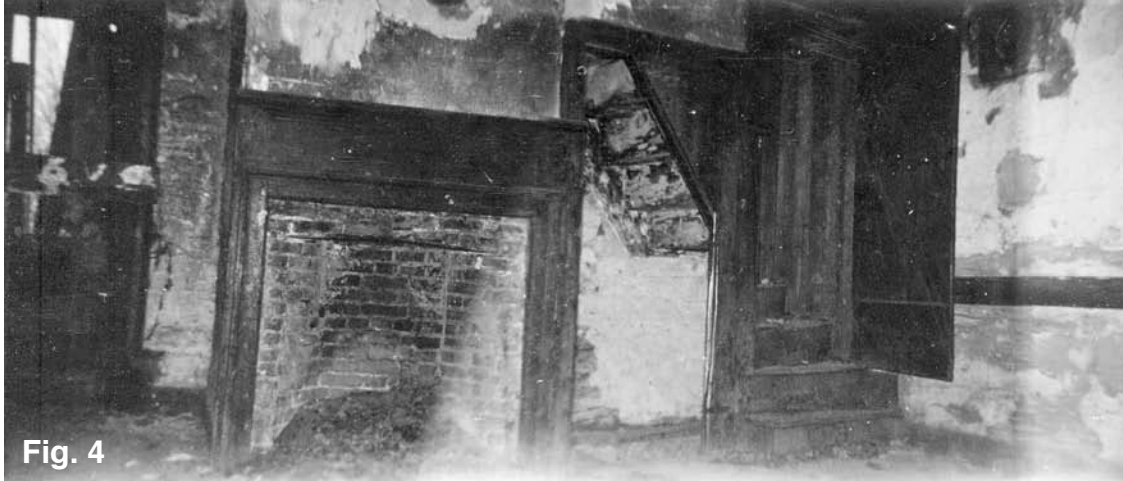
Fig. 4 – House #1, interior view looking south to southwest.

The door on the south end wall is seen in a photograph of the interior that I've created by joining Carl's three interior photos into a composite image (Fig. 4). This image depicts what I presume to be the south and west walls of the first floor of the south room. The door – of the simplest board and batten type – is partially seen at the left side of the image. The shallow and narrow firebox, constructed with Flemish bond brickwork, retained the supports for a crane in its left-side jamb. That this fireplace was later supplanted by a stove is indicated by the presence of thimbles in the wall above the mantle and in the wall between the front and rear rooms.

Immediately to the right of the fireplace was a closet, the door of which was missing by the time Carl visited. Adjacent to that was a stair, all but the bottom tread of which was enclosed by a simple board and batten door.

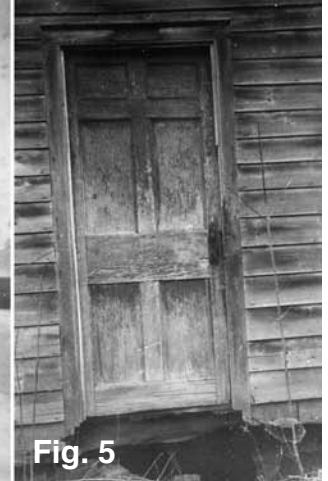
Fig. 5 – House #1, view of exterior doorway, probably on the road facade.

The walls within the enclosed stair were finished with vertical planks. A chair rail extended from behind this door along the west wall. The form of the house and details used suggest a construction date of c.1790-1820 or so. Carl took an additional photograph of what must have been one of the doors on the road facade (Fig. 5). It depicts a six-panel door with finely detailed mouldings, in keeping with that period.

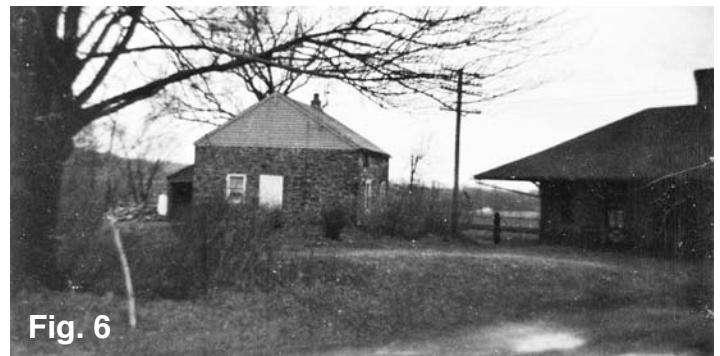
Fig. 6 – View of House #2 looking southeast.

The second building photographed by Carl is a small stone dwelling (Fig. 6). House #2 was apparently inhabited at the time of Carl's visit, hence there is no interior documentation. It appears to be adjacent to a railroad depot, and I believe this to be the same building as the house that still exists south of County Route 28 west of Chatham Center and adjacent to the Boston & Albany Railroad right of way (Fig. 7). The 1873 Atlas of Columbia County shows two buildings comprising the depot at that time, and it is likely that this house was pressed into service as a residence for the stationmaster or for an office. The name of the family who originally constructed it is so far unknown to me.

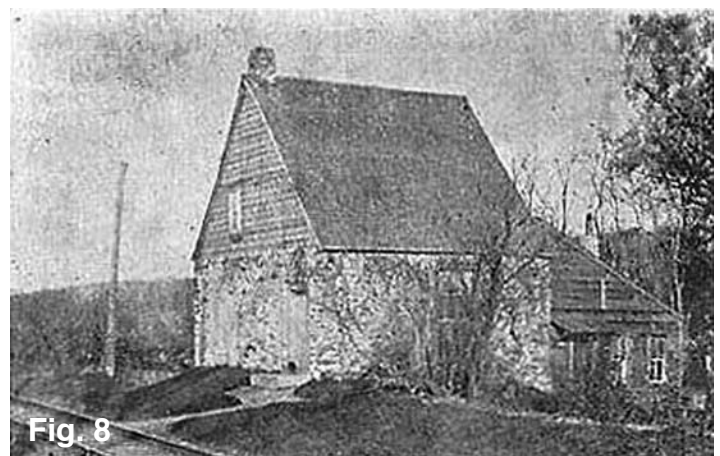
Fig. 8 – View of an early stone house in the vicinity of Ghent, adjacent to either the Boston & Albany or the New York Central & Harlem River Railroad tracks, c.1905. (unidentified photographer).

The situation of House #2 brings to mind another stone house, now long gone, located adjacent to a rail line in the Town of Ghent, to the south (Fig. 8). The caption accompanying the photograph says that the house burned in April 1905, and that "before the Civil War the cellar of this building was used as a place of detention for slaves." If anyone has additional information on either of these stone houses – please send it along!
